Child Safety Seat Fatality Investigation/Vehicle Rollover
Dynamic Science, Inc./Case Number: DS05018
1996 Isuzu Oasis LS Minivan
North Dakota
September 2005

1. Report No. DS05018	2. Government Accession No.	3. Recipient Catalog No.	
4. Title and Subtitle Child Safety Seat Fatality Investigation		5. Report Date June 14, 2006

The focus of this on-site investigation was on a child safety seat installed in the second row right seating position of a 1996 Isuzu Oasis LS minivan. This single vehicle crash occurred in September, 2005 at 1550 hours in the state of North Dakota. The crash occurred on a two-lane divided highway. The posted speed limit was 105 km/h (65 mph).

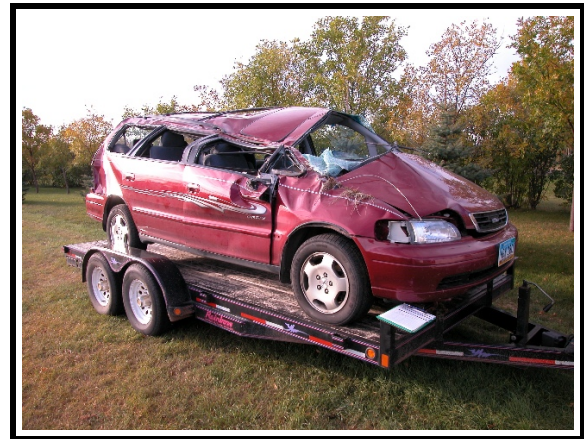
The case vehicle is a 1996 Isuzu Oasis LS (VIN: JR2RJ1871TCxxxxxx) minivan that was being driven by a restrained 29-year-old female (Figure 1). There were two additional occupants in the vehicle—a 3 year-old female, restrained in a

Figure 1. 1996 Isuzu Oasis LS minivan

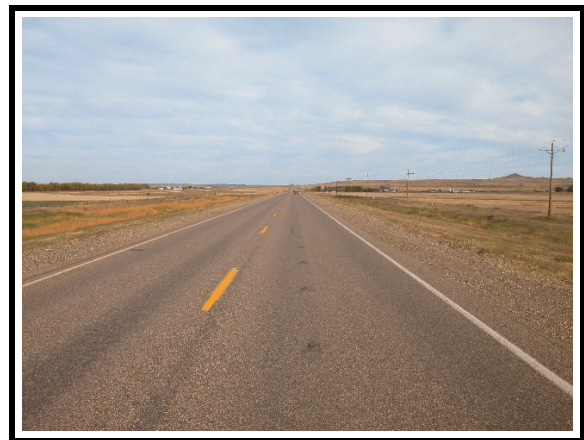
This single vehicle crash occurred in September, 2005 at 1550 hours in the state of North Dakota. The crash occurred on the west side of a two-lane divided highway (Figure 2). The roadway was of asphalt construction and was straight with a -2.8% downgrade. The west side of the roadway was bordered by an asphalt shoulder, an area of gravel with a -5.4% downgrade, and an area of low grass. The posted speed limit was 105 km/h (65 mph).

Figure 2. Overview of travel path (north)

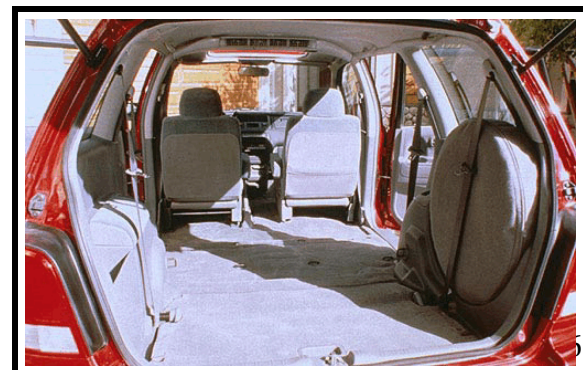
The vehicle sustained significant intrusion along the right roof, pillars and side rail areas (Figure 6). These field measurements were obtained from the floor vertically, and an exemplar vehicle was located in order to obtain comparative, undamaged measurements (Figure 7).

Figure 7. View of exemplar vehicle interior

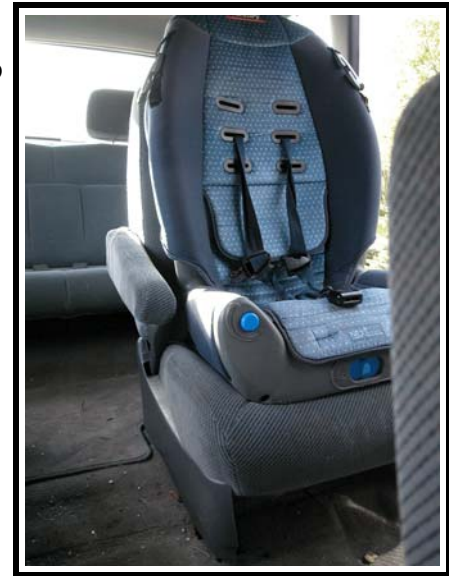
The second row right seat was occupied by a 3-year-old female who was seated in a forward facing Century Next Step booster seat (Figure 8). It had been manufactured on December 20, 2001 with a model number of 44905 HCB. Its internal 5-point harness had the shoulder straps located in the middle position (three slot settings available on the back). There was a retainer clip present. According to the label affixed to the side of this particular seat, it was designed to have the internal harness worn by children ranging in size from 9.1-18.1 kg (20-40 lbs). Once a child had grown to the point where their shoulders were at the top of the upper slots, the internal harness was to be removed and the vehicle's seat belt was to be placed around the child and the booster seat. The size range for a child to be using the seat in this manner was 13.6-36.3 kg (30-80 lbs).

Figure 8. Century Next Step booster seat

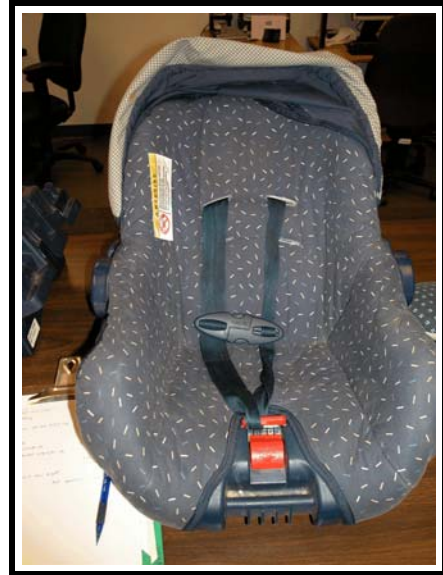
The second row right seat was occupied by a 7-month-old male who was seated in a rear-facing Evenflo Discovery Infant safety seat (Figure 10). According to information provided by the manufacturer, this particular infant seat was designed for infants within the 2-10 kg (5-22 lbs) range. The weight of this child was 8.0 kg (17.6 lbs), but his height is not known. The separate base provides quick access in and out of the car. The internal harness has two slot positions which provide flexibility to secure an infant comfortably.

Figure 10. Evenflo Discovery Infant Safety Seat

The infant seat used in this particular crash was manufactured on March 23, 2002 with a model number of 4791270P1. The internal 3-point harness had its shoulder strap webbing located in the upper slot (top) and the handle was found in the downward position. Post-crash photos also show the handle in the down position. The infant seat base did not exhibit any signs of stressing or flexing as a result of the crash (Figure 11). This particular base was no longer in the case vehicle, but was being held at the highway patrol office when it was inspected. An examination of the seat and seat base revealed that the locking mechanism attaching the seat to the seat base was functioning correctly. There were no indications of stressing or flexing at the locking points. It appears likely that the child safety seat had been placed on the seat base, but had not been properly locked down.
