### **ON-SITE CERTIFIED ADVANCED 208- COMPLIANT VEHICLE INVESTIGATION**

CASE NUMBER - IN-05-018  
LOCATION - TEXAS  
VEHICLE - 2003 CADILLAC C1500 ESCALADE  
CRASH DATE - March 2005

April 26, 2006  
Revised: March 31, 2008

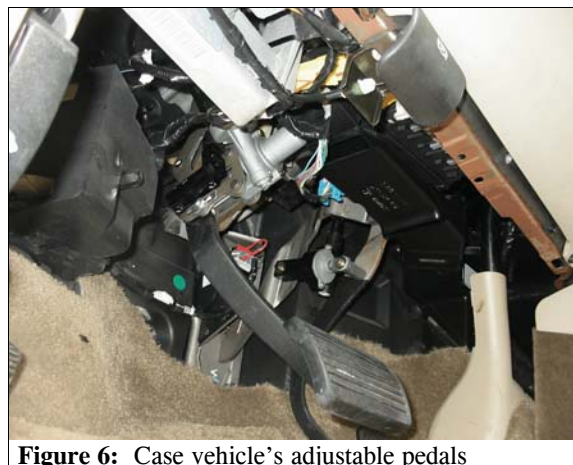
The 2003 Cadillac Escalade 1500 was a rear wheel drive, four-door sport utility vehicle (VIN: 1GYEC63T43R-----) equipped with 5.3L, V8 engine; four speed automatic transmission with overdrive; four wheel, anti-lock brakes; traction control, stability control and power adjustable pedals (**Figure 6** below). The front seating row was equipped with bucket seats with

Figure 6: Case vehicle's adjustable pedals

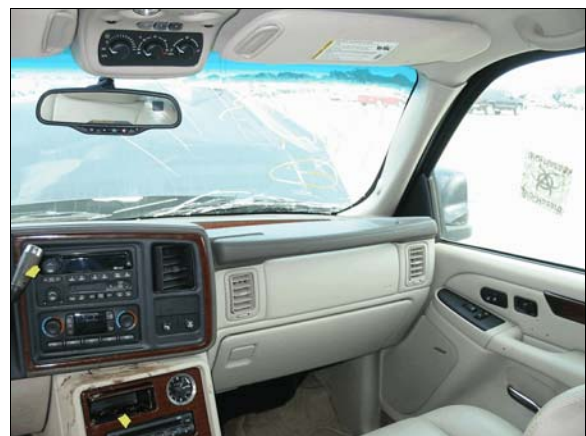
The front right passenger's air bag was located in the middle of the instrument panel (**Figure 15**). The seat back-mounted, side impact air bags were located in the outside of the driver and front right passenger's seat backs.

**Figure 15:** Front right air bag located in middle of right instrument panel above glove box door
