Redesigned Air Bag Investigation / Vehicle to Vehicle
Dynamic Science, Inc. / Case Number: DS05022
1998 Plymouth Breeze
Idaho
September, 2005

1. Report No. DS05022	2. Government Accession No.	3. Recipient Catalog No.	
4. Title and Subtitle Redesigned Air Bag Investigation		5. Report Date May 1, 2006

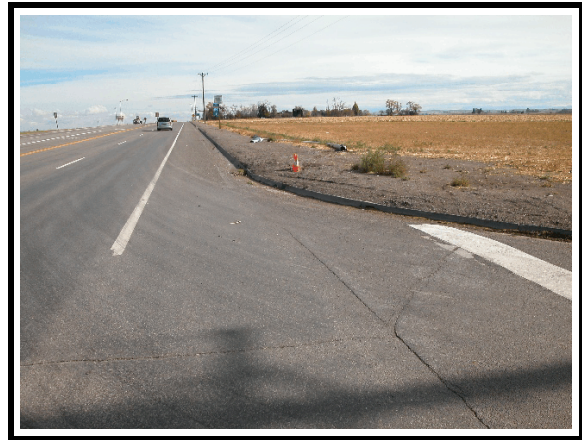
Figure 3. Path to impact with light pole

The Breeze was deflected to the right and struck a metal light pole in the southeast corner of the intersection. The light pole sheared at the base. The Geo Storm came to rest east of the intersection facing northeast.
