Certified Advanced Compliant Air Bag Investigation / Vehicle to Vehicle  
Dynamic Science, Inc. / Case Number: DS05027  
2005 Lexus RX330  
California  
October 2005

1. Report No. DS05027	2. Government Accession No.		3. Recipient Catalog No.	
4. Title and Subtitle Certified Advanced Compliant Air Bag Investigation		5. Report Date May 27, 2006

**Dynamic Science, Inc.**  
**Crash Investigation**  
**Case Number: DS05027**

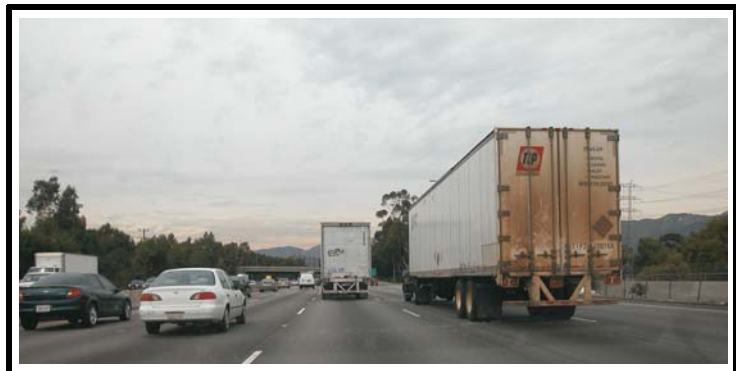
**Figure 2.** Overview of travel path (north)

The crash occurred in the northbound lanes of a five-lane, divided interstate highway. The asphalt roadway is straight and level. The roadway is bordered on the right by a solid white line and an asphalt shoulder. The roadway is separated from southbound traffic by a concrete New Jersey barrier. The weather was clear and the roadway was dark with no streetlights available. The speed limit is 105 km/h (65 mph).

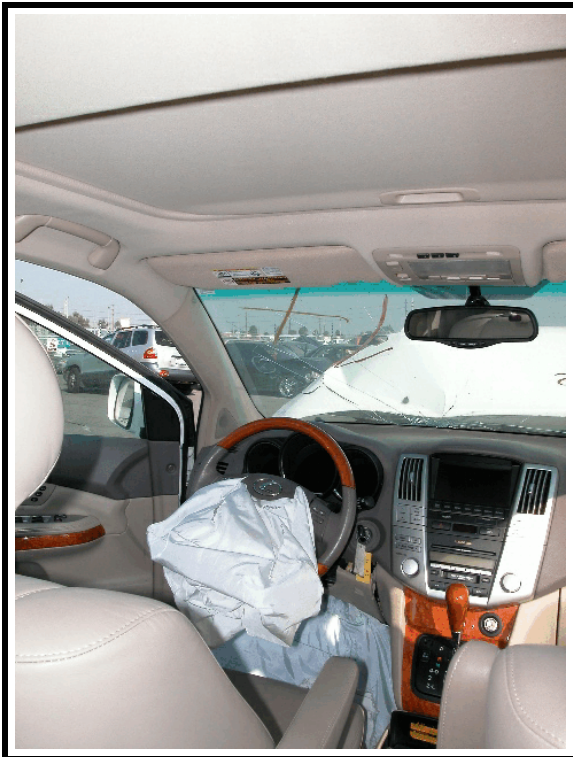
**Figure 4.** Driver's seated position

The 37-year-old male driver was seated in an upright posture and restrained by the 3-point manual lap and shoulder belt. The leather covered bucket seat was positioned between the middle and full back position. Prior to impact, the driver began braking. At impact, the driver's frontal air bag and knee air bag deployed, and the driver's safety belt pretensioner actuated. The male driver initiated a forward trajectory. He loaded the safety belt and his left knee engaged both the knee air bag and the knee bolster. He did not report any injuries. He was able to exit the vehicle under his own power.

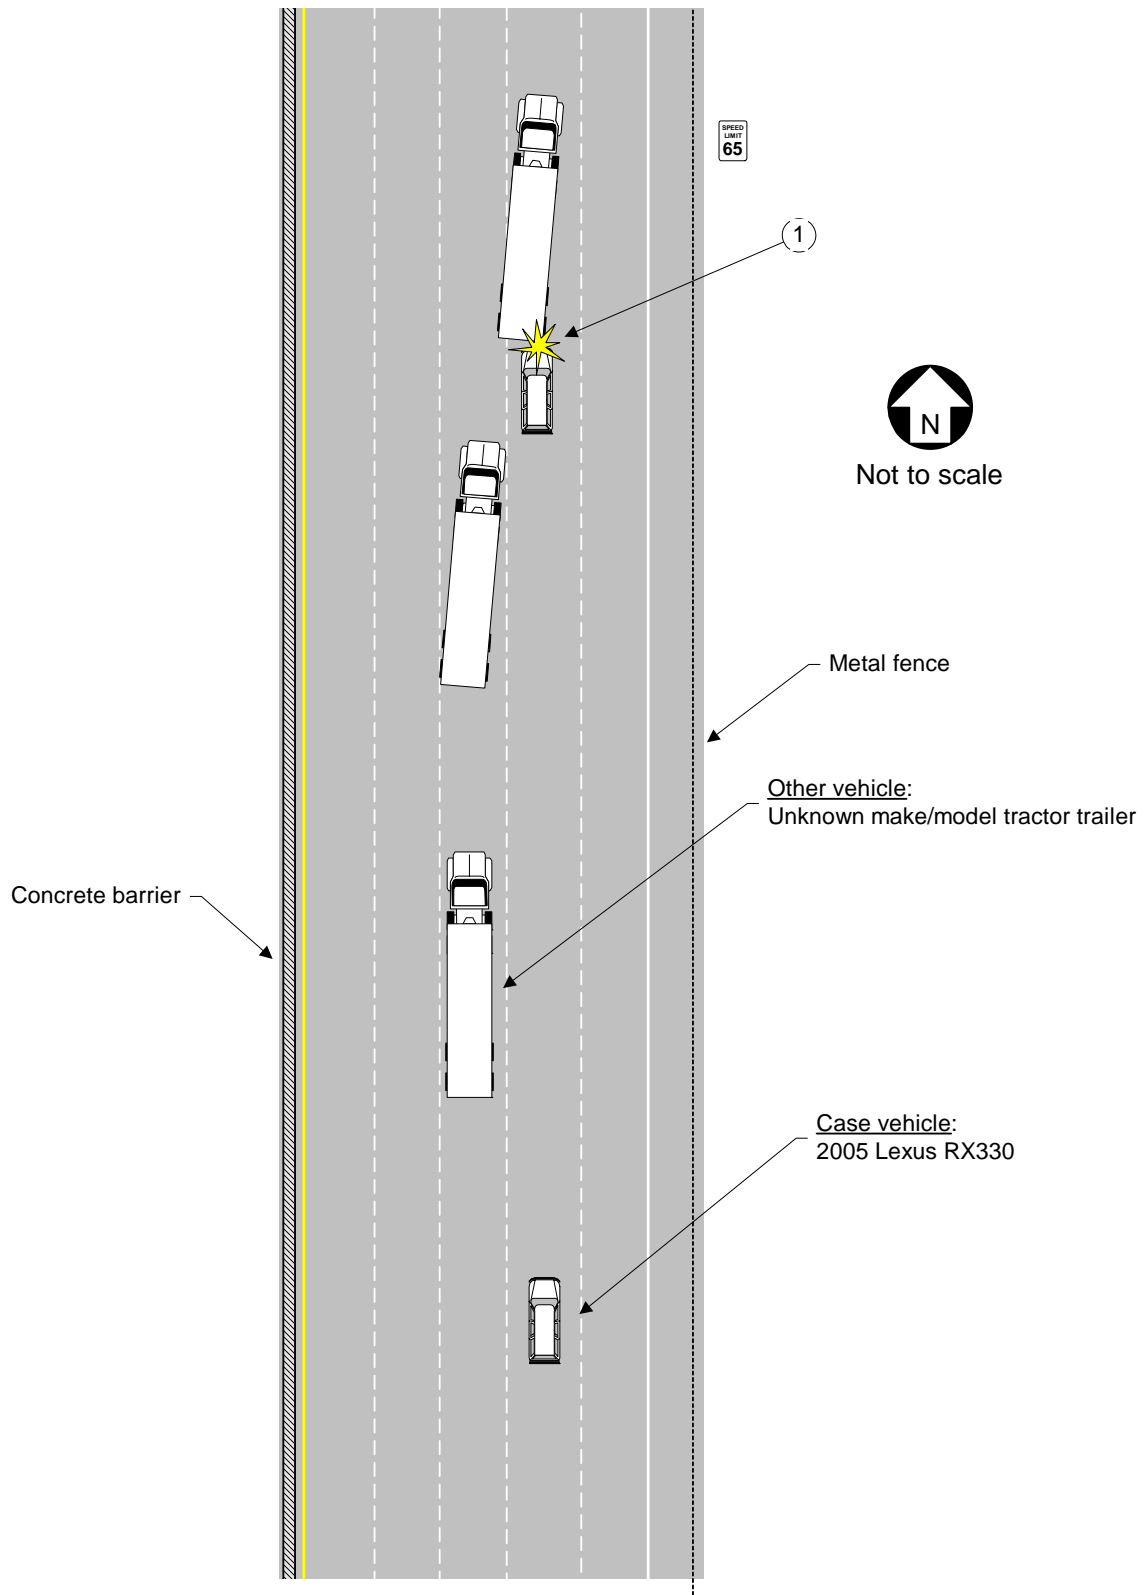
**Attachment 1. Scene Diagram**

The Lexus RX330 was traveling northbound in the second lane from the right at a driver reported travel speed of 105 km/h (65 mph). The other vehicle was traveling northbound in the third lane from the right and was ahead of the case vehicle. This vehicle was traveling at approximately 89 km/h (55 mph).

For unknown reasons, the tractor trailer abruptly changed lanes to the right and directly into the path of the Lexus. The driver of the Lexus saw the lane change.

The driver of the Lexus braked but was unable to stop in time, and the front of the Lexus struck the rear of the tractor trailer. The impact severity was moderate and resulted in the deployment of the driver's frontal air bag and the driver's knee air bag. The driver's seat belt pretensioner also actuated at this time.

The Lexus came to rest in its original lane of travel. The tractor trailer did not stop. The driver and vehicle were never identified.
