**CALSPAN ON-SITE CERTIFIED ADVANCED 208-COMPLIANT VEHICLE  
CRASH INVESTIGATION**

**CALSPAN CASE NO: CA05-027**

**VEHICLE: 2005 NISSAN ALTIMA**

**CRASH DATE: MARCH 2005**

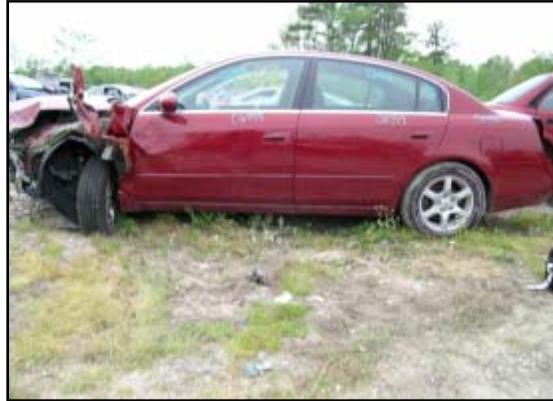
**Figure 1. Subject vehicle 2005 Nissan Altima.**

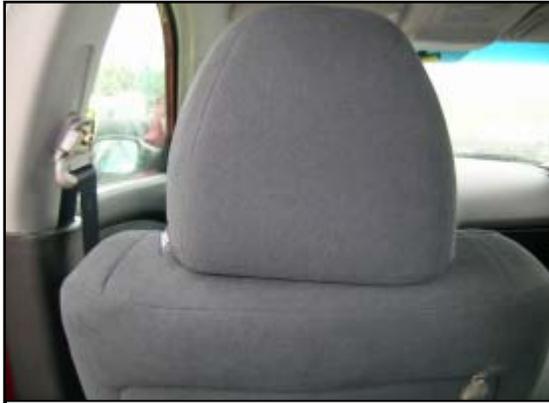
The 2005 Nissan Altima was equipped with Active Head Restraints (AHR) for the front seating positions. The AHR's were designed to move forward in the event of a rear-end collision. The Nissan did not sustain a rear-end collision therefore the AHR's were not activated. **Figures 8 and 9** are of the driver AHR and label.

**Figure 8. Driver's Active Head Restraint.**
