**CALSPAN ON-SITE ADULT AIR BAG RELATED FATALITY CRASH
INVESTIGATION**

CASE NO: CA05-029

VEHICLE: 2003 HONDA CIVIC LX

CRASH DATE: MAY 2005

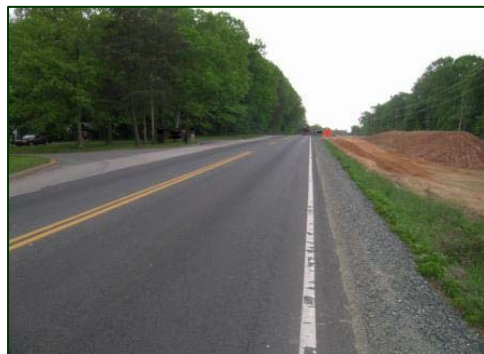
The crash occurred on a two-lane state route in a commercial area during evening hours. The roadway was wet at the time of the crash. The roadway consisted of two travel lanes that were 3.7 m (12.1') in width and delineated by a double yellow centerline. The road edges were marked with painted white edge lines and bordered by a

Figure 2. Overall westbound view of the crash site.

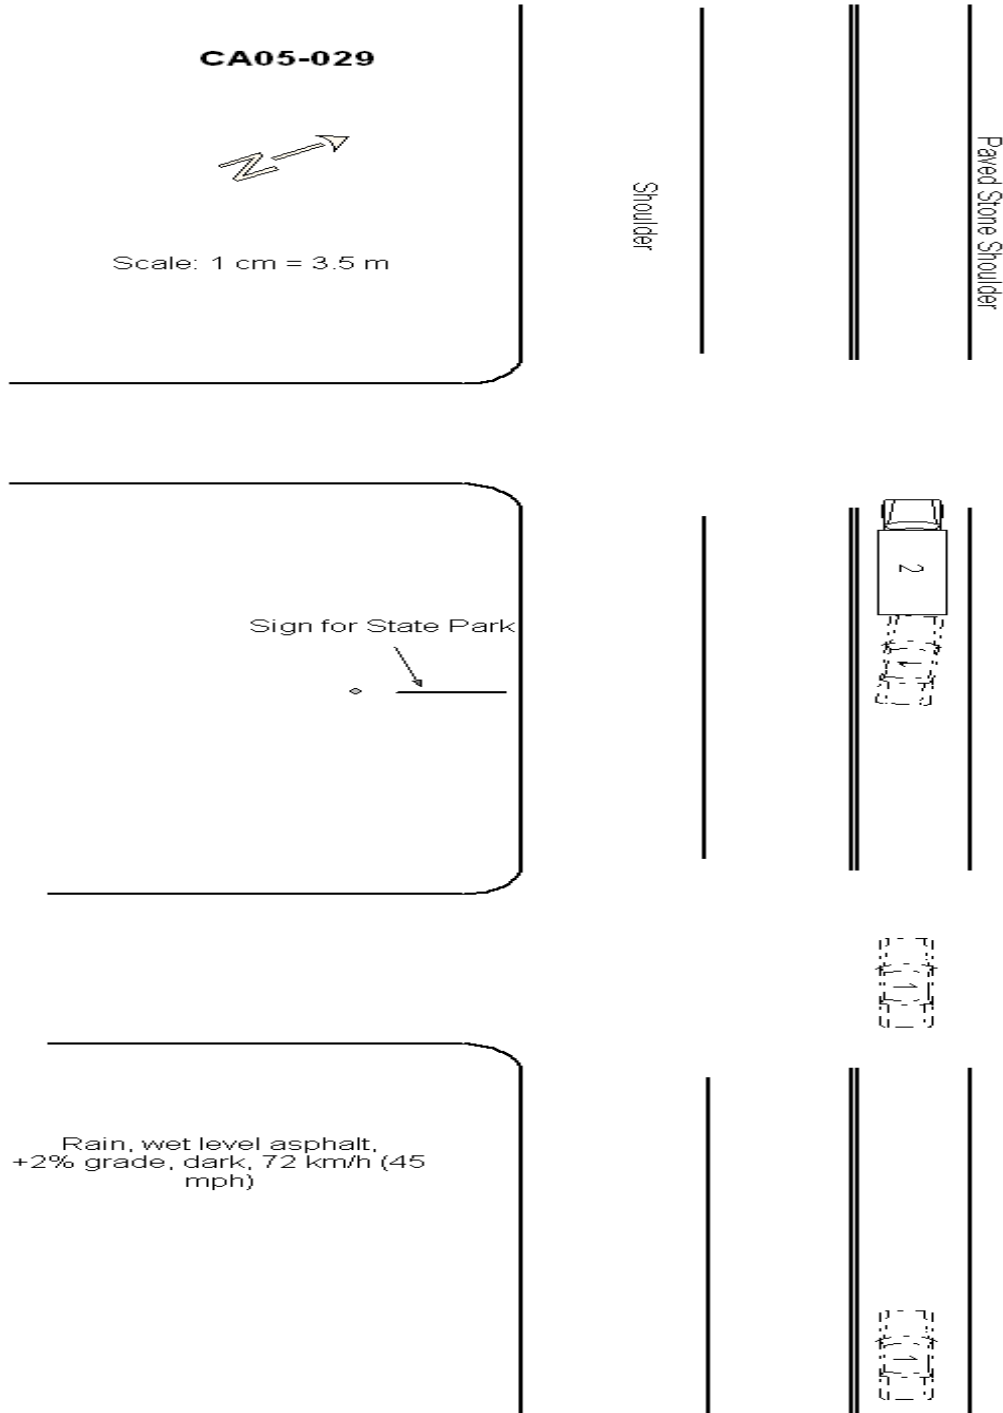
Figure 11. Crash Schematic

The driver of the motor home was stopped in a westerly direction and was waiting to turn left into a driveway to the park. The 70-year old female driver of the Honda Civic was traveling in a westerly direction and approached the back of the stopped motor home. She was either distracted or failed to detect the motor home as she continued westbound. The frontal damage to the Civic was skewed to the left indicating a probable right steering maneuver prior to impact. The driver also applied a braking input at or immediately prior to impact. There was no physical evidence at the crash site to support the level of braking. The brake pedal was deformed by driver loading and a shoe scuff mark was present on the rubber pad to support the braking input.
