**CALSPAN ON-SITE CERTIFIED ADVANCED 208-COMPLIANT
VEHICLE CRASH INVESTIGATION**

CASE NO: CA05-031

VEHICLE: 2005 JEEP GRAND CHEROKEE

CRASH DATE: MAY 2005

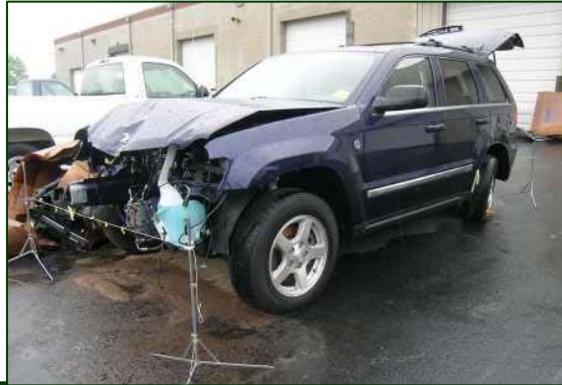
Figure 1. Overall view of the 2005 Jeep Cherokee.

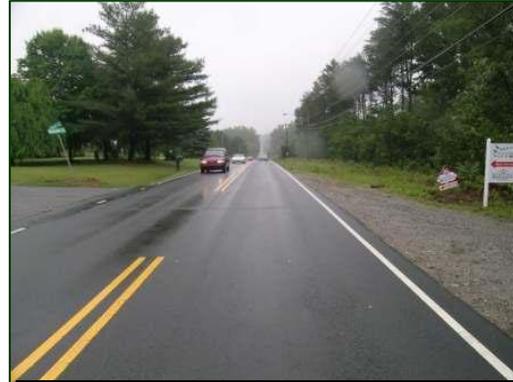
Figure 2 - Eastbound trajectory of the Jeep Grand Cherokee.

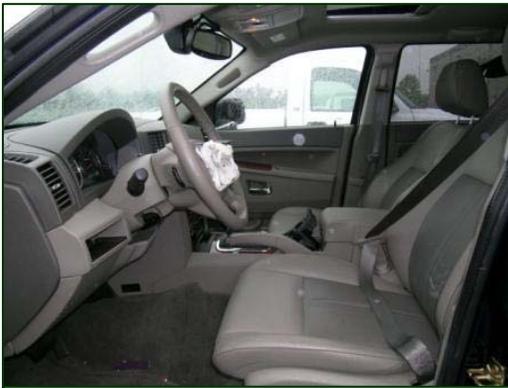
The 66-year old male driver of the Jeep Grand Cherokee was seated in a full rear track position with the seat back reclined to a measured angle of 26 degrees. The vertical height of the power seat (measured at the leading edge) was adjusted 32 cm (12.5”) above the floor of the vehicle. In this position, the, the horizontal distance between the center of the driver’s air bag module cover and the seat back was 65 cm (25.5”), measured 41 cm (16”) above the seat bight (**Figure 9**). The adjustable pedals were set to a forward position with respect to the vehicle. The horizontal distance between the brake pedal and the leading edge of the seat cushion was 51 cm (20.125”). The driver was restrained by the manual 3-point lap and shoulder belt system. Although there was no loading

Figure 9. Overall view of the driver's position and the safety systems.

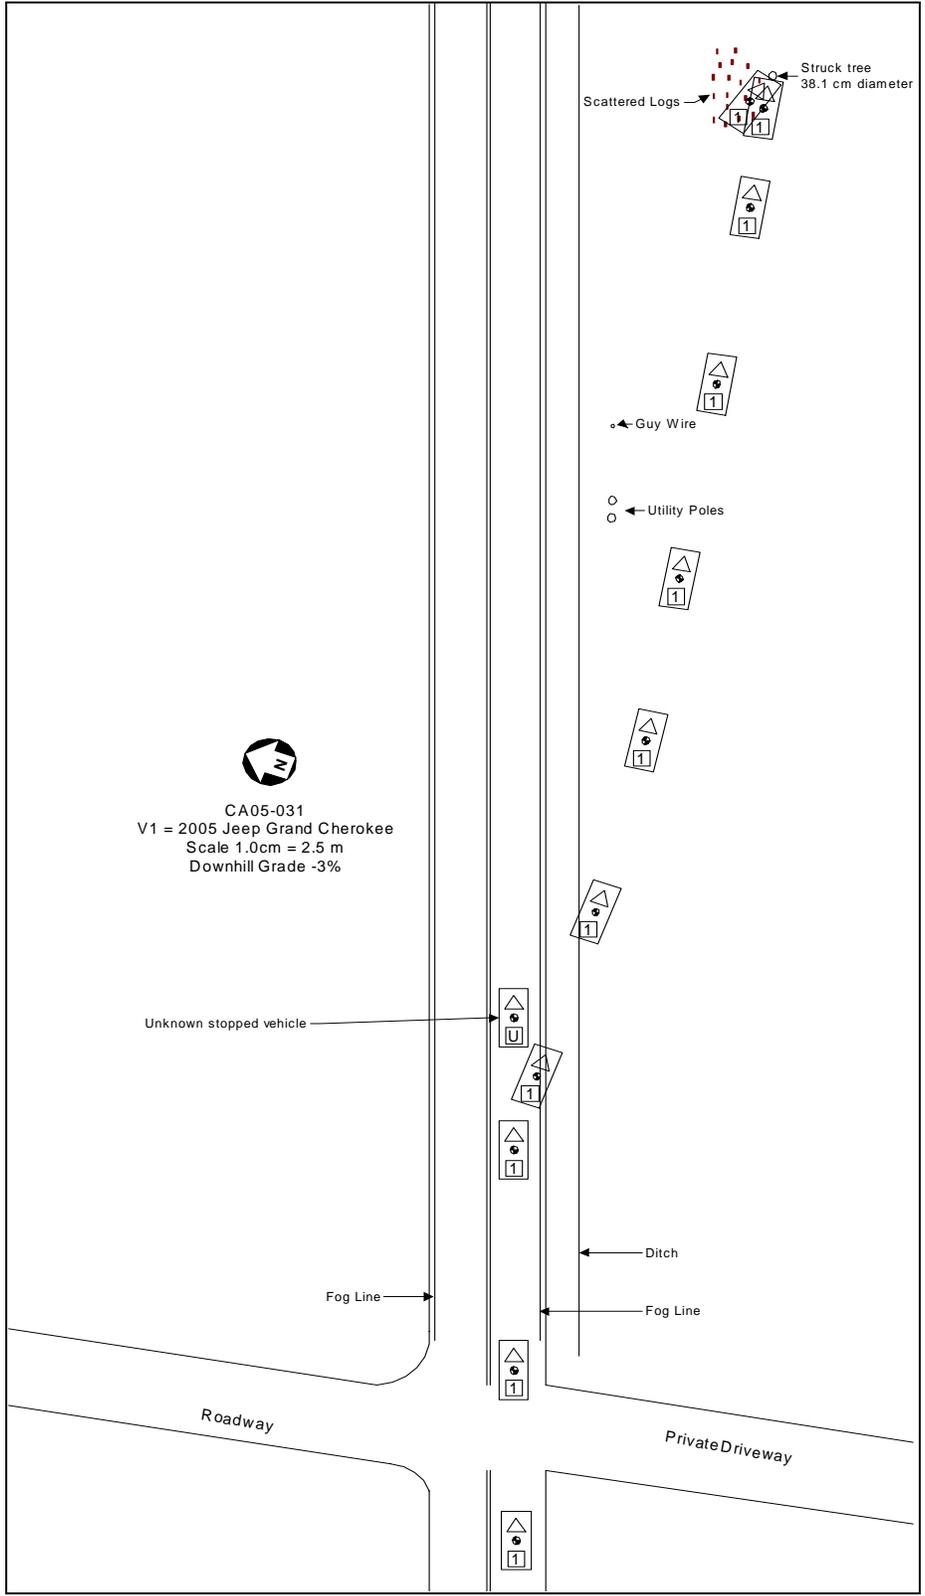
Figure 11 – Crash Schematic

Located adjacent to the eastbound travel lane was an area that consisted of tall weeds and a tree line that began approximately 25 m (80') south of the referenced travel lane. Prior to the crash, this area was under construction. Numerous trees were felled and the trunks were cut into firewood length logs and scattered in the area. The tree trunks were left in place. Post-crash, additional work was conducted prior to the SCI investigation. The specific trees and/or trunks that were struck by the Jeep were no longer in place at the scene. The Cherokee did strike a 38 cm (15") diameter spruce tree that was located 27.1 m (88.9') off-road. The tree did not yield in the crash and was debarked by the frontal impact. The Crash Schematic is included as **Figure 11** of this report.
