ON-SITE CERTIFIED ADVANCED 208-COMPLIANT VEHICLE INVESTIGATION

CASE NUMBER - IN-05-032

VEHICLE - 2005 HONDA ACCORD EX

CRASH DATE - August 2005

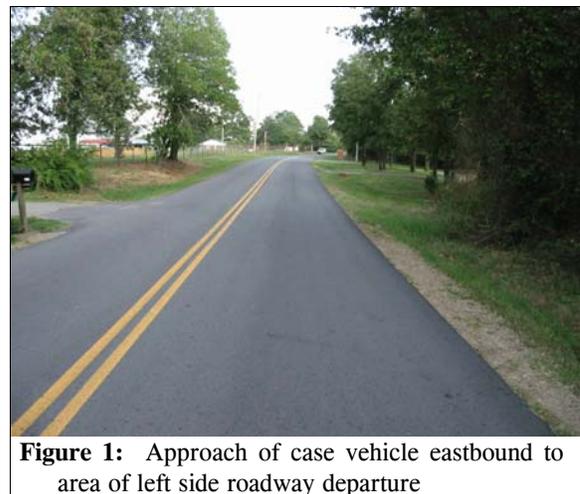
Crash Environment: The trafficway on which the case vehicle was traveling was a curved, two-lane county roadway traversing in an east and west direction (**Figure 1**). Each travel lane was 3.2 meters (10.5 feet) in width. The roadway was bordered by shallow ditches on each side. The ditch on the south side of the roadway was approximately 3.5 meters (11.5 feet) in width while the ditch on the north side of the roadway was approximately 4.5 meters (14.8 feet) in width. A metal farm fence was located adjacent to the ditch on the north side of the roadway. A woods was adjacent to the ditch on the south side of the roadway. The case vehicle's approach to the crash location was controlled by double yellow no-passing lines, and the speed limit was 72 km.p.h. (45 m.p.h.). At the time of the crash the light condition was daylight, the weather was clear, the roadway pavement was dry bituminous and the roadway had an approximate positive 4% grade on the case vehicle's approach. Traffic density was light and the site of the crash was rural residential.
