CALSPAN ON-SITE ROLLOVER CRASH INVESTIGATION

SCI CASE NO: CA05-034

VEHICLE: 2005 LEXUS RX330

CRASH DATE: MAY, 2005

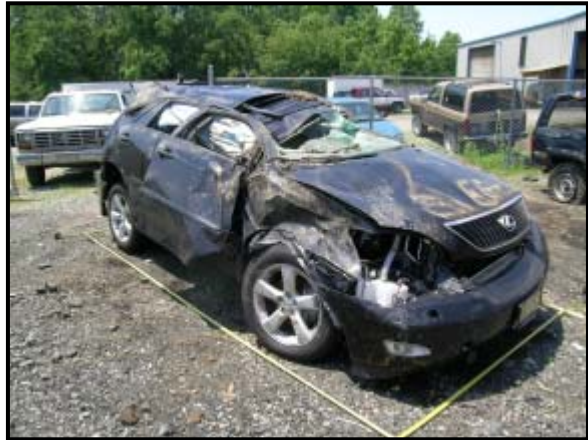
Figure 1: Front right view of the Lexus.

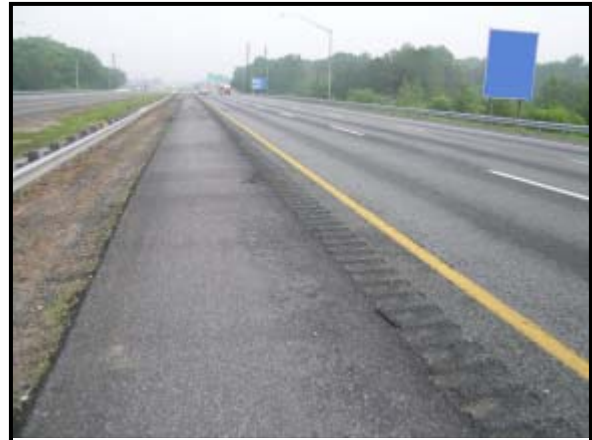
Figure 2 is a westbound trajectory view of the roadway. At the crash site, the total width of the three westbound lanes measured 11 m (36 ft). The north (outboard) side of the travel lanes was bordered by a 3.7 m (12 ft) wide shoulder and a W-beam guardrail. The south (inboard) side of the west travel lanes was bordered by a 3.3 m (10.8 ft) wide shoulder. Three tire marks were identified on the inboard travel lane and shoulder that defined the off-road trajectory of the Lexus.

Figure 2: Westward trajectory view at the crash site.

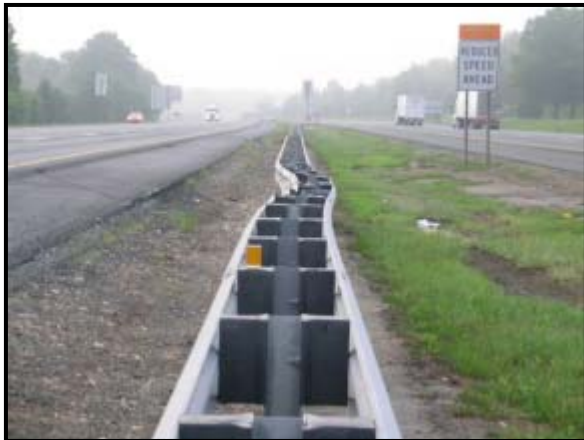
A 9 m (30 ft) wide depressed grass median separated the east and west travel lanes. A W-beam guardrail system was located within the median 3 m (6 ft) south of the inboard westbound shoulder. The Lexus impacted and tripped over the guardrail during the course of the crash. **Figure 3** is a view looking east along the guardrail. The guardrail system was mounted to 10 cm x 15 cm (4 in x 6 in) I-beams spaced 2 m (6.5 ft) apart. The W-beam was mounted on 19 cm (7.5 in) block-outs and spanned the height 46 cm to 76 cm (18 in to 30 in) above the ground. The Lexus' impact to the guardrail deformed the rail 0.4 m (1.4 ft) to the south. The vehicle's direct contact to the guardrail measured 8 m (26.4 ft). **Figure 4** is a view of the vehicle's roadside departure and the direct contact to the guardrail.

Figure 3: Eastward lookback view along the guardrail.

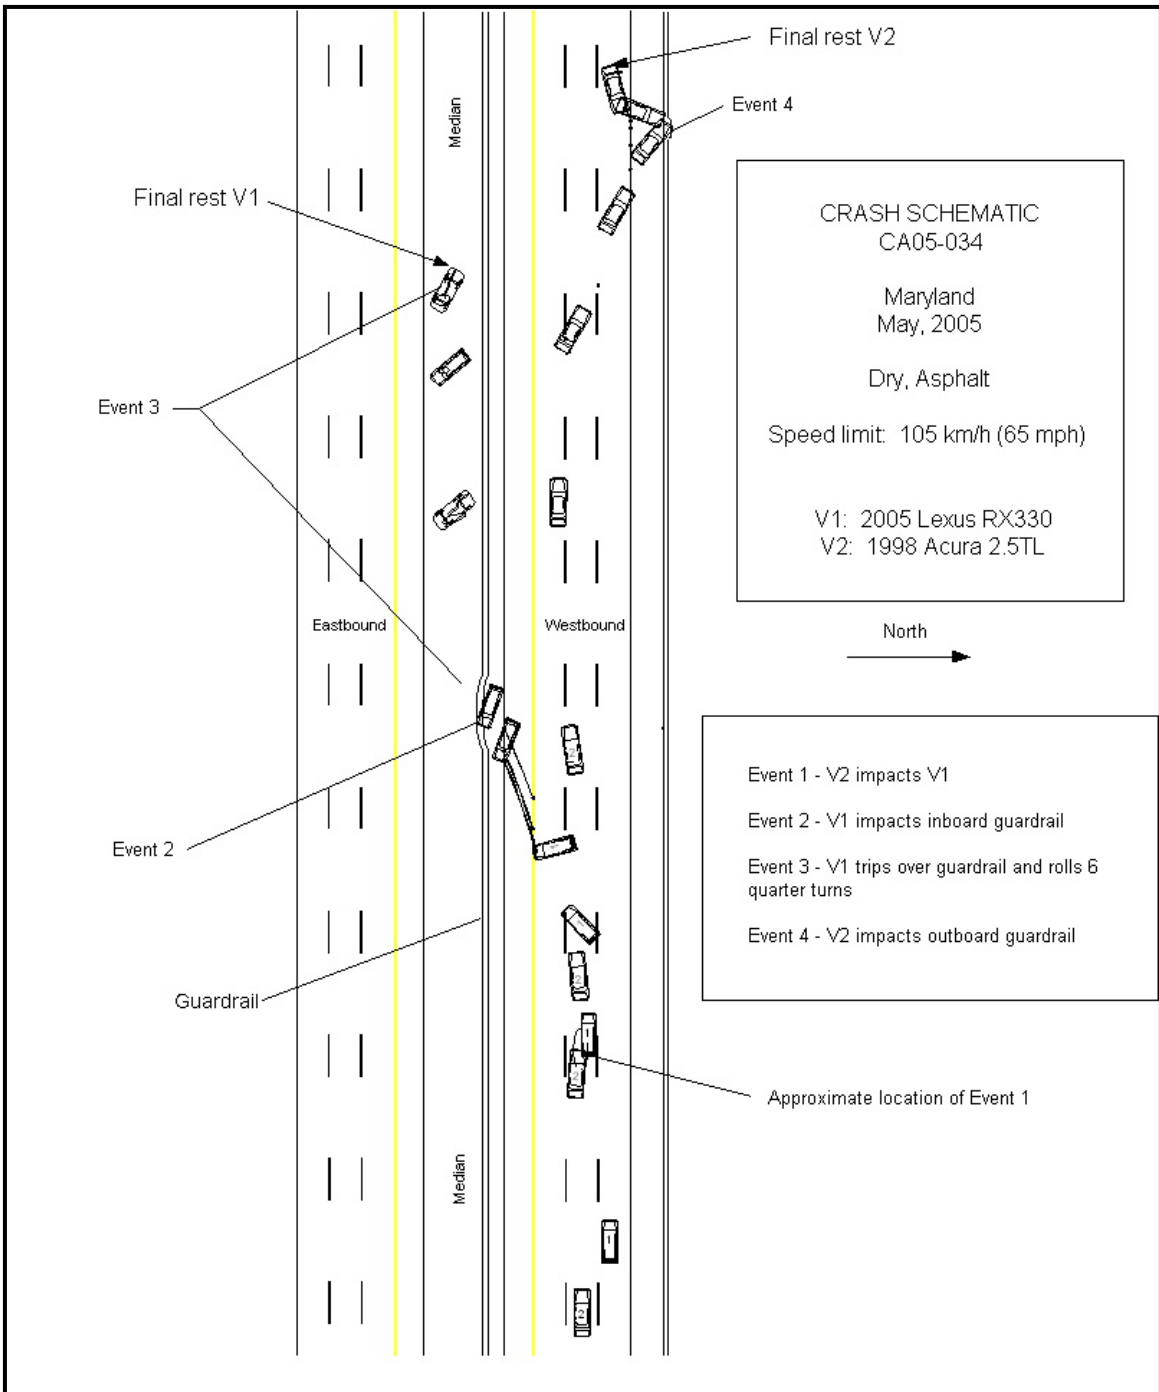
Figure 12: Crash Schematic.

During the process of these steering maneuvers, the right front of the Acura impacted the left rear corner of the Lexus. The impact resulted in both vehicles losing directional control. The force of the impact caused the Lexus to rotate counterclockwise as evidenced by the three tire marks through the inboard traffic lane and inboard shoulder. The tire marks measured 9.8 m (32 ft) in length and were attributed to the left front, right front, and right rear tires of the Lexus. The right side wheel rims were abraded. The Lexus rotated approximately 160 degrees counterclockwise and struck the inboard guardrail with the right front fender. The force of the impact with the guardrail coupled with the vehicle's momentum resulted in a tripped right side leading rollover over the guardrail. The vehicle's pretensioners actuated and the inflatable side curtains deployed in response to the roll event. The Lexus rolled six-quarter turns and came to rest on its roof within the center median 46.3 m (152 ft) from its impact with the guardrail. The vehicle's roll trajectory was evidenced by three distinct ground contacts on the south side of the guardrail.

The Acura separated from its frontal impact with the Lexus with a northwest trajectory. The Acura traveled through the outboard lane and shoulder and impacted the north guardrail. The impact initiated a clockwise rotation to the vehicle and the Acura slid to rest facing east-northeast in the outboard westbound lane. A schematic of the crash is included at the end of this narrative report as **Figure 12**.
