ON-SITE OTHER INFLATABLE OCCUPANT PROTECTION INVESTIGATION

CASE NUMBER - IN-05-039

VEHICLE - 2005 INFINITI QX56

CRASH DATE - September 2005

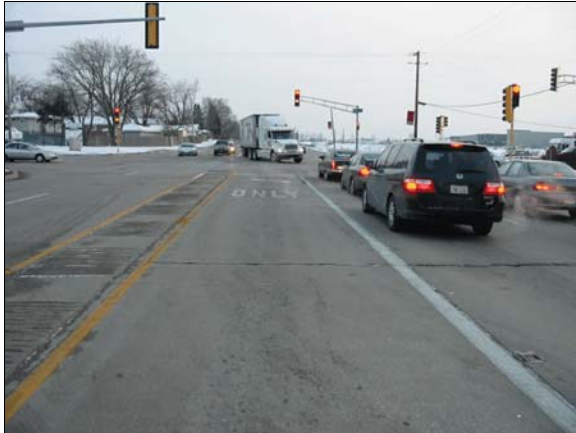
Figure 1: Approach of the case vehicle to the intersection, southbound in the left turn lane

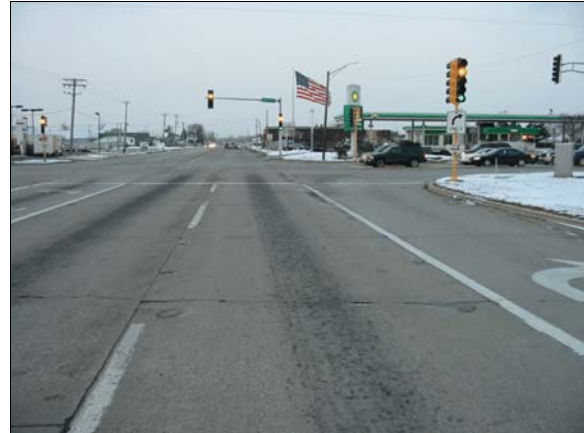
Figure 2: Approach of the Oldsmobile northbound in outside through lane

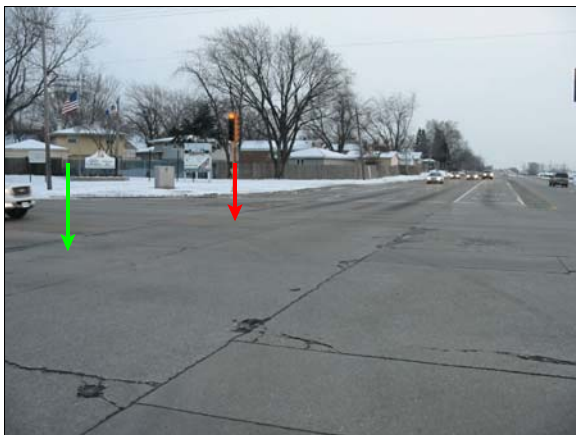
Figure 3: View southeast from case vehicle's approach to the impact area (red arrow), green arrow shows area of case vehicle's final rest

Post-Crash: The case vehicle rotated counterclockwise approximately 170 degrees and came to rest in the intersection facing northwest (**Figure 3**). Following the impact with the Geo, the Oldsmobile traveled off the east leg of the intersection and came to rest on the north side of the roadway facing northeast (**Figure 7** below). The Geo rotated counterclockwise and traveled off the roadway and came to rest on the northeast corner of the intersection facing northeast (**Figure**

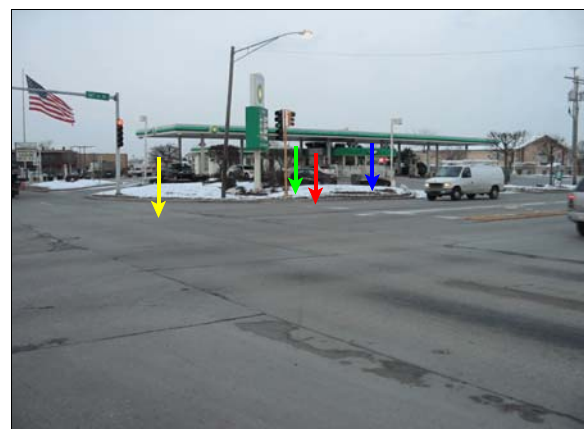
Figure 7: View northeast to area of impact between Oldsmobile and Geo (red arrow), green arrow shows area of rest of Geo, blue arrow shows area of rest of Oldsmobile, yellow arrow shows area of rest of case vehicle

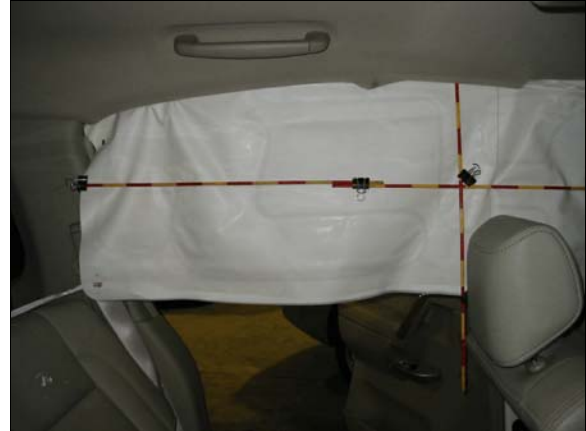
The case vehicle's driver and second seat left were equipped with a single side curtain air bag (**Figures 12** and **13** below), which was located along the left roof side rail below the headliner. The back left seat was equipped with an individual side curtain air bag (**Figure 14** below). The driver/second seat left side curtain air bag was approximately rectangular in shape. It was approximately 162 centimeters (63.8 inches) in length and 41 centimeters (16.1 inches) in height. The air bag was constructed with what appeared to be four inflatable chambers adjacent to the driver's seat, and three inflatable chambers adjacent to the second seat. The air bag was attached to the left "A"-pillar by a cloth anchor cord. The anchor cord was approximately 26 centimeters (10.2) in length, attached to the upper portion of the left "A"-pillar, and flared out to attach along the front edge of the air bag. A double tether cord (**Figure 15** below), 65 centimeters (25.6 inches) in length attached the back of the air bag to the front of the back left side curtain air bag.

Figure 13: Second seat left side curtain air bag

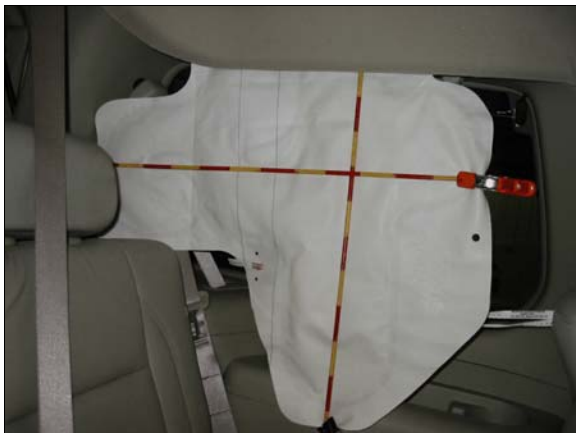
Figure 14: Overview of back left side curtain air bag

The back left side curtain air bag (**Figure 14**) was irregularly shaped. It was constructed with three inflatable chambers. The air bag's overall dimensions were 62 centimeters (24.4 inches) in length and 52 centimeters (20.5 inches) in height. A double tether cord, 65 centimeters (25.6 inches) in length, attached the front of the air bag to the back edge of the driver/second seat left air bag. The back left side curtain air bag was not equipped with internal tethers, and there were no visible vent ports. Inspection of the air bag revealed no evidence of damage due to deployment.

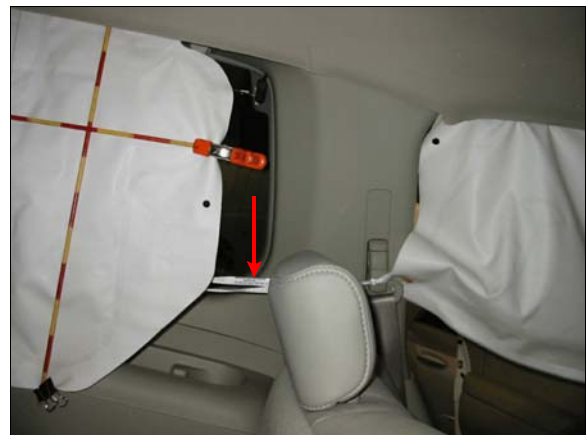
Figure 15: Overview of tether (arrow) between the back left side curtain air bag and the second seat left side curtain air bag
