CALSPAN ON-SITE CHILD SAFETY SEAT INVESTIGATION

SCI CASE NO. – CA05-047

SUBJECT VEHICLE – 2003 FORD F-150 PICK-UP TRUCK

CRASH DATE – JUNE 2005

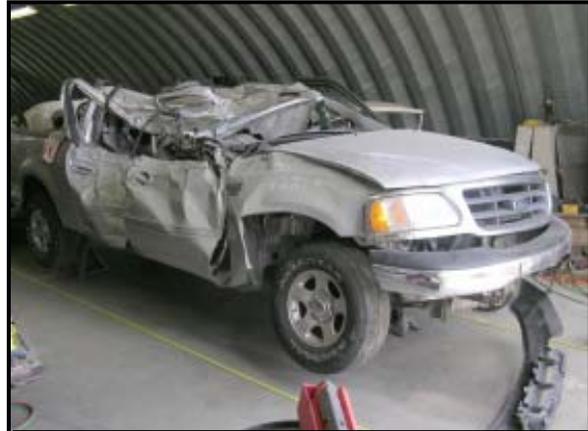
Figure 2: Right front oblique view.

Tire	Measured Pressure	Tread Depth	Restricted	Damage
LF	0 kPa	6 mm (8/32 in)	No	Rim fractured; tire debanded
LR	83 kPa (12 PSI)	10 mm (13/32 in)	No	Axle fractured at wheel; outboard rim surface fractured; grass in bead
RF	262 kPa (38 PSI)	3 mm (4/32 in)	No	Tire cut – steel ply exposed; grass in bead
RR	214 kPa (31 PSI)	10 mm (12/32 in)	No	None

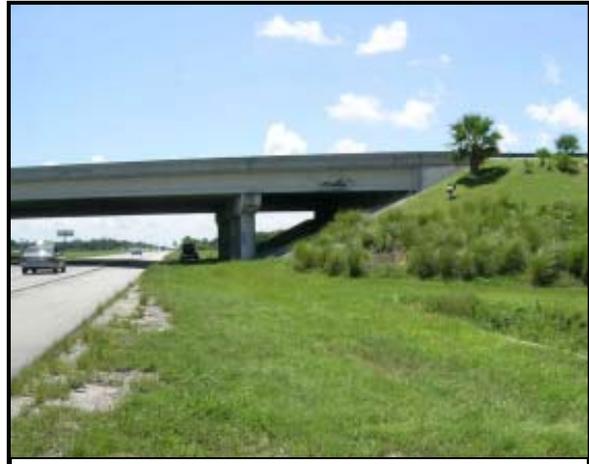
This single-vehicle crash occurred during the daylight hours of June 2005. At the time of the crash, the weather was cloudy and the roadway was dry. The crash occurred on the southbound lanes of a north/south interstate highway. **Figure 3** is a southbound trajectory view at the crash site. The interstate was configured with two travel lanes in each direction, which were delineated by a broken white center line. The travel lanes were bordered by solid fog lines and asphalt shoulders. A W-beam guardrail and a depressed grass median separated the north/southbound lanes. The roadside in the area of the road departure consisted of grass, shrubbery, and an open drainage ditch. The open ditch was oriented perpendicular to the interstate and transitioned to a culvert pipe that passed under the roadway. The open ditch terminated at a concrete headwall located 9.1 m (30 ft) west of the road edge. Approximately

13.7 m (45 ft) south of the drainage ditch, the level roadside terrain transitioned to a 30 degree embankment that ascended 2.1 m (7 ft) along the Ford's trajectory. A 35 m (116 ft) wide concrete overpass was located 15 m (50 ft) south of the embankment. The east/west overpass crossed the interstate roadway at a 60 degree angle in relation to the roadway. The exposed sidewall of the overpass along the Ford's path of travel exhibited evidence of an impact. The overpass was supported by four 1 m (3 ft) diameter pillars spaced 9.1 m (30 ft) apart. The Ford came to rest on its left side against the north-most pillar. The posted speed limit for the interstate highway was 113 km/h (70 mph).

Figure 3: Southbound trajectory view at the crash site.
