**CALSPAN ON-SITE SIDE IMPACT INFLATABLE OCCUPANT PROTECTION
INVESTIGATION**

CASE NO.: CA05-050

VEHICLE: 2004 INFINITI QX56

DATE OF CRASH: AUGUST 2005

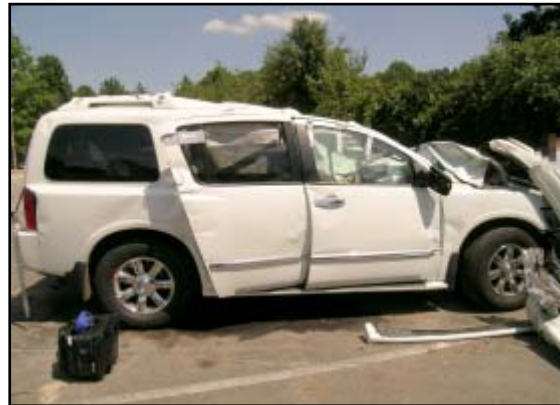
This on-site investigation focused on the side impact inflatable occupant protection system that deployed in a 2004 Infiniti QX56 full size sport utility vehicle (**Figure 1**). The system consisted of seat back mounted side impact air bags for the front seating positions and canopy air bags for the six outboard seating positions. In addition, the Infiniti was equipped Vehicle Dynamic Control and Traction Control, a Certified Advanced 208-Compliant (CAC) frontal air bags system, dual front safety belt pretensioners, and an Event Data Recorder. The EDR data is summarized in the *Event Data Recorder* section of this report. The Infiniti was occupied by a restrained 18-year-old

Figure 1. Subject vehicle 2004 Infiniti QX56.

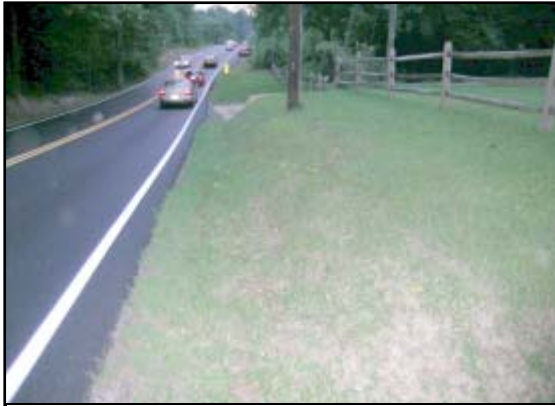
The restrained 18-year-old female driver of the Infiniti was operating the vehicle eastbound on the two-lane roadway. The driver was negotiating a slight right curve and descending a negative grade at a high rate of speed. For unknown reasons, the driver allowed the vehicle to depart the right roadside (**Figure 2**) where she applied an aggressive left steering maneuver to correct the

Figure 2. Right side road departure.

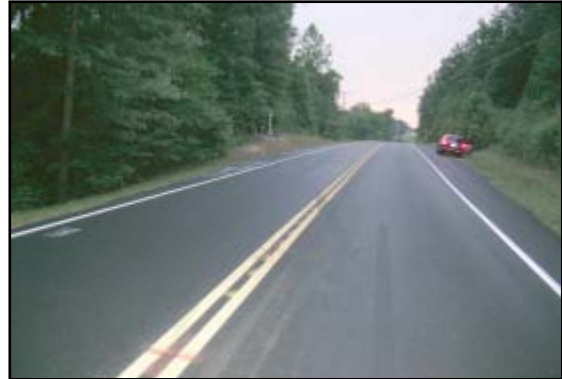
roadside departure. Consequently, this steering input and speed of the vehicle induced a counterclockwise (CCW) rotation that was evidenced by yaw marks on the asphalt road surface (**Figure 3**). Although the vehicle was equipped with VDC and TC, the rapid left steering input and velocity of the vehicle induced a yaw that was typical of a vehicle without these systems. The Infiniti crossed both travel lanes and departed the south (left) roadside and traversed the asphalt shoulder. The driver probably counter steered to the right as the vehicle traversed the shoulder allowing the front left aspect of the vehicle to enter the ditch in a near tracking mode. The EDR recorded no lateral acceleration at the onset of this event. Additionally, the VDC system possibly assisted in redirecting the vehicle in a clockwise direction.

Figure 3. Infiniti re-enters the roadway and traverses the travel lanes toward the embankment.

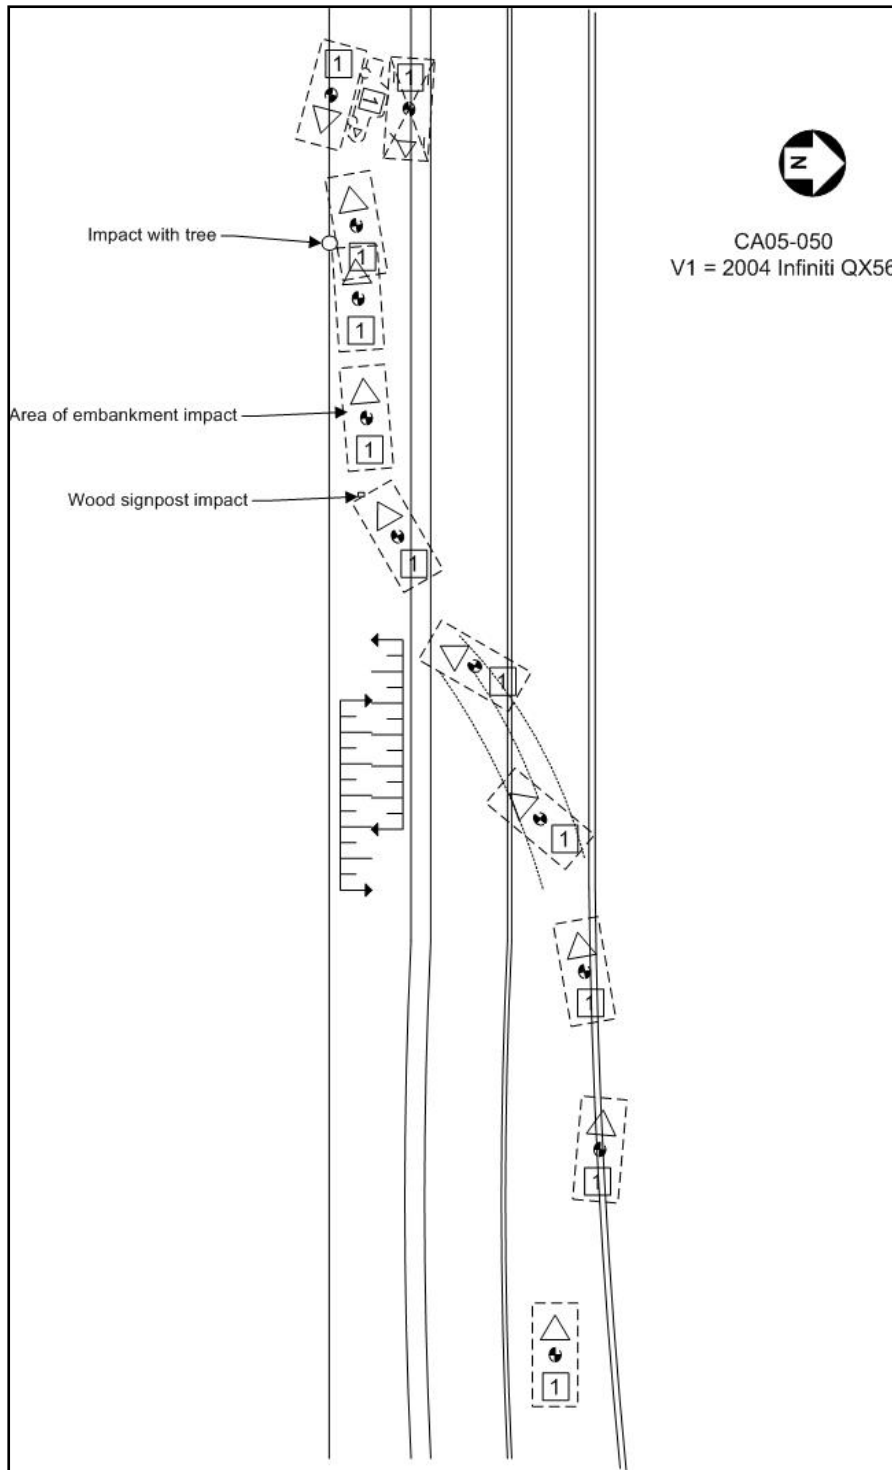
Figure 12. Scene schematic

This run-off-road crash occurred during the early morning hours of August 2005 under dark and dry conditions. The crash occurred off-road of an east/westbound two-lane, two-way, rural roadway. The east/westbound roadway was configured with one travel lane in each direction that were delineated by double-yellow centerlines and bordered by white fog lines. The roadway was recently resurfaced with asphalt that included both shoulders that extended beyond the painted fog lines. The roadway curved slightly right for westbound travel. Additionally, there was a sag in the roadway east of the crash location. The south roadside consisted of a ditch, wooden signpost, grass embankment, and a tree line. The posted speed limit for the east/west roadway was 72 km/h (45 mph). The scene schematic is included as **Figure 12** of this report.
