**CALSPAN ON-SITE CERTIFIED ADVANCED-208 COMPLIANT VEHICLE
CRASH INVESTIGATION**

SCI CASE NO. – CA05-052

SUBJECT VEHICLE – 2005 GMC SIERRA

CRASH DATE – JULY 2005

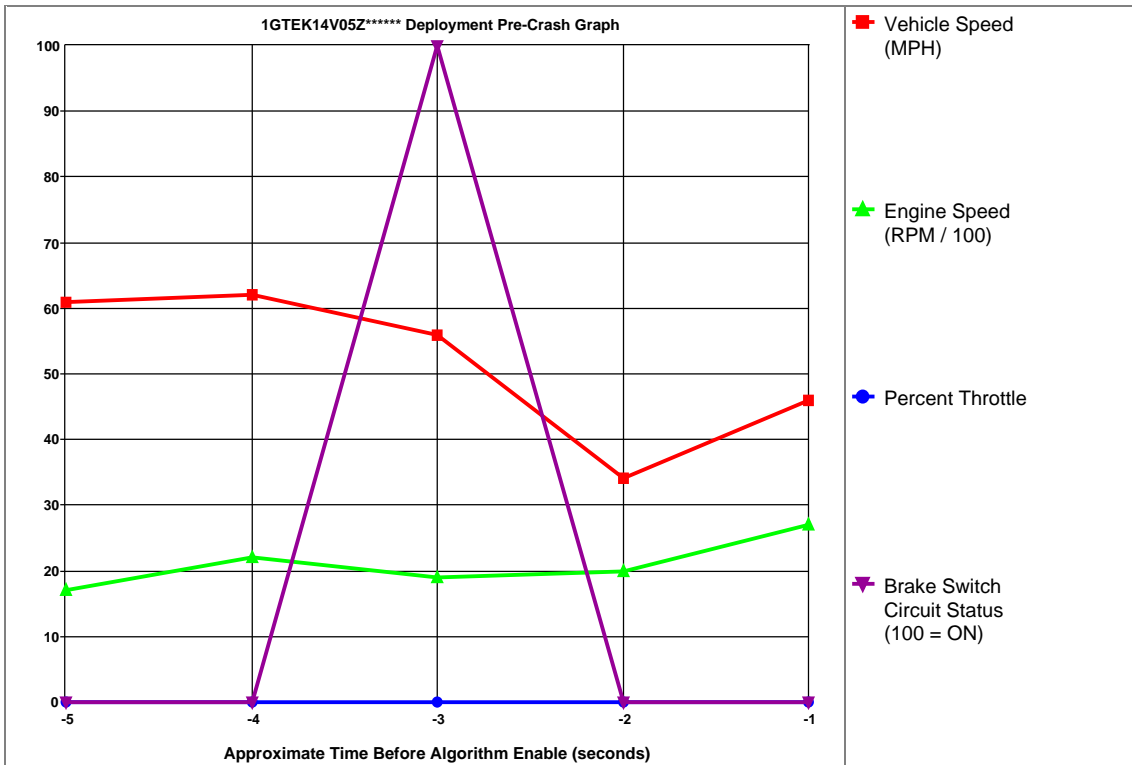
Seconds Before AE	Vehicle Speed (MPH)	Engine Speed (RPM)	Percent Throttle	Brake Switch Circuit Status
-5	61	1664	0	OFF
-4	62	2176	0	OFF
-3	56	1920	0	ON
-2	34	1984	0	OFF
-1	46	2688	0	OFF

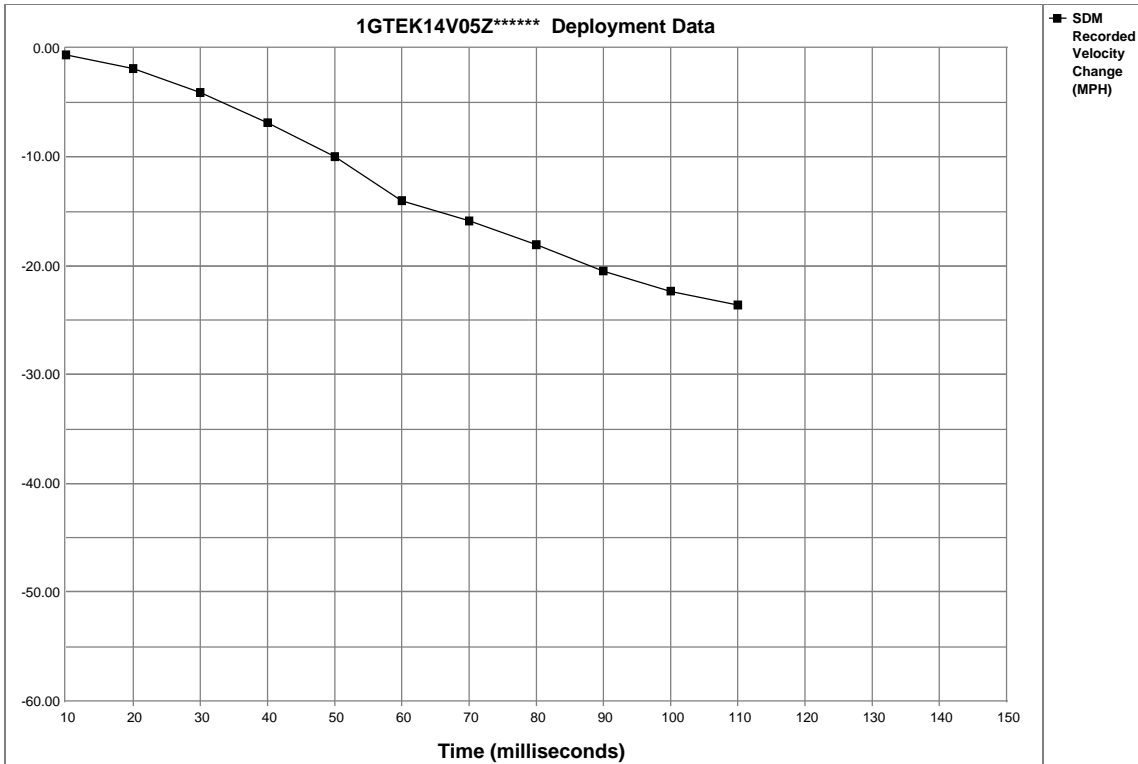
Time (milliseconds)	10	20	30	40	50	60	70	80	90	100	110	120	130	140	150
Recorded Velocity Change (MPH)	-0.62	-1.86	-4.03	-6.82	-9.92	-13.95	-15.81	-17.98	-20.46	-22.32	-23.56	N/A	N/A	N/A	N/A

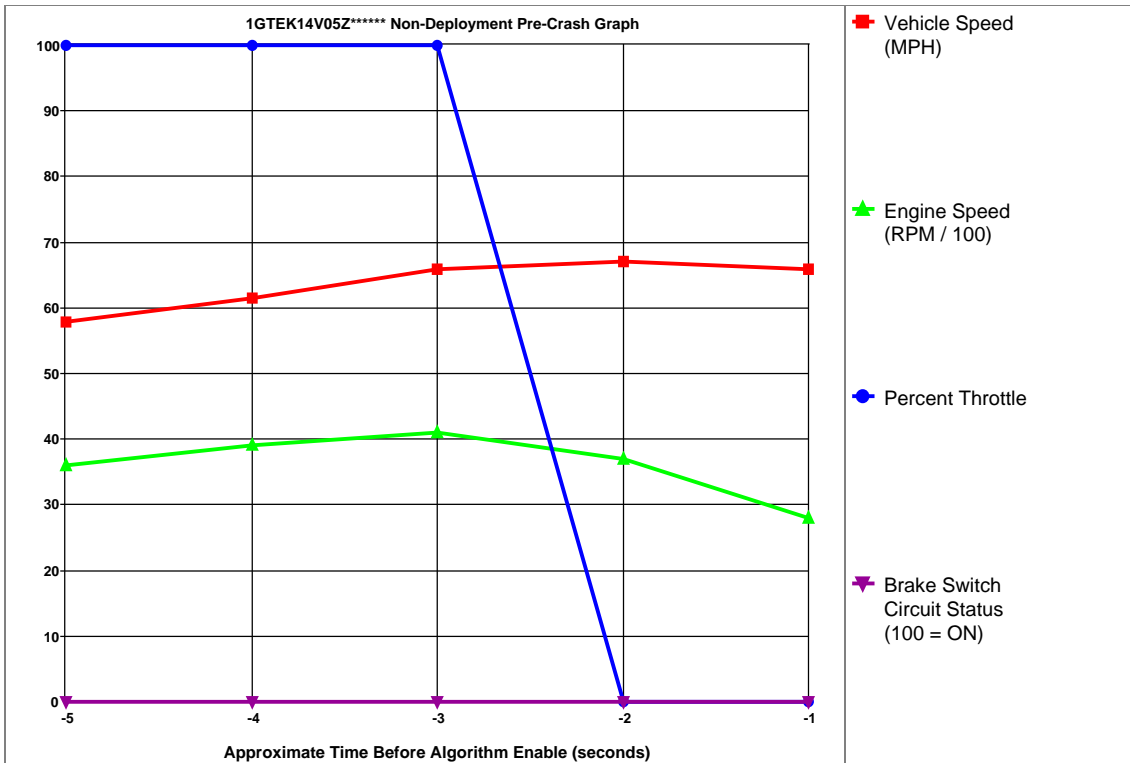
Seconds Before AE	Vehicle Speed (MPH)	Engine Speed (RPM)	Percent Throttle	Brake Switch Circuit Status
-5	58	3648	100	OFF
-4	62	3904	100	OFF
-3	66	4096	100	OFF
-2	67	3712	0	OFF
-1	66	2816	0	OFF

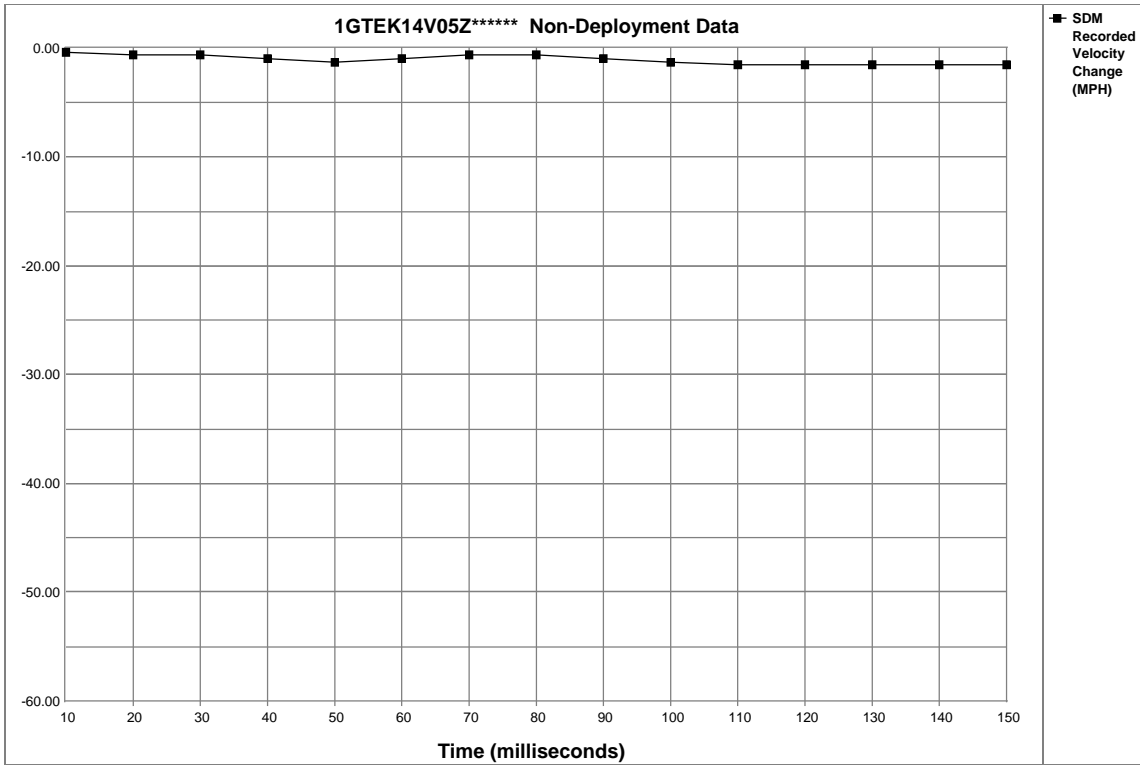
Time (milliseconds)	10	20	30	40	50	60	70	80	90	100	110	120	130	140	150
Recorded Velocity Change (MPH)	-0.31	-0.62	-0.62	-0.93	-1.24	-0.93	-0.62	-0.62	-0.93	-1.24	-1.55	-1.55	-1.55	-1.55	-1.55
