CALSPAN ON-SITE CHILD SAFETY SEAT CRASH INVESTIGATION

CALSPAN CASE NO: CA05-054

VEHICLE: 2000 SATURN SL2

CRASH DATE: AUGUST 2005

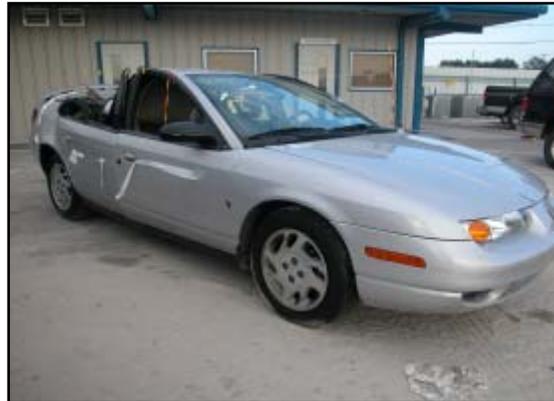
Figure 1. Subject vehicle: 2001 Saturn SL2.

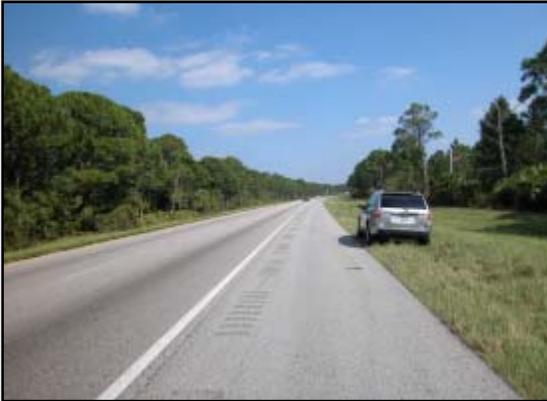
The 32-year-old female driver was operating the vehicle southbound on the interstate on the outboard lane (**Figure 2**). The driver stated to the SCI investigator that she attempted to change lanes to the inboard travel lane. As she initiated this lane change maneuver, a non-contact vehicle, which was traveling adjacent to the Saturn, activated its horn. The driver stated that she applied a right steering input and in doing so, relinquished directional control of the vehicle. The steering maneuver resulted in a clockwise (CW) rotation of the vehicle. The Saturn traversed the outboard travel lane and the asphalt shoulder and entered the grass roadside. The vehicle traveled approximately 15 meters (49') on the grass roadside while rotating CW (**Figure 3**).

Figure 2. Southbound pre-crash travel direction of the Saturn.

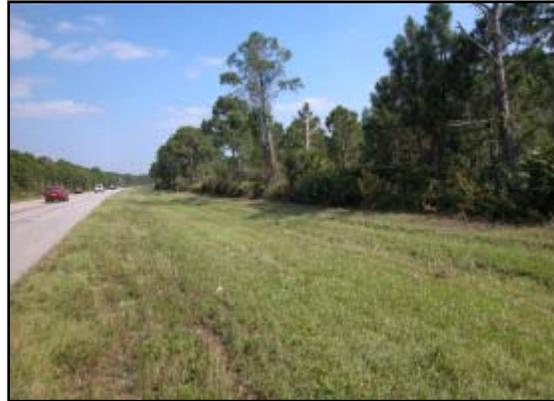
Figure 3. Off-road pre-crash travel of the Saturn.

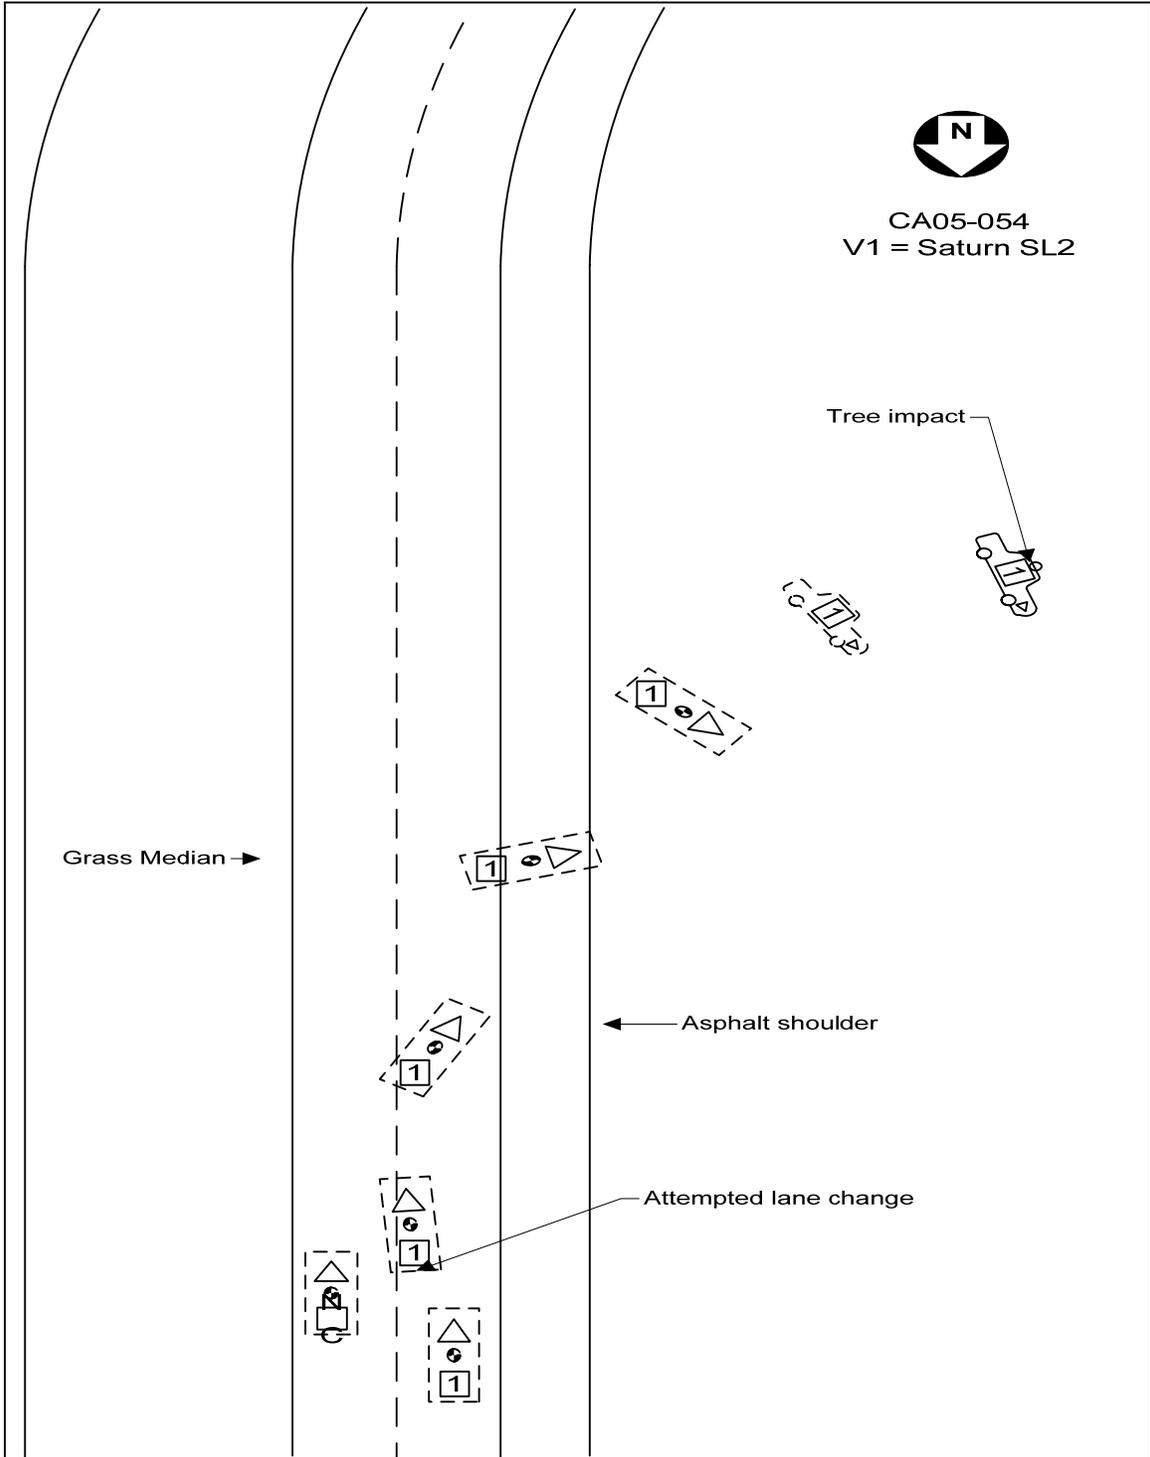
Figure 12 - Scene Schematic

This road departure crash occurred on the west roadside of a four-lane north/south interstate highway. The specific crash site location could not be located due to the inaccurate documentation by the investigating police officer. The approximate area of the crash was pinpointed based on statements by the driver during the SCI interview. The southbound travel direction consisted of two through traffic lanes that were delineated by a broken white lane line. The north/south roadways were separated by a depressed grass median with a tree line. A 3-meter (9.8 feet) asphalt shoulder extended beyond the west fog line. The west roadside consisted of a grass area and a tree line that was located 15 meters (49.2 feet) beyond the road edge. The roadway was wet at the time of the crash and the posted speed limit was 113 km/h (70 mph). The scene schematic is included as **Figure 12** of this report.
