Rollover and Certified Advanced 208-Compliant Air Bag Investigation
Dynamic Science, Inc./Case Number: DS06001
2005 Chevrolet Trailblazer
California
August 2005

1. Report No. DS06001	2. Government Accession No.	3. Recipient Catalog No.	
4. Title and Subtitle Rollover and Certified Advanced 208-Compliant Air Bag Investigation		5. Report Date July 28, 2006

Dynamic Science, Inc.
Crash Investigation
Case Number: DS06001

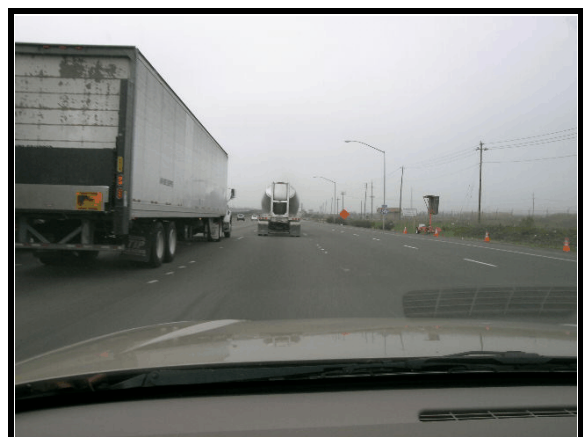
Figure 3. Approach of case vehicle - east

The driver of the case vehicle reported to police that he had been traveling in lane three but changed lanes to the left and continued east in lane four. The driver reported that he began to change lanes to his left again, but then realized that lanes five and six were blocked by the traffic cones. The driver steered back to his right and began to lose control of the vehicle. He attempted to regain control by steering left but

overcorrected and the Chevrolet Trailblazer began to rotate counterclockwise. The case vehicle traveled across lanes five and six and the front end impacted the jersey barrier (01FDEW2) dividing the east and westbound lanes. The impact severity was moderate and resulted in the deployment of the driver's front air bag and actuation of his seat belt pretensioner. The Trailblazer continued rotating counterclockwise and the back right impacted the concrete barrier (05BREW1). The vehicle continued traveling east as it rotated and began to rollover to the left (00TDDO3). The case vehicle completed two quarter turns and came to final rest on its top, facing southeast.

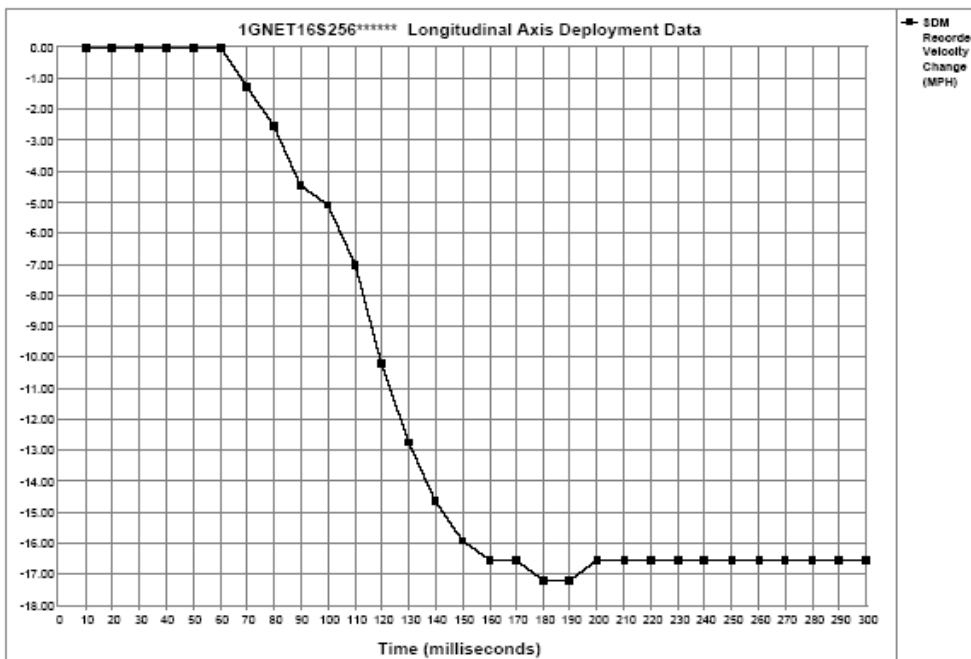
Two events were recorded by the SDM, a Deployment Event and a Non-Deployment Event. The Deployment Event occurred as a result of the first impact with the concrete barrier. The data in the Non-Deployment Event appears to mirror the Deployment Event data to some extent. The cause of this has not been determined.

Time (milliseconds)	10	20	30	40	50	60	70	80	90	100	110	120	130	140	150
Longitudinal Axis Recorded Velocity	0.00	0.00	0.00	0.00	0.00	0.00	-1.27	-2.55	-4.46	-5.09	-7.00	-10.19	-12.73	-14.64	-15.92
Time (milliseconds)	160	170	180	190	200	210	220	230	240	250	260	270	280	290	300
Longitudinal Axis Recorded Velocity	-16.55	-16.55	-17.19	-17.19	-16.55	-16.55	-16.55	-16.55	-16.55	-16.55	-16.55	-16.55	-16.55	-16.55	-16.55

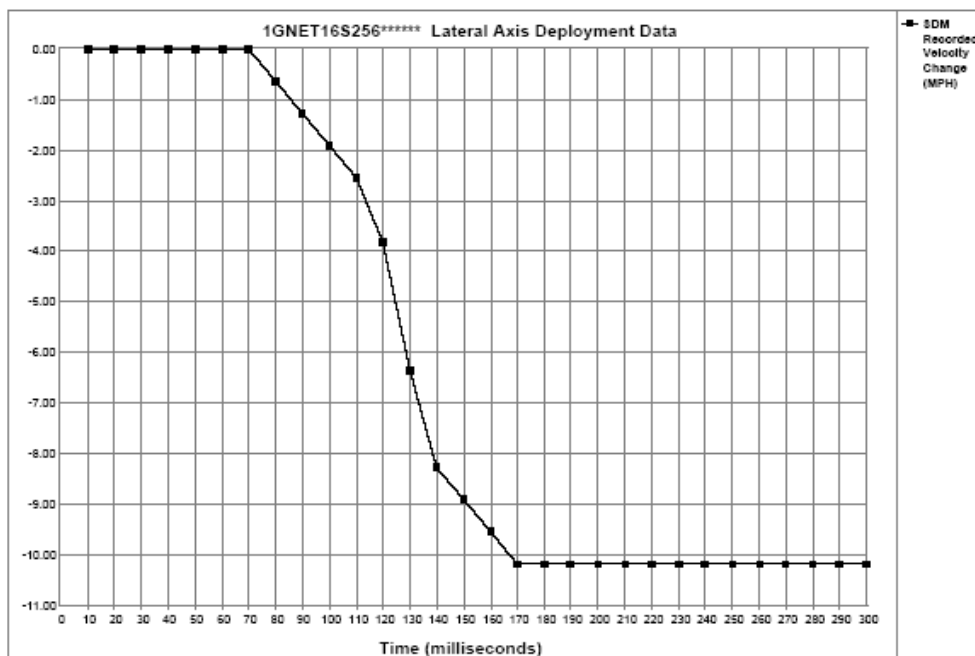
Time (milliseconds)	10	20	30	40	50	60	70	80	90	100	110	120	130	140	150
Lateral Axis Recorded Velocity Change (MPH)	0.00	0.00	0.00	0.00	0.00	0.00	0.00	-0.64	-1.27	-1.91	-2.55	-3.82	-6.37	-8.28	-8.91
Time (milliseconds)	160	170	180	190	200	210	220	230	240	250	260	270	280	290	300
Lateral Axis Recorded Velocity Change (MPH)	-9.55	-10.19	-10.19	-10.19	-10.19	-10.19	-10.19	-10.19	-10.19	-10.19	-10.19	-10.19	-10.19	-10.19	-10.19

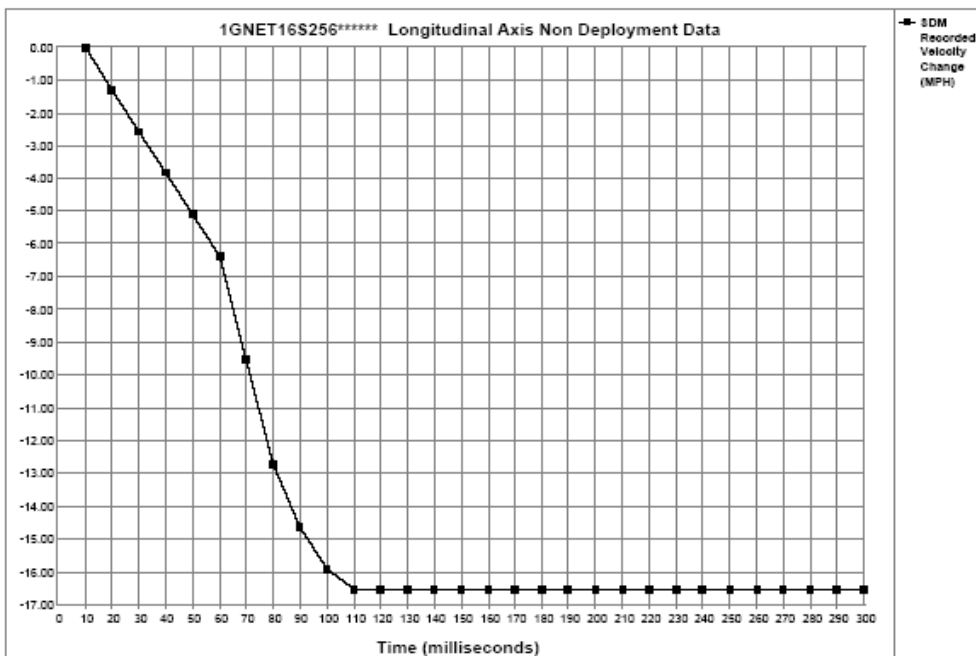
Diagnostic Trouble Codes at Event, fault number: 8	N/A
Diagnostic Trouble Codes at Event, fault number: 9	N/A
Maximum SDM Recorded Velocity Change (MPH)	22.82
Algorithm Enable to Maximum SDM Recorded Velocity Change (msec)	1880
Crash Record Locked	Yes
Deployment Event Recorded in the Non-Deployment Record	No
Vehicle Event Data (Pre-Crash) Associated With This Event	No
Event Recording Complete	Yes
Estimated Principal Direction of Force (PDOF) degrees	30

Time (milliseconds)	10	20	30	40	50	60	70	80	90	100	110	120	130	140	150
Longitudinal Axis Recorded Velocity	0.00	-1.27	-2.55	-3.82	-5.09	-6.37	-7.64	-8.92	-10.19	-11.46	-12.73	-14.00	-15.27	-16.55	-16.55
Time (milliseconds)	160	170	180	190	200	210	220	230	240	250	260	270	280	290	300
Longitudinal Axis Recorded Velocity	-16.55	-16.55	-16.55	-16.55	-16.55	-16.55	-16.55	-16.55	-16.55	-16.55	-16.55	-16.55	-16.55	-16.55	-16.55

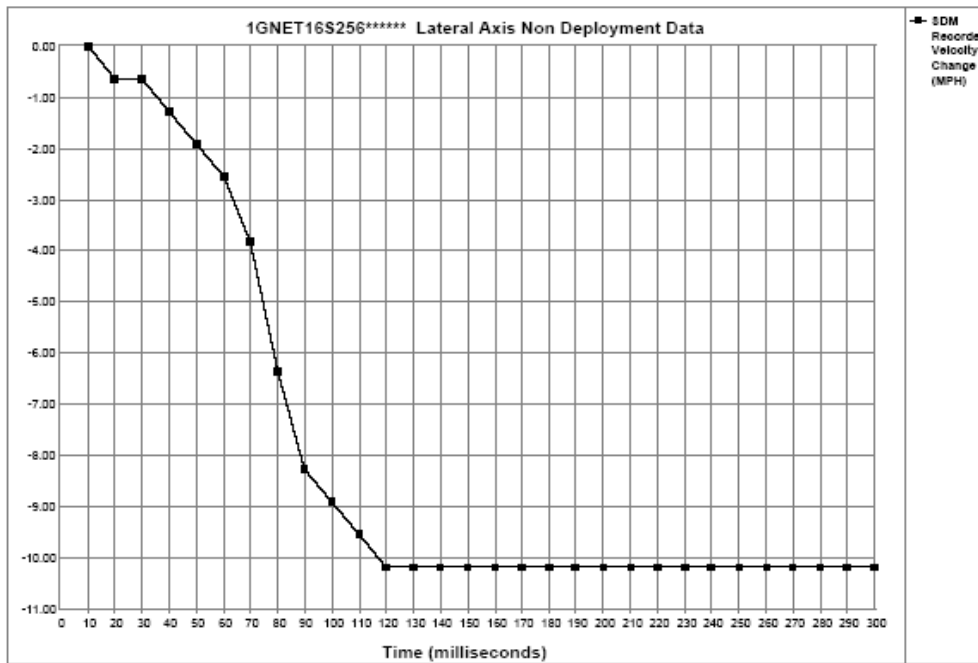
Time (milliseconds)	10	20	30	40	50	60	70	80	90	100	110	120	130	140	150
Lateral Axis Recorded Velocity Change (MPH)	0.00	-0.64	-0.64	-1.27	-1.91	-2.55	-3.82	-6.37	-8.28	-8.91	-9.55	-10.19	-10.19	-10.19	-10.19
Time (milliseconds)	160	170	180	190	200	210	220	230	240	250	260	270	280	290	300
Lateral Axis Recorded Velocity Change (MPH)	-10.19	-10.19	-10.19	-10.19	-10.19	-10.19	-10.19	-10.19	-10.19	-10.19	-10.19	-10.19	-10.19	-10.19	-10.19
