Child Safety Seat Fatality Investigation / Vehicle to Vehicle
Dynamic Science, Inc. / Case Number: DS06002
2000 Toyota Echo
California
December 2005

1. Report No. DS06002	2. Government Accession No.		3. Recipient Catalog No.	
4. Title and Subtitle Child Safety Seat Fatality Investigation			5. Report Date May 17, 2006

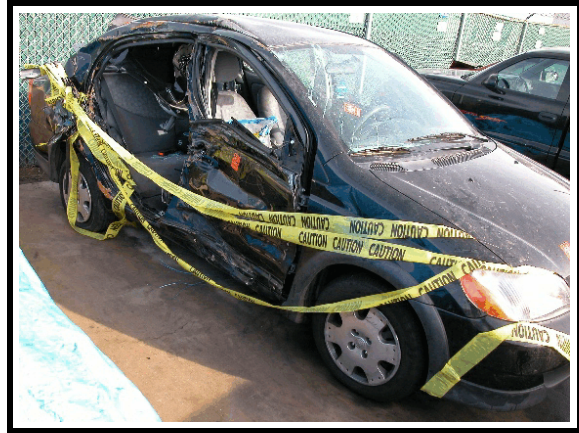
Figure 1. Right side, 2000 Toyota Echo

Damage Description: Moderate right side damage as a result of the impact with the Dodge Durango. The direct damage began 47.0 cm (18.5 in) rear of the front axle and extended 216.0 cm (85.0 in) rearward along the right side. Both right side doors were deformed and jammed shut. The right rear door was pried open at some point. The combined direct and induced damage began 41.0 cm (16.1 in) rear of the front axle and extended 226.0 cm (88.9 in) rearward. The right B pillar and right roof rail were deformed laterally. Both right side windows had disintegrated. The windshield was fractured from impact forces and the backlight glazing had disintegrated.

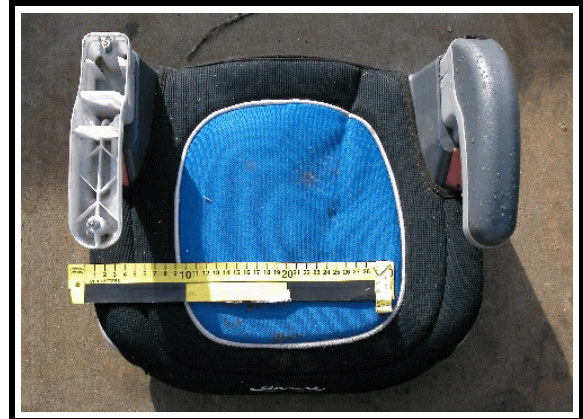
Figure 5. Top, Graco booster seat

The booster seat sustained moderate damage as a result of the crash. The upper part of the right side arm rest was dislodged. The forward aspect of the seat bottom was abraded from contact to the intruding right rear door.

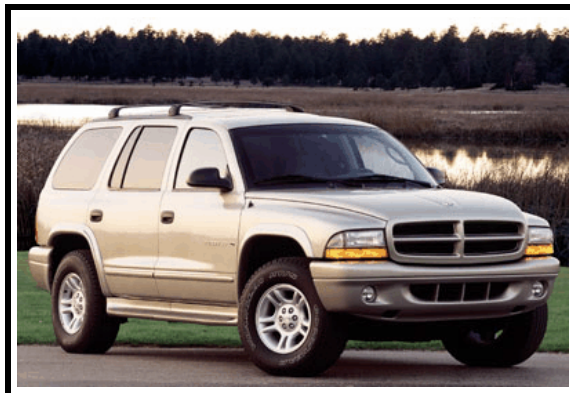
Description:	2001 Dodge Durango sport utility vehicle	
VIN:	Unknown	
Odometer:	Unknown	
Engine:	Unknown	
Reported Defects:	None noted	
Cargo:	Unknown	
Damage Description:	Per the police report: Moderate left rear damage consisting of, but not limited to, the following: left rear passenger door dented, and bent forward, left rear quarter panel at left rear taillight crushed inward, left rear rim scratched, front bumper center to left side dented and scratched, right front bumper dented away from grille, and left side front bumper pushed into the left front tire.	
	Human body tissue and blood found on the rear cargo door.	
CDC:	Unknown	
Delta V (Impact 1):	Total	13.0 km/h (8.1 mph)
	Longitudinal	12.8 km/h (8.0 mph)
	Latitudinal	2.3 km/h (1.4 mph)
	Energy	17,829 joules (13,150 ft/lbs)

Figure 10. Exemplar photo, 2001 Dodge Durango

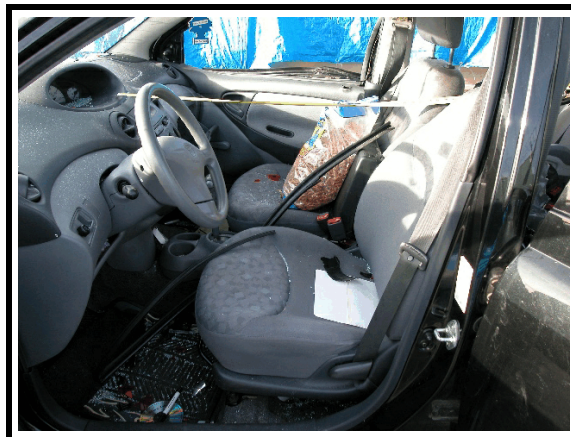
The 28-year-old female driver was seated in an upright posture and was restrained by the 3-point manual lap and shoulder belt. The seat was adjusted to the rear most track position. The driver's seat back was at a 70 degree angle, the seat bottom was at a 12 degree angle. According to police accounts, she was actively steering and braking. The driver was pitched first to the right and then to the left. As she lost control of the vehicle, and the vehicle began a counterclockwise rotation, the driver began pitching to the right. At impact, the driver initiated a lateral and slightly forward trajectory to the right. There were no indications that the driver contacted any interior structures. The driver was not injured. She was able to exit the vehicle under her own ability.

Figure 11. Driver seated position
