**CALSPAN ON-SITE CHILD AIR BAG RELATED FATALITY CRASH
INVESTIGATION**

CASE NO: CA06-002

VEHICLE: 1999 CHEVROLET CORVETTE

CRASH DATE: FEBRUARY 2006

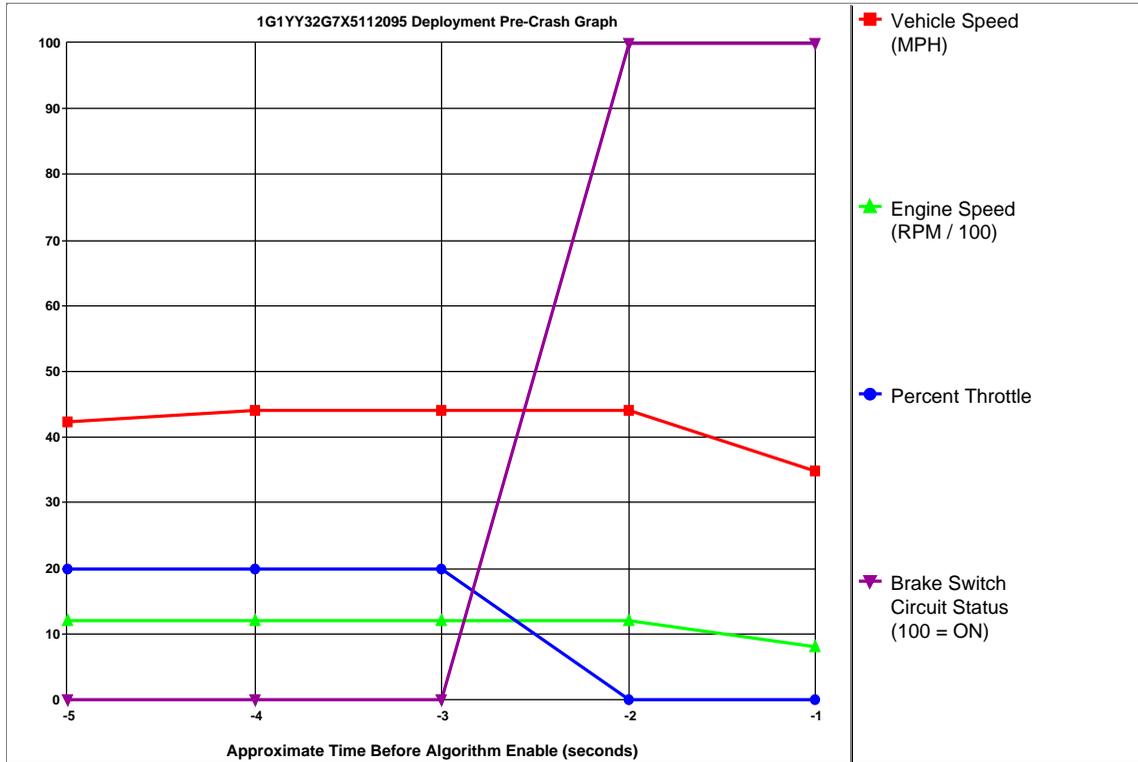
System Status At Deployment

SIR Warning Lamp Status	OFF
Driver's Belt Switch Circuit Status	UNBUCKLED
Passenger Front Air Bag Suppression Switch Circuit Status	Air Bag Not Suppressed
Ignition Cycles At Deployment	5217
Time Between Non-Deployment And Deployment Events (sec)	N/A

Seconds Before AE	Vehicle Speed (MPH)	Engine Speed (RPM)	Percent Throttle	Brake Switch Circuit Status
-5	42	1216	20	OFF
-4	44	1216	20	OFF
-3	44	1216	20	OFF
-2	44	1216	0	ON
-1	35	832	0	ON

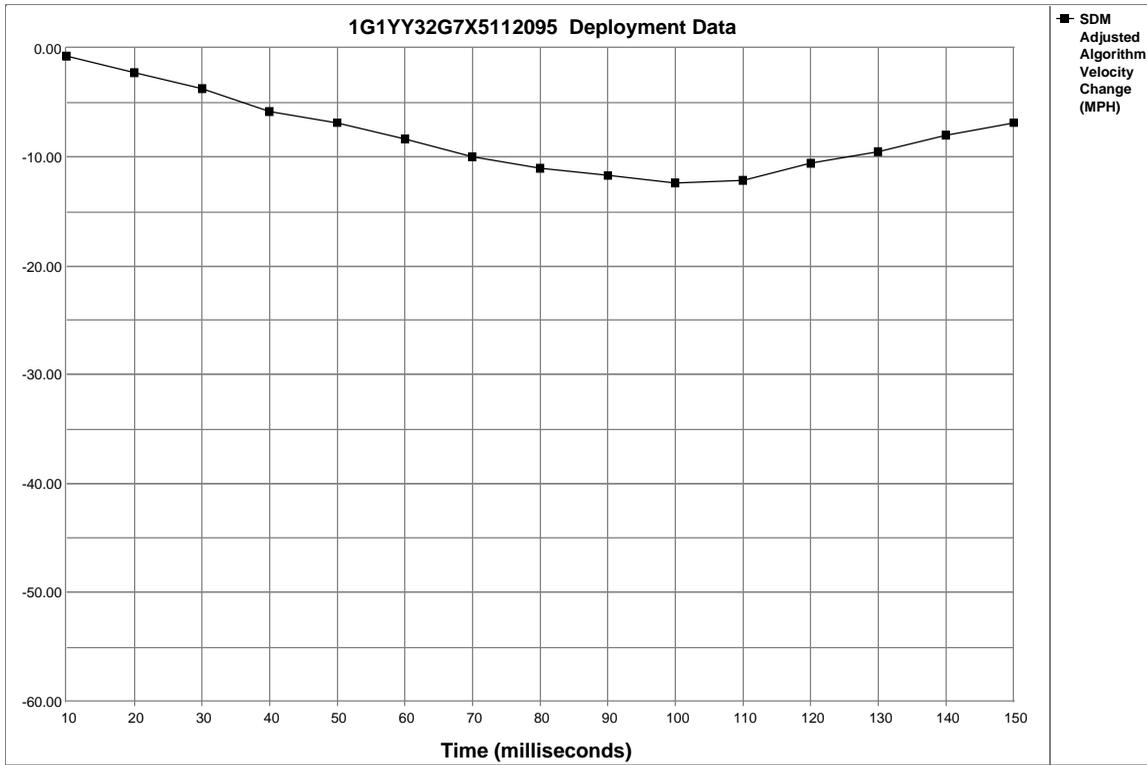
The Deployment file occurred at ignition cycle 5217. The output data recorded the driver's safety belt switch as Unbuckled and the front right air bag as Not Suppressed. It should be noted that this vehicle did not have a manual cut-off switch. The pre-crash data recorded a vehicle speed of 68 km/h (42 mph) at the -5 second interval prior to AE with a slight increase to 71 km/h (44 mph) to the -2 second interval. At this recording cycle, the driver released throttle pressure and applied a braking force, which decelerated the Corvette to 89 km/h (35 mph) at the -1 second recording interval. The maximum velocity change was 20 km/h (-12.3 mph).

Time (milliseconds)	10	20	30	40	50	60	70	80	90	100	110	120	130	140	150
Adjusted Algorithm Velocity Change	-0.68	-2.22	-3.75	-5.73	-6.83	-8.36	-9.90	-11.00	-11.66	-12.31	-12.10	-10.56	-9.46	-7.93	-6.83

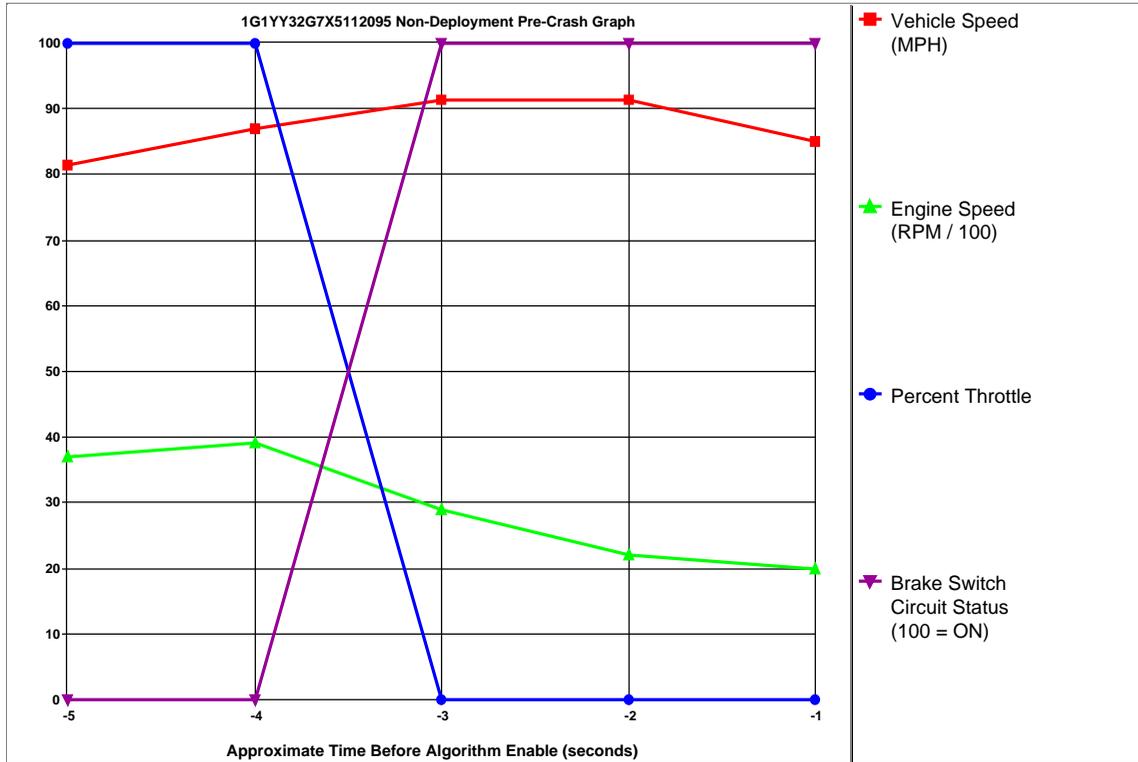
System Status At Non-Deployment

SIR Warning Lamp Status	OFF
Driver's Belt Switch Circuit Status	UNBUCKLED
Passenger Front Air Bag Suppression Switch Circuit Status	Air Bag Not Suppressed
Ignition Cycles At Non-Deployment	5166
Maximum SDM Algorithm Forward Velocity Change (MPH)	-0.10

Seconds Before AE	Vehicle Speed (MPH)	Engine Speed (RPM)	Percent Throttle	Brake Switch Circuit Status
-5	81	3712	100	OFF
-4	87	3904	100	OFF
-3	91	2944	0	ON
-2	91	2240	0	ON
-1	85	1984	0	ON
