**CALSPAN ON-SITE SIDE IMPACT INFLATABLE OCCUPANT PROTECTION  
VEHICLE CRASH INVESTIGATION**

**CASE NO: CA06-007**

**VEHICLE: 2005 VOLKSWAGEN PASSAT**

**CRASH DATE: APRIL 2006**

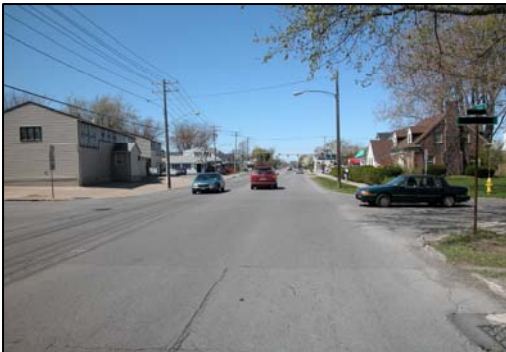
The 2005 Volkswagen Passat was traveling on the northbound lane and passing through the intersection (**Figure 2**). The 24-year-old driver of the Taurus was traveling eastbound and disregarded the stop sign and entered the intersection (**Figure 3**). The driver of the Taurus claimed that he was being chased by an unknown vehicle and ran the stop sign out of fear for his safety. The driver of the Passat reported that he saw the Taurus approaching a second prior to the impact but did not have sufficient time to attempt any avoidance measures.

**Figure 2 - Northbound approach of the 2005 Volkswagen Passat.**

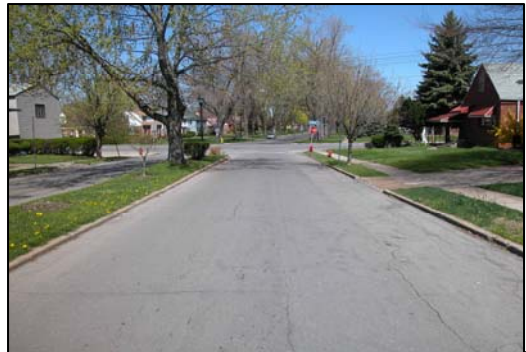
**Figure 3 - Eastbound approach of the 2000 Ford Taurus.**
