ON-SITE CHILD SAFETY SEAT INVESTIGATION

CASE NUMBER - IN-06-012

VEHICLE - 1999 OLDSMOBILE ALERO GX

CRASH DATE - May 2006

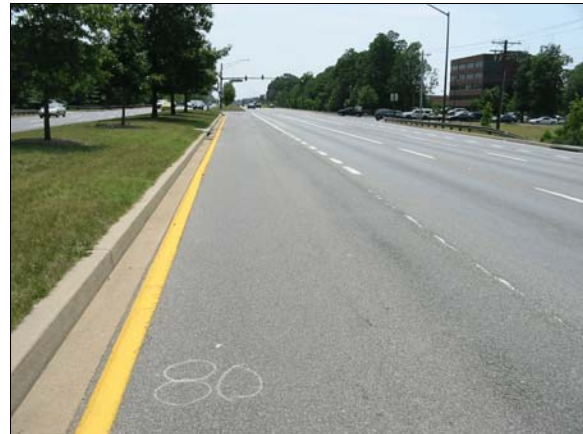
Figure 1: View southwest of approach roadway to impact, case vehicle stopped in left turn lane at intersection, Nissan and Chevrolet initially in inside through lane, number shows meters to impact

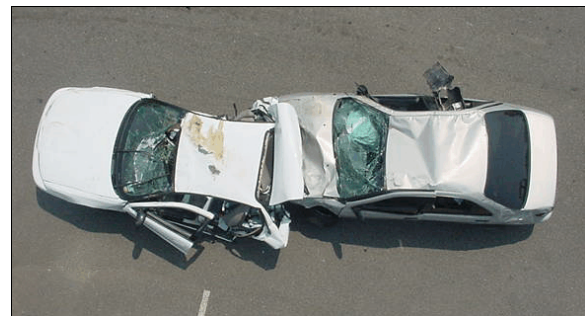
Figure 7: Police photo showing their reconstructed impact orientation of the case vehicle and Nissan

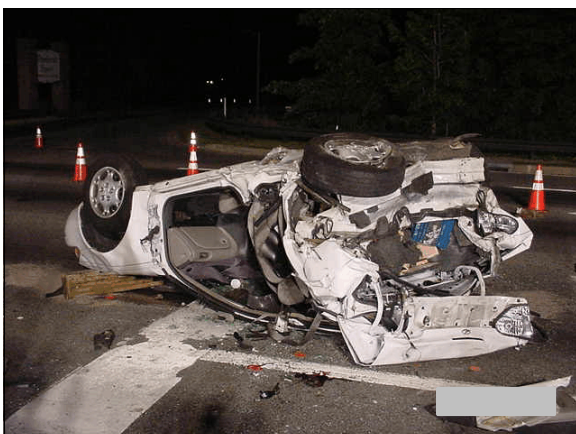
Figure 8: Police on-scene photo showing case vehicle's final rest position, view to east

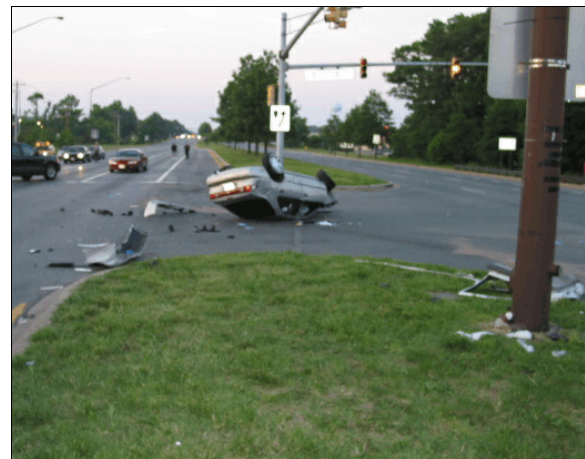
Figure 9: Police on-scene photo showing Nissan's final rest position, view is northeast back to approach of all vehicles

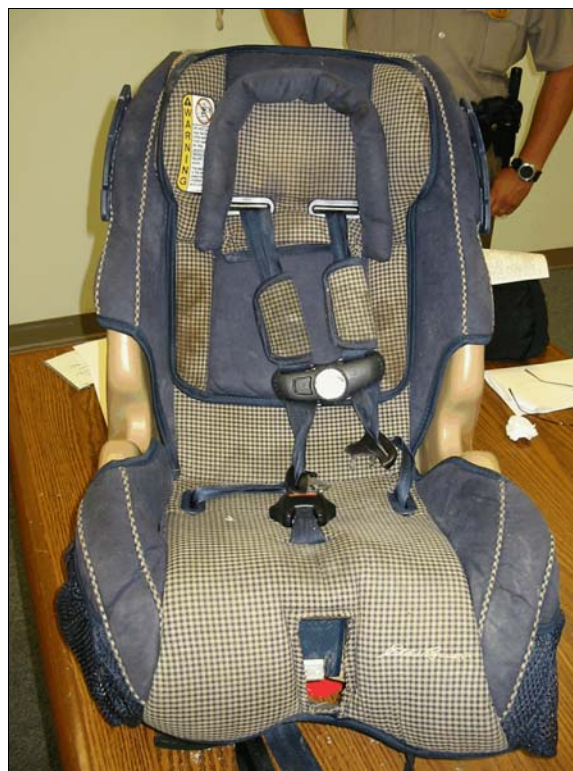
Back Center Child Safety Seat: The back center passenger [3-year-old, female; 91 centimeters and 11 kilograms (36 inches, 25 pounds)] was seated in a convertible child safety seat with five-point harness (**Figure 12**). It was used in the forward facing position. The child safety seat was manufactured by the Dorel Juvenile group and was indicated as a Cosco, Eddie Bauer child

Figure 12: Overview of case vehicle's back center child safety seat

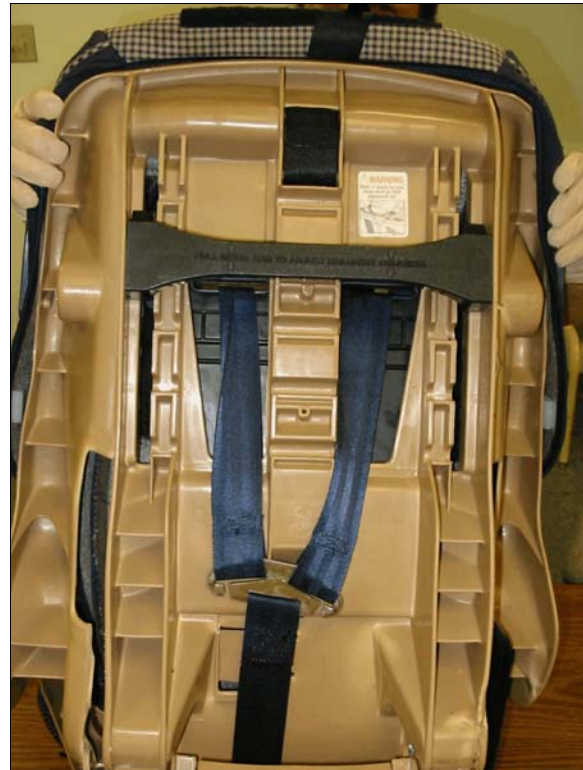
Figure 13: Back of back center passenger's child safety seat showing harness strap slots and harness adjuster mechanism

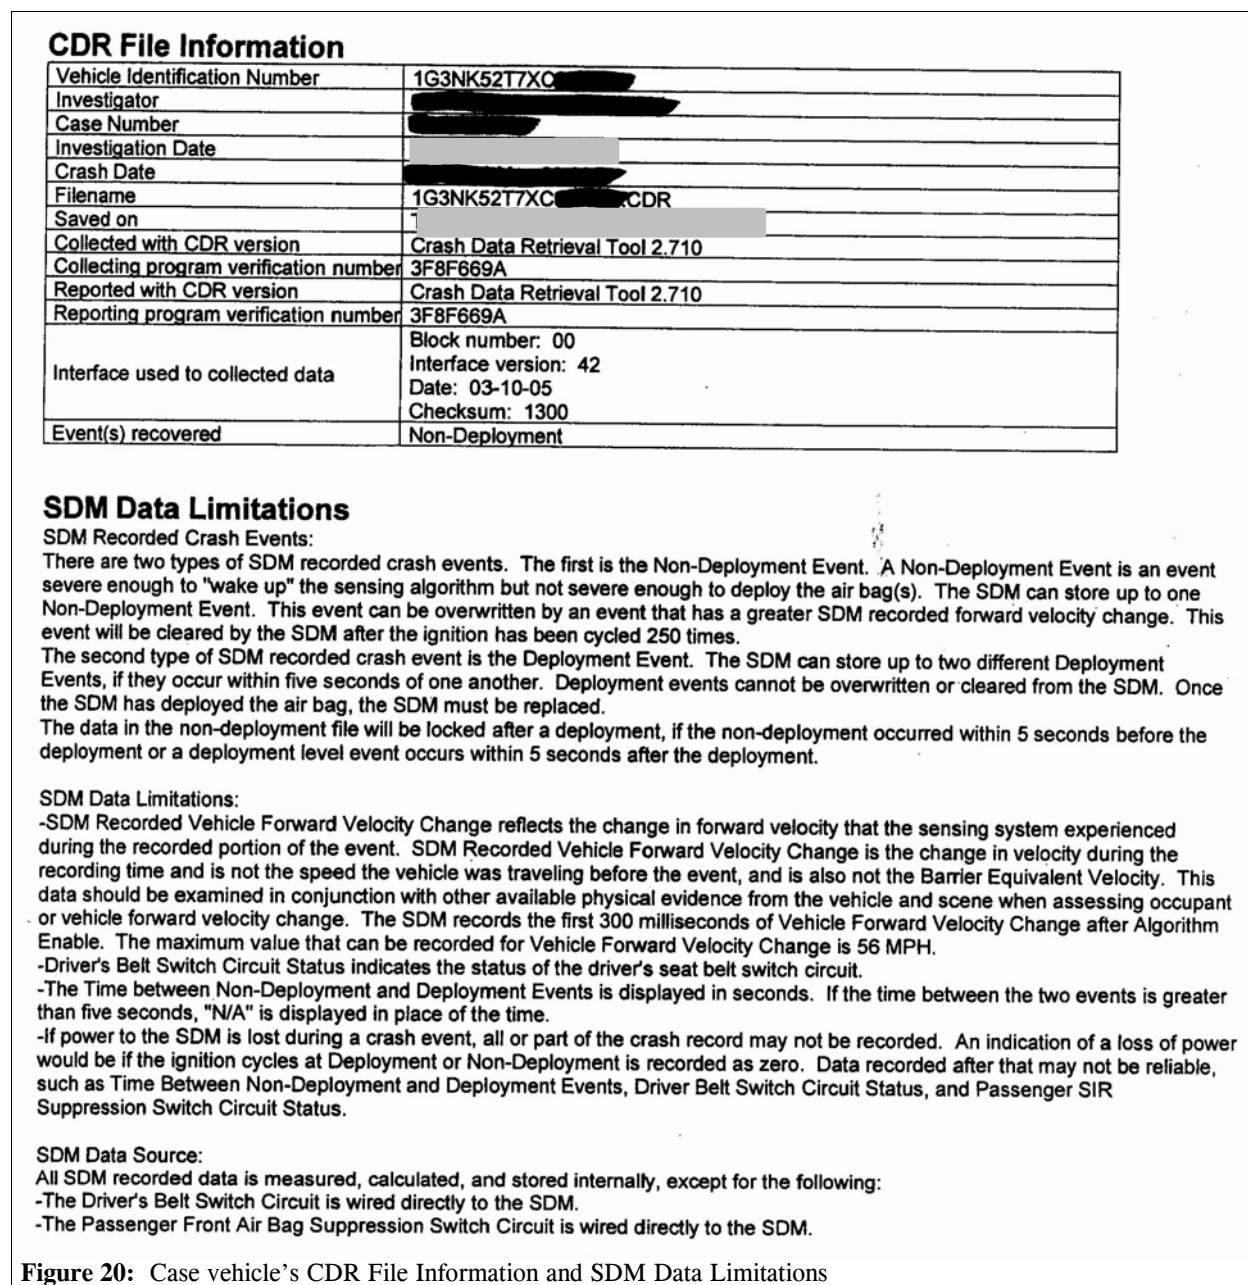
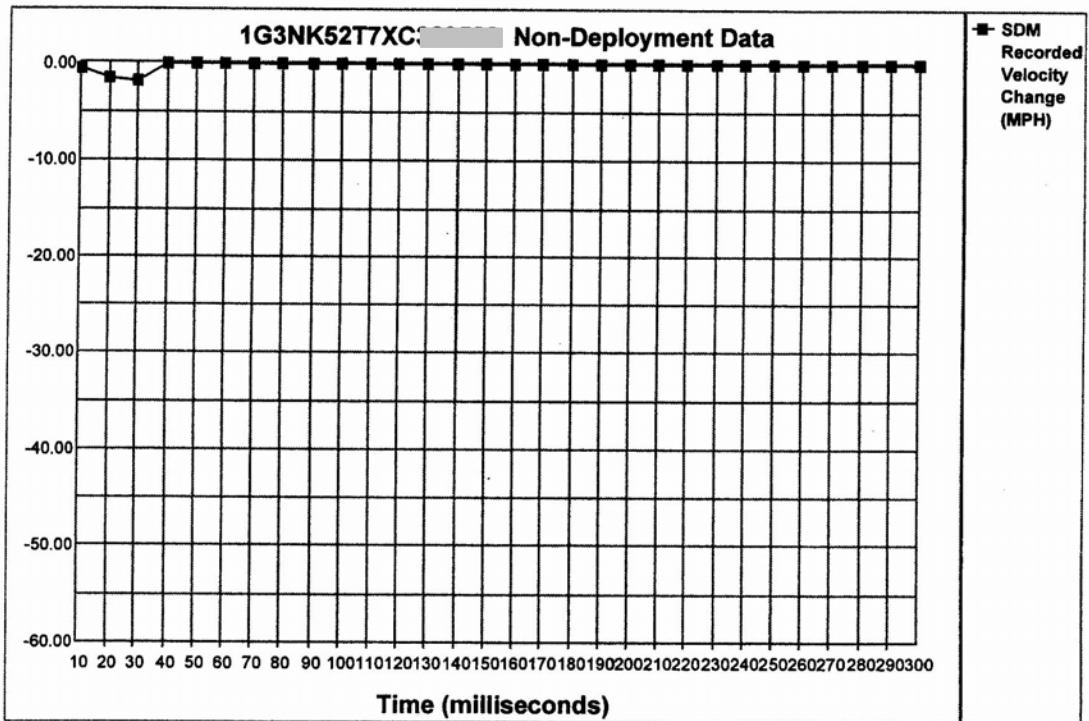
SIR Warning Lamp Status	OFF
Driver's Belt Switch Circuit Status	BUCKLED
Passenger Front Air Bag Suppression Switch Circuit Status	Air Bag Not Suppressed
Ignition Cycles At Non-Deployment	9688
Ignition Cycles At Investigation	9689
Algorithm Enable to Maximum SDM Recorded Velocity Change (msec)	21.25
Maximum SDM Recorded Velocity Change (MPH)	-1.76
A Deployment was Commanded Prior to this Event	No

Time (milliseconds)	10	20	30	40	50	60	70	80	90	100	110	120	130	140	150
Recorded Velocity Change (MPH)	-0.44	-1.54	-1.76	0.00	0.00	0.00	0.00	0.00	0.00	0.00	0.00	0.00	0.00	0.00	0.00
Time (milliseconds)	160	170	180	190	200	210	220	230	240	250	260	270	280	290	300
Recorded Velocity Change (MPH)	0.00	0.00	0.00	0.00	0.00	0.00	0.00	0.00	0.00	0.00	0.00	0.00	0.00	0.00	0.00

Figure 21: Case vehicle's System Status at Non-deployment data and SDM recorded velocity change data

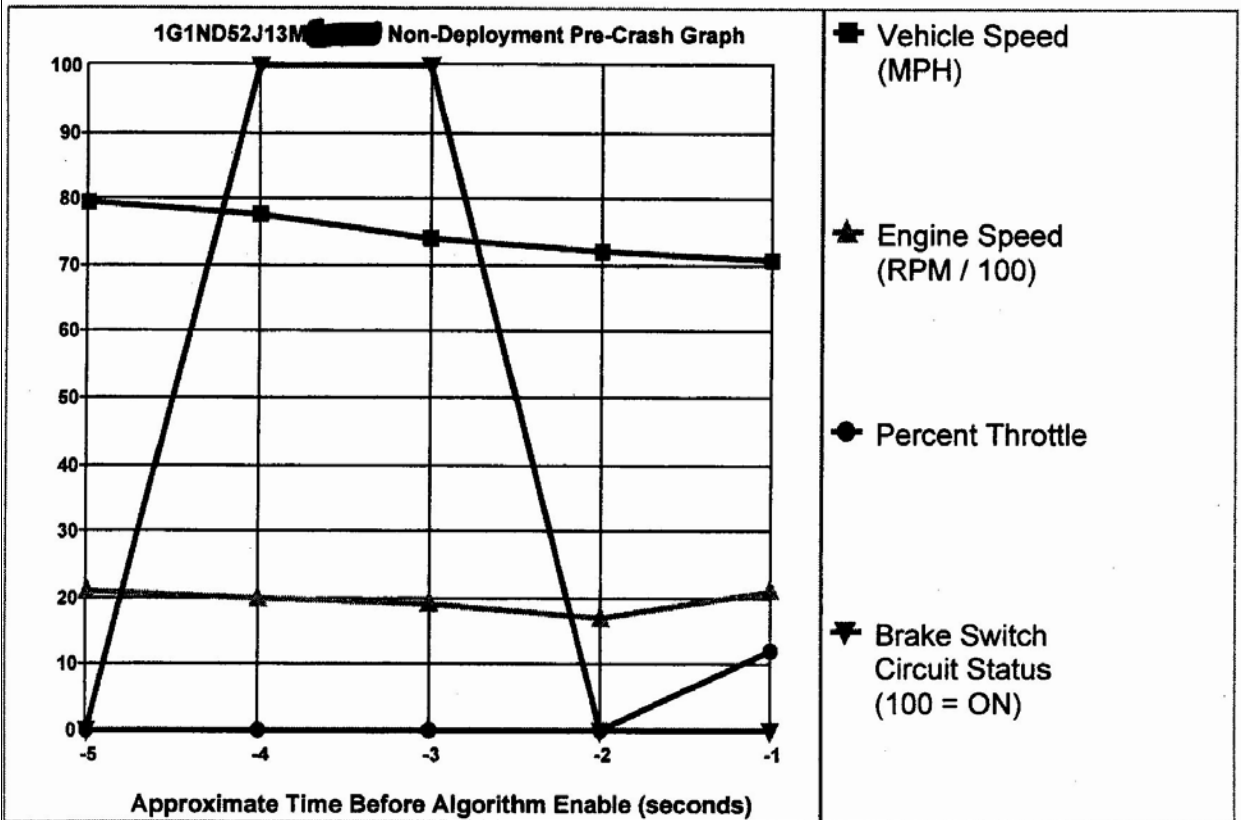
Seconds Before AE	Vehicle Speed (MPH)	Engine Speed (RPM)	Percent Throttle	Brake Switch Circuit Status
-5	80	2112	0	OFF
-4	78	2048	0	ON
-3	74	1856	0	ON
-2	72	1728	0	OFF
-1	71	2112	12	OFF

Figure 23: Chevrolet's System Status at Non-deployment report and pre-crash data

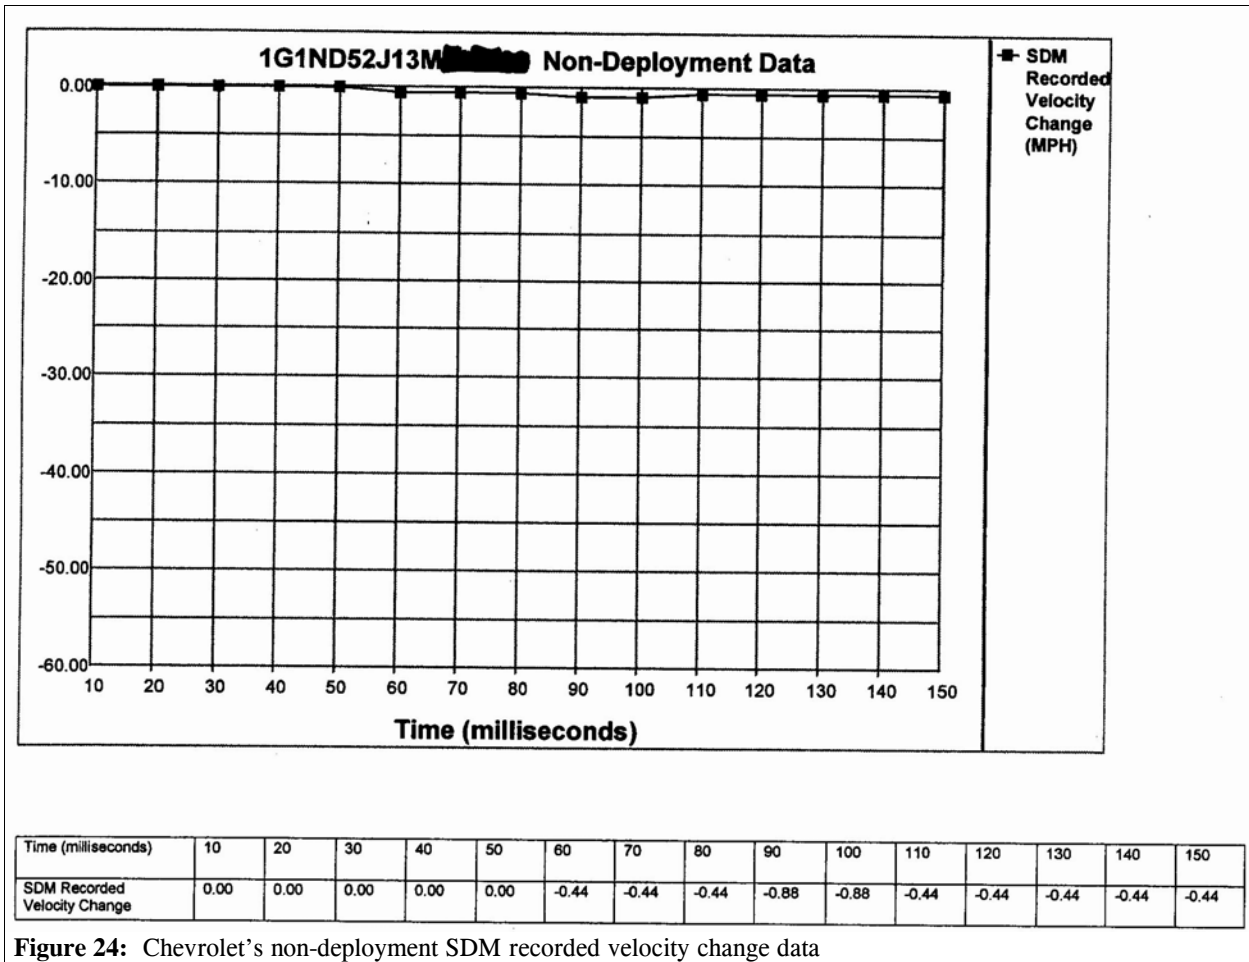
Figure 24: Chevrolet's non-deployment SDM recorded velocity change data
