Child Safety Seat Investigation / Vehicle to Vehicle
Dynamic Science, Inc. / Case Number: DS06013
2006 Ford Mustang
California
June 2006

| 4. Title and Subtitle Child Safety Seat Investigation | | 5. Report Date August 28, 2006 | |

**Dynamic Science, Inc.
Crash Investigation
Case Number: DS06013**

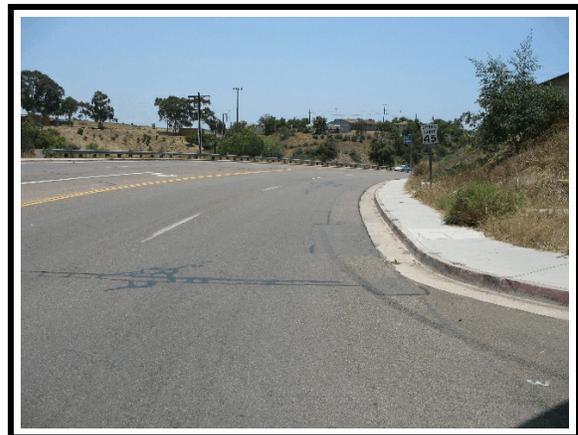
Figure 2. Approach to area of impact (south)

The 2006 Ford Mustang was traveling southbound in the first lane from the right and had passed through the four-leg intersection (see Figure 2). The Ford Mustang was occupied by a 23-year-old male driver, a 19-year-old female front right seat occupant, and a 2-week-old male rear right seat passenger, restrained in the rear facing child seat. The 1992 Honda Accord was traveling northbound in the first lane from the right (see Figure 3). The Honda Accord was being driven by a male. There were two additional male occupants in this vehicle.

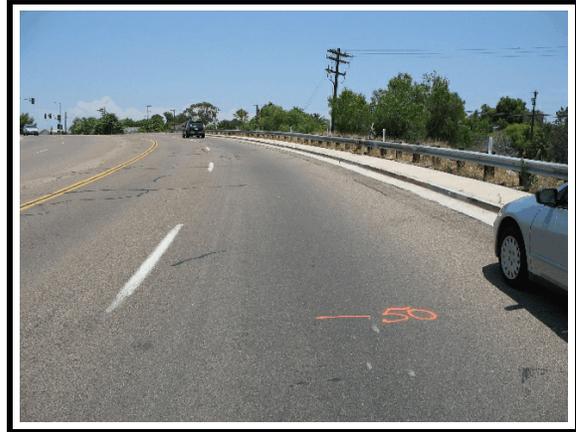
Figure 3. Approach to area of impact (north)

As the Mustang passed through the intersection, the driver began braking and steered sharply to the left, possibly in an effort to avoid striking the western curb. The Mustang began a counterclockwise rotation. The Mustang had rotated approximately 45 degrees before it crossed the double yellow center line, and was at a greater than 90 degree angle as it entered the northbound travel lane.

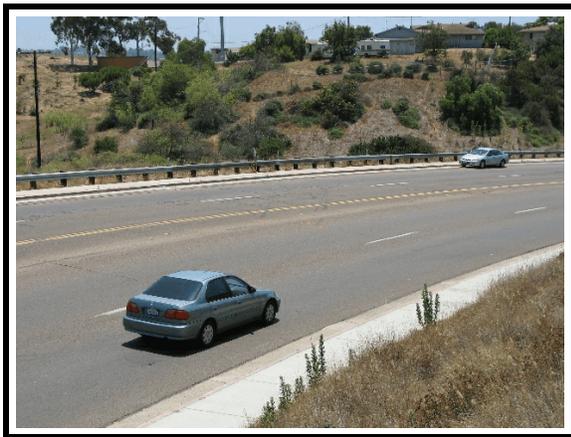
Figure 4. Overview of impact and final rest area (east)

It does not appear that the driver of the Honda Accord was able to brake or take any avoidance actions. The front of the Accord struck the right side of the Ford Mustang (03RYEW4). See Figure 4 for an overview impact area. The missing vehicle routine of the WinSmash program computed a total delta V of 43.0 km/h (26.7 mph) for the case vehicle. The longitudinal and lateral components were 7.5 km/h (4.6 mph) and -42.3 km/h (-26.3 mph), respectively. The impact severity was moderate. The impact tripped the Mustang and caused it to roll two quarter turns onto the hood of the Accord, where it came to rest (see Figure 5).

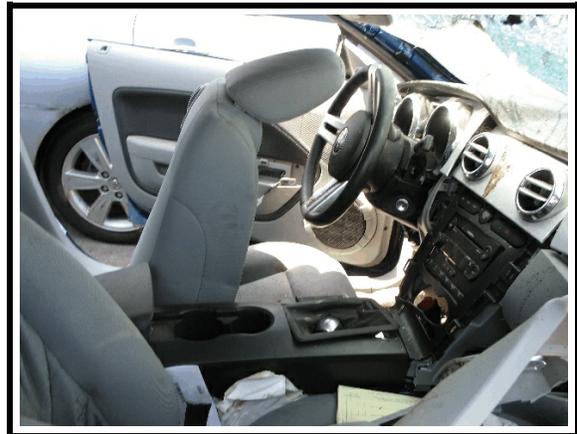
Figure 14. Driver's seated position

The 23-year-old male driver was likely seated in an upright posture and was restrained by the manual lap and shoulder belt (see Figure 14). The fabric covered bucket seat was adjusted to the mid track position. The seat bottom angle this seat was 30 degrees. The seat back angle for the driver's seat was unknown—it had been moved. Prior to impact, the driver was actively steering both left and right. He was also braking—likely with his right foot. Both hands were likely on the steering wheel during the active steering efforts. As the driver lost control of the vehicle and it began a counterclockwise rotation, the driver began pitching to the right. At impact, the driver initiated a lateral and slightly rearward trajectory to the right in response to the 3 o'clock (100 degree) direction of force. His right hip likely engaged the center console to some extent. As the vehicle overturned, the driver continued the movement to the right and then to the top as the vehicle came to rest on its roof. The driver of the Mustang sustained a right clavicle fracture, a cervical spine fracture, a right lung contusion, and a concussive head injury. The head and neck injuries were most likely as a result of contact with the right seat back. He required extrication by EMS personnel due to his injuries. He was transported to an area hospital, treated and then placed under arrest on various felony charges. He was hospitalized for a total of four days.

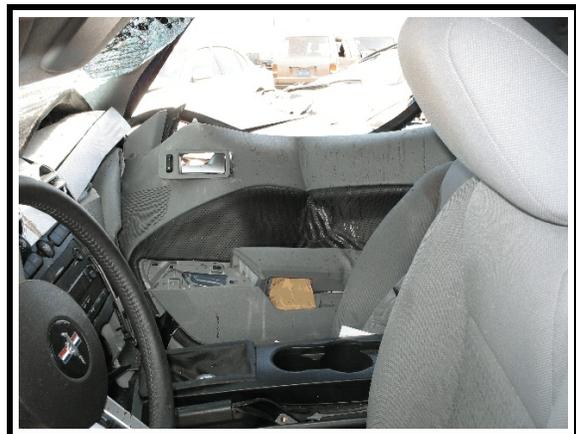
Figure 15. Front right occupant seated position

The 19-year-old female front right occupant was likely seated in an upright posture and was restrained by the manual lap and shoulder belt (see Figure 15). The fabric covered bucket seat was adjusted to the mid track position. The seat bottom angle for this seat was 30 degrees; the angle for the front right passenger's seat back was 65 degrees. Prior to impact, the driver was actively steering both left and right. As the driver lost control of the vehicle and it began a counterclockwise rotation, the front right occupant began pitching to the right. At impact, the front right occupant initiated a lateral and slightly rearward trajectory to the

right in response to the 3 o'clock (100 degree) direction of force. This occupant's entire right side torso likely engaged the right door as a result of both the direction of force and intrusion through the right side plane. Her left hip likely engaged the center console to some extent. As the vehicle overturned, the front right occupant continued the movement to the right and then to the top as the vehicle came to rest on its roof. She was trapped in the vehicle and fatally injured.

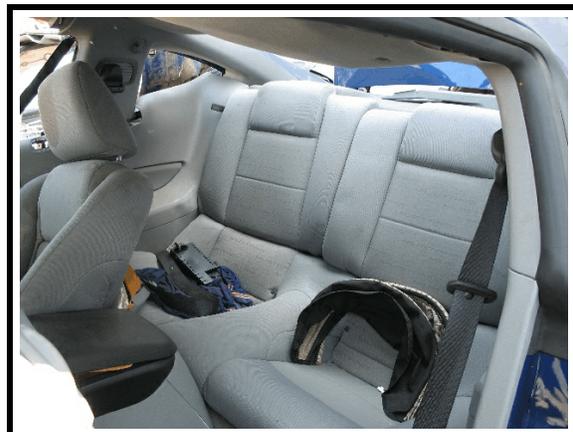
Figure 17. Second row right occupant seated position

The 2-week-old male child was restrained in the rear facing infant seat by the five point harness. The infant seat was installed in the rear right position of the Ford Mustang using the vehicle lap and shoulder belt (see Figure 17). The fabric covered bench seat had a seat back angle of 69 degrees and a seat bottom angle of 21 degrees. Based on the post-crash harness adjustment, it appeared that the child was held relatively tightly in place. The child remained in the child seat after the rollover.
