## ON-SITE OTHER INFLATABLE OCCUPANT PROTECTION INVESTIGATION

CASE NUMBER - IN-06-014

VEHICLE - 2006 MAZDA 5

CRASH DATE - June 2006

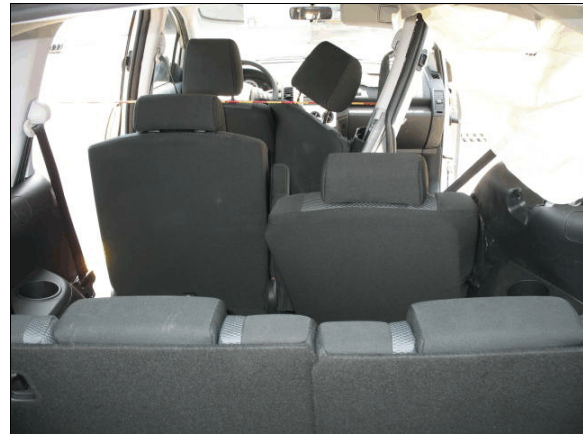
**Vehicle Interior:** Inspection of the case vehicle’s interior (Figures 11, 12 and Figure 13 below) revealed probable occupant contact evidence on the right side curtain air bag, front right seat back-mounted side impact air bag, both right side doors, left side of the center console, the right roof side rail, glove box door and instrument panel below the glove box door. No other occupant contact evidence was found. Both right side doors and the right “B”-pillar had intruded significantly into the passenger compartment. The lower portion of the right “B”-pillar intruded laterally approximately 65 centimeters (25.6 inches) into the second seat row and approximately 55 centimeters (21.7 inches) into the front seat row. In addition, the right front door intruded laterally approximately 46 centimeters (18.1 inches) into the front seat row and the right rear door intruded approximately 50 centimeters (19.7 inches) into the second seat row. Finally, there was no compression of the energy absorbing steering column and no deformation to the steering wheel.

Figure 13: Overview of interior from rear hatch

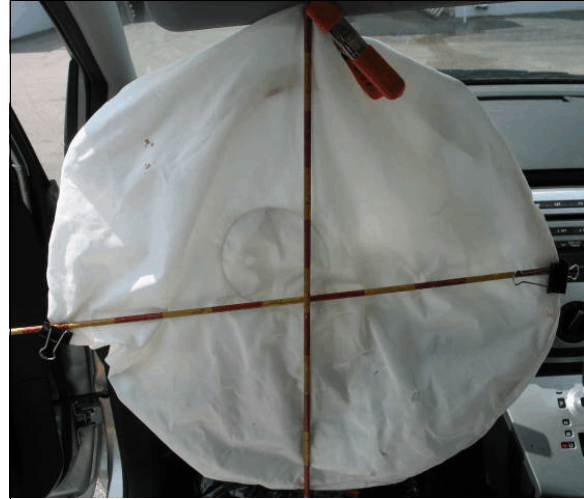
The case vehicle's driver air bag was located in the steering wheel hub. The air bag module cover consisted of three asymmetrical flaps made of pliable vinyl positioned within an overall approximate hexagonal shape. The top flap was essentially a rectangle, except that the bottom was semicircular-shaped so as to accommodate the manufacturer's logo. The overall dimensions of the top flap were approximately 9 centimeters (3.5 inches) in width and 11 centimeters (4.3 inches) in height. The overall dimensions of each of the two bottom flaps were approximately 7 centimeters (2.8 inches) in width, approximately 3 centimeters (1.2 inches) in height at the inside tear seam and 4 centimeters (1.6 inches) in height at their outer edge. The distance between the mid-center of the driver's seat back as positioned at the time of the vehicle inspection [i.e., distance from seat back to air bag module was 55 centimeters (21.7 inches), seat back slightly reclined] and the front surface of the air bag fabric at approximate full excursion was 29 centimeters (11.4 inches). An inspection of the air bag module cover flaps and the air bag fabric revealed that the cover flaps opened at the designated tear points (**Figure 20**). There was no

evidence of damage during the deployment to the air bag or the module cover flaps, and no evidence of occupant contact to the air bag. However, a few small holes were observed in the air bag that were most likely caused by flying glass fragments from the right front window glazing, which cut the air bag fabric during the crash. The deployed driver's air bag (**Figure 21** below) was round with a diameter of approximately 57 centimeters (22.4 inches). The air bag was designed with one tether, approximately 5.5 centimeters (2.2 inches) in width and had two vent ports, each approximately 3 centimeters (1.2 inches) in diameter, located at the 11 and 1 o'clock positions.

**Figure 21:** Case vehicle driver's air bag

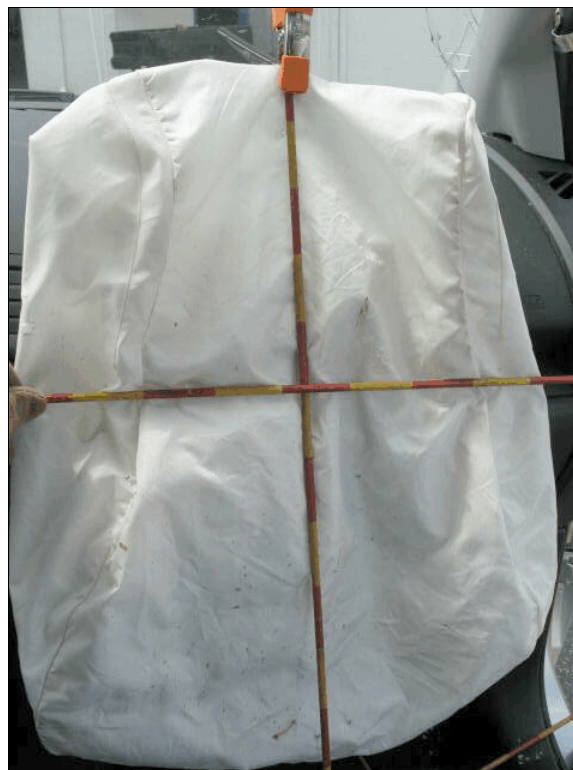
The case vehicle's front right passenger air bag was located in the top of the instrument panel. The module cover consisted of a single rectangular cover flap with rounded corners constructed of stiff vinyl. The cover flap was 19 centimeters (7.5 inches) in width and 15 centimeters (5.9 inches) in height. The distance between the front of the instrument panel and the leading edge of the cover flap was approximately 6 centimeters (2.4 inches). An inspection of the air bag module cover flap and the air bag fabric revealed that the cover flap opened at the designated tear points. There was no evidence of damage during the deployment to the air bag or the module cover flap, and no evidence of occupant contact to the air bag. Numerous small holes were observed in the front and both sides of the air bag (**Figure 22** below). The fabric at the edges of these holes was discolored and brittle and appeared to be melted. The holes were most likely formed when flying glass fragments from the right front window glazing impacted and cut the air bag fabric during the crash. The deployed front right passenger air bag (**Figure 23** below) was rectangular in shape and was 54 centimeters (21.5 inches) in height and 42 centimeters (16.5 inches) in width. The air bag was designed without tethers and had two vent ports, each approximately 7 centimeters (2.8 inches) in diameter, located at the 10 and 2 o'clock positions. There was no evidence of occupant contact to the front right passenger air bag; however, some blood splatter, most likely from the front right passenger, was observed on the front of the air bag.

**Figure 23:** Case vehicle’s front right passenger front air bag
