ON-SITE CERTIFIED ADVANCED 208-COMPLIANT VEHICLE INVESTIGATION

CASE NUMBER - IN-06-015

VEHICLE - 2006 CHEVROLET COBALT

CRASH DATE - May 2006

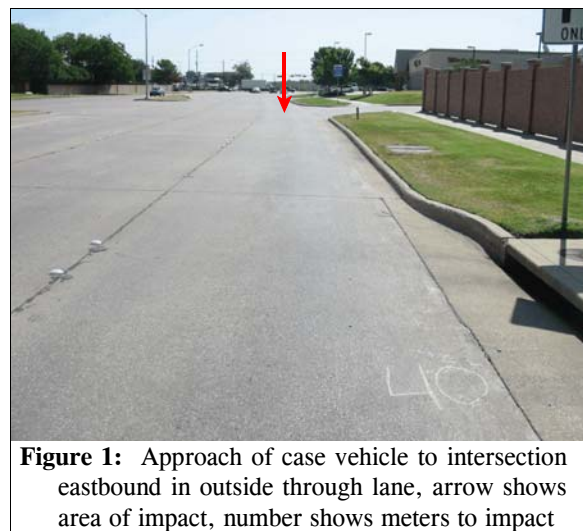
Figure 1: Approach of case vehicle to intersection eastbound in outside through lane, arrow shows area of impact, number shows meters to impact

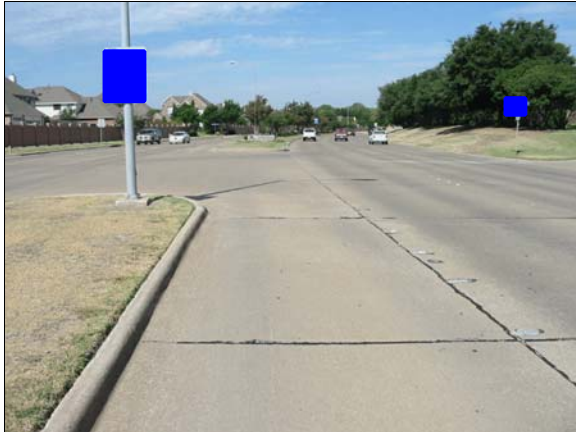
Figure 2: Approach of Kia westbound to intersection in left turn lane

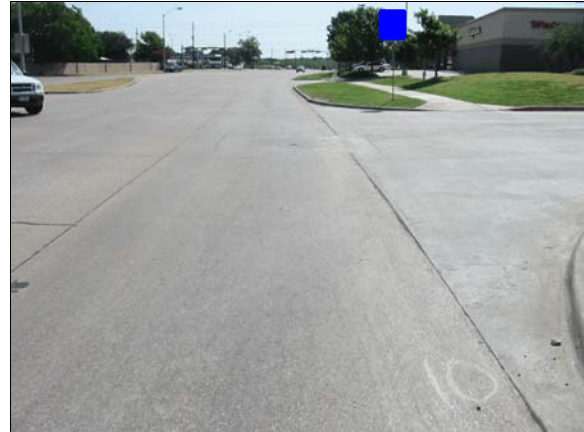
Figure 3: Approach of case vehicle into intersection to area of impact, vehicle on left is following likely approach path of the Kia to impact

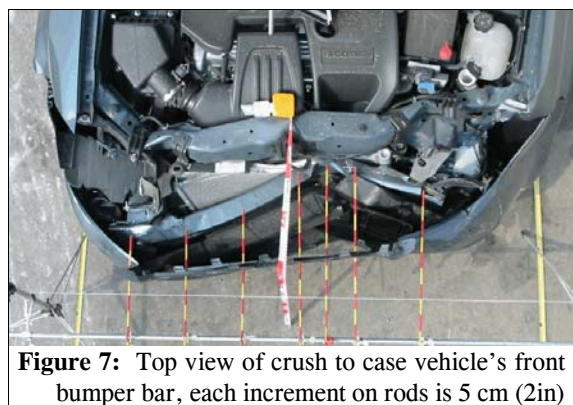
Exterior Damage: The case vehicle's impact with the Kia involved the front end. The front bumper, grille, hood and front of the left fender were directly contacted and crushed rearward and slightly to the right (**Figure 6**). The direct damage began at the left corner of the front bumper fascia and extended across the full width of the front bumper. The bumper fascia had sprung back, away from the underlying bumper bar, so crush measurements were taken at the bumper bar. The direct damage began at the front left bumper corner and extended 120 centimeters (47.2 inches) across the bumper. The maximum residual crush was measured as 43.0 centimeters (16.9 inches) occurring 9 centimeters (3.5 inches) right of C₂ (**Figure 7** below). The table below shows the case vehicle's front crush profile.

Figure 6: Overview of damage to front of case vehicle from impact with Kia, vertical scale is in tenths of meter, each stripe on rods in 5 cm (2 in)

The case vehicle’s left side wheelbase was shortened 0.8 centimeters (1.2 inches) and the right side wheelbase was shortened 3.0 centimeters (1.2 inches). Induced damage involved both fenders and the hood.
