Certified Advanced 208 Compliant Air Bag Investigation / Vehicle to Vehicle
Dynamic Science, Inc. / Case Number: DS06018
2005 Ford Focus
California
July 2006

1. Report No. DS06018	2. Government Accession No.	3. Recipient Catalog No.	
4. Title and Subtitle Certified Advanced 208 Compliant Air Bag Investigation		5. Report Date November 22, 2006

Dynamic Science, Inc.
Crash Investigation
Case Number: DS06018

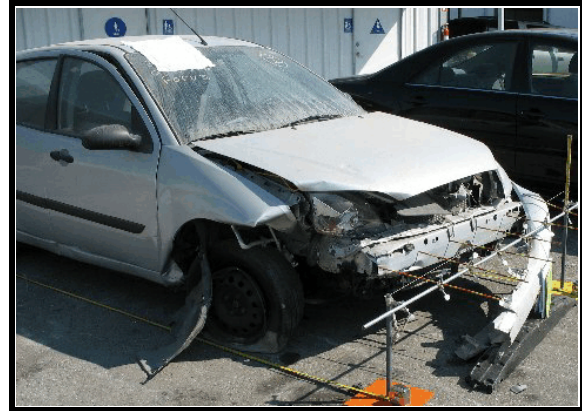
Figure 1. Front right, 2005 Ford Focus

The 2005 Ford Focus sustained moderate front end damage as a result of the impact with the Honda Civic. The direct damage began 20.0 cm (7.9 in) right of the bumper centerline and extended 48.0 cm (18.9 in) laterally to the right. The bumper fascia was torn away from the bumper backing bar. Both right side doors were jammed shut. There was remote buckling at the right roof area and at the right sill between the two right side doors. The front right rim was dented and the front right tire was flat. The wheelbase was shortened by 2.0 cm (0.8 in) on the right side, and elongated 1.0 cm (0.4 in) on the left side. There were spider web fractures to the windshield from contact with the mirror and its support. Six crush measurements were documented at the bumper level as follows: C1=3.0 cm (1.2 in), C2=2.0 cm (0.8 in), C3=3.0 cm (1.2 in), C4=4.0 cm (1.6 in), C5=5.0 cm (2.0 in), C6=10.0 cm (3.9 in). Maximum crush was located at C6 and measured 10.0 cm (3.9 in). The Collision Deformation Classification (CDC) for the impact with the Honda was 01FZEW1.

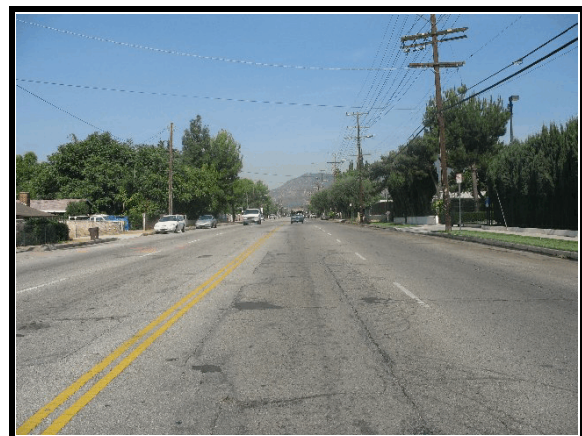
Figure 3. Approach to area of impact (north)

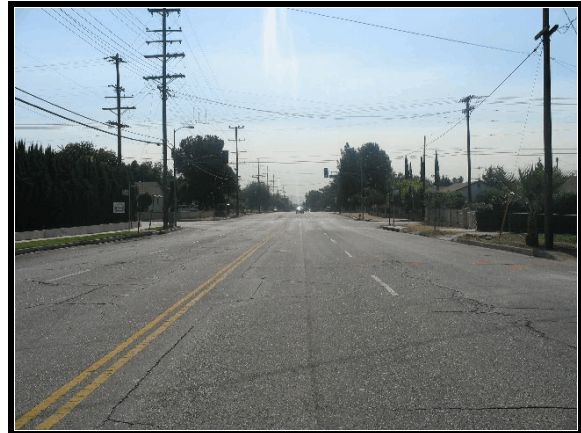
Figure 4. Approach to area of impact (south)

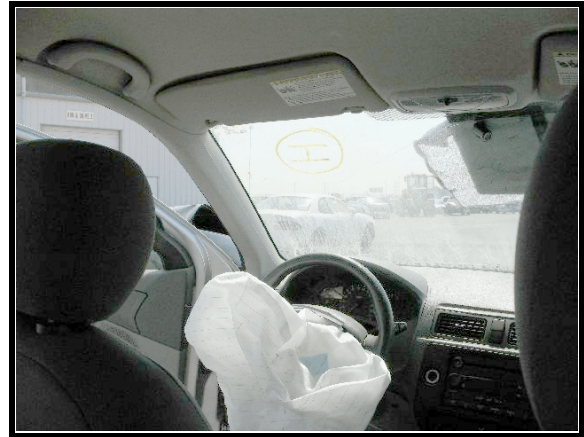
The 2005 Ford Focus sustained minor interior damage due to occupant contact. The windshield was fractured at two points along the line formed by the mirror and its supporting hardware. The mirror was likely contacted by the driver's right hand. The driver's left knee contacted the left lower instrument panel, causing the fuse door to be dislodged. There was 0.3 cm (0.1 in) of steering column shear capsule movement due to occupant loading. The panel above the steering column was missing.

Figure 9. Driver's position

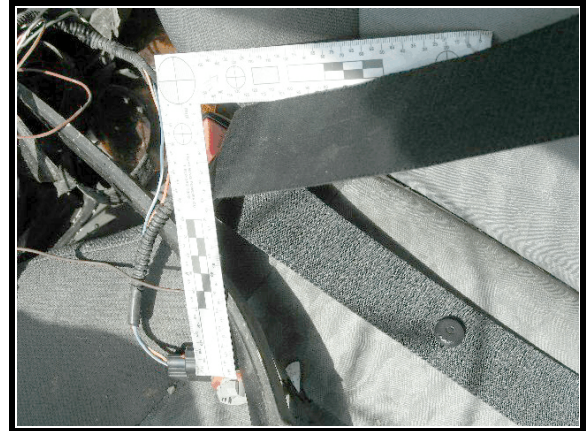
The 2005 Ford Focus was configured with manual 3-point lap and shoulder belts for each of the five seating positions. Both front seat safety belts were equipped with retractor pretensioners and adjustable D rings that were in the full up positions. The driver's safety belt was configured with a sliding latch plate and an Emergency Locking Retractor (ELR). There were indications of loading on the belt webbing at the sliding latch plate guide. The retractor pretensioner likely actuated, but the belt was found to be free spooling at the time of the vehicle inspection. The remaining safety belts were configured with sliding latch plates and switchable ELR/Automatic Locking Retractors (ALR).

Figure 12. Driver's seat belt
