CALSPAN ON-SITE ROLLOVER CRASH INVESTIGATION

CALSPAN CASE NO.: CA06-020

VEHICLE: 2005 FORD FREESTAR

CRASH DATE: JULY 2006

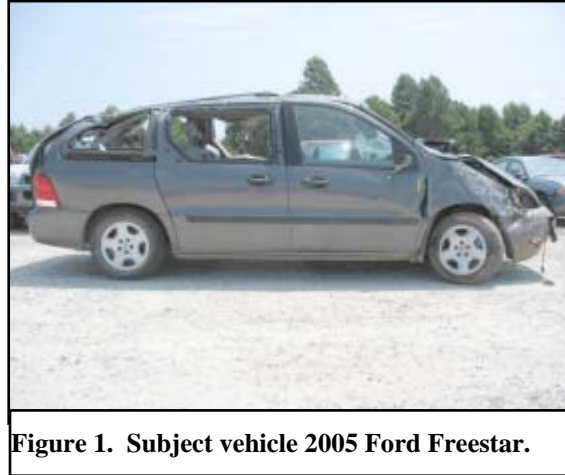
Figure 1. Subject vehicle 2005 Ford Freestar.

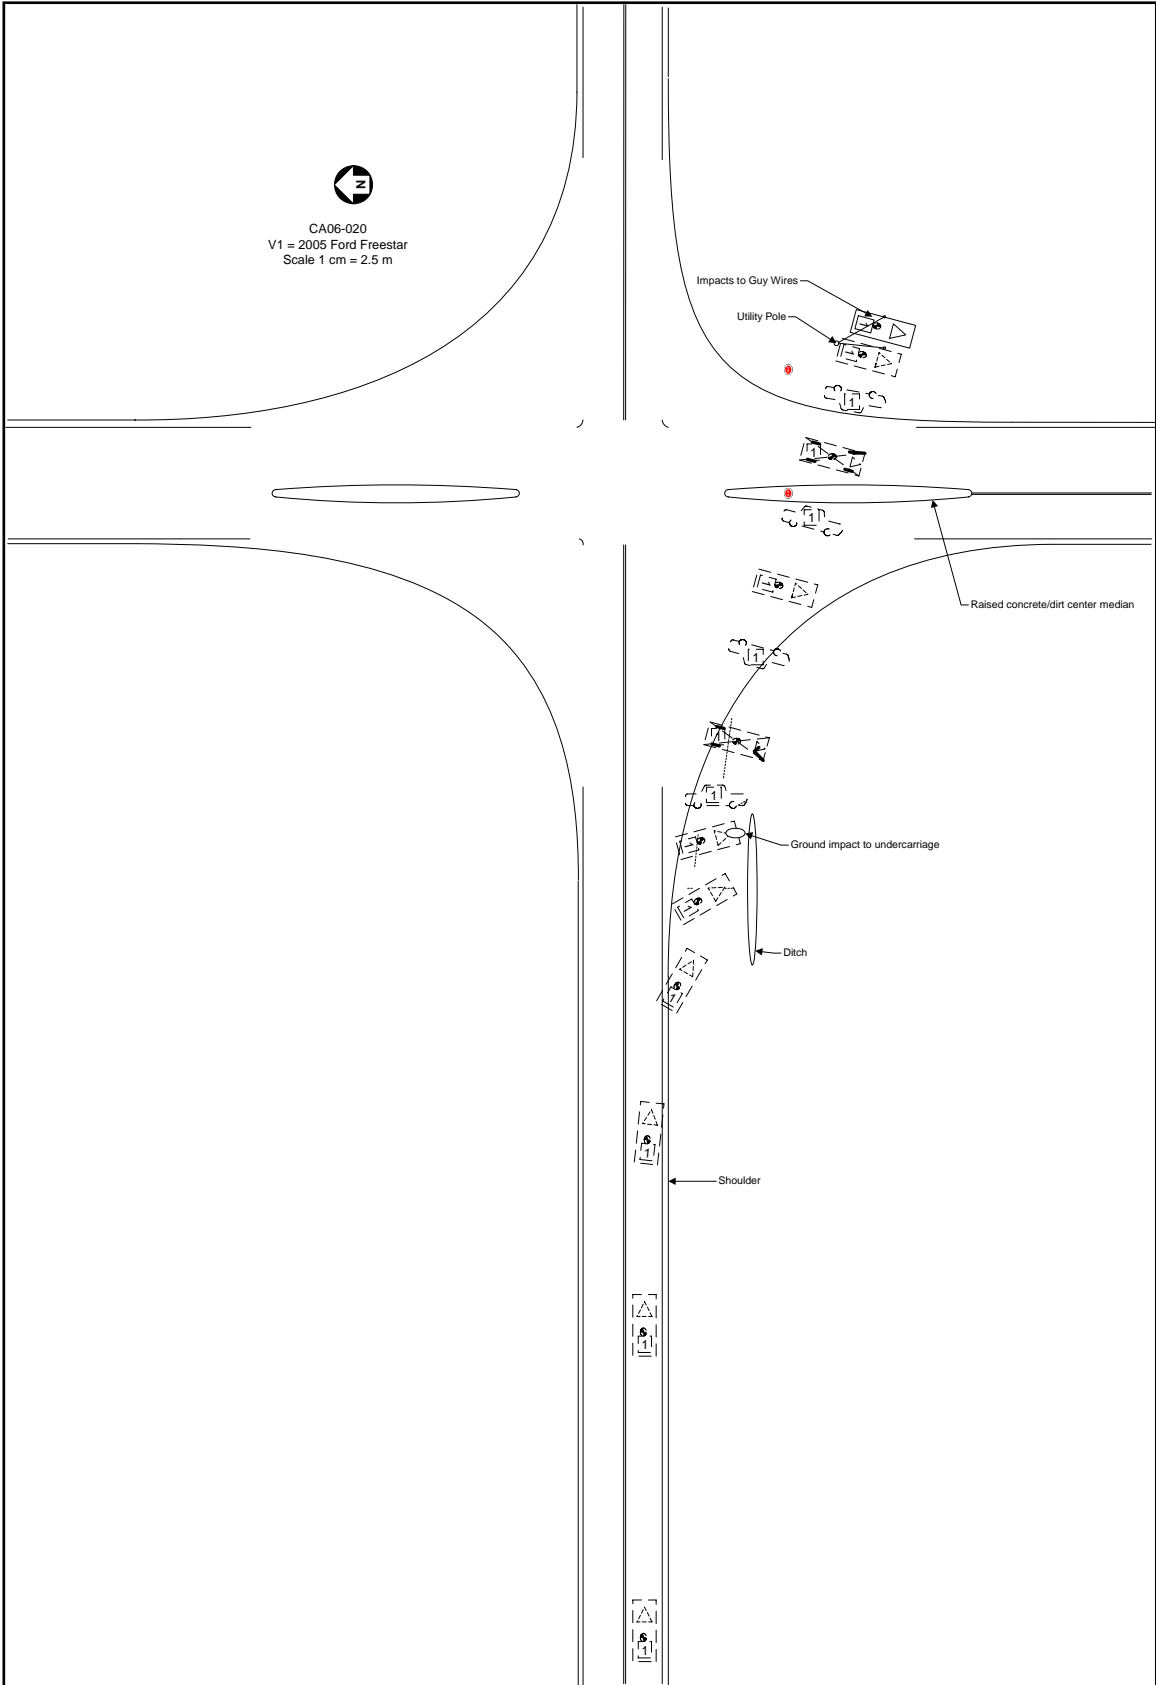
Figure 12: Scene Schematic

The crash occurred on the south road side of an east/west roadway at a four-leg intersection in a rural, undeveloped area during nighttime hours July 2006. The east/west bound travel lanes were 3.7 meters (12.1 feet) and 3.1 (10.2 feet) meters wide, respectively. A long downhill grade was present for eastbound travel. The travel lanes were separated by a double yellow center line and were bordered by white fog lines. A 0.5 meters (1.6 feet) asphalt shoulder extended beyond the fog line. Located adjacent to the shoulder was a shallow grass embankment. The north/south legs of the intersection consisted of two travel lanes that were separated by a double yellow centerline that transitioned to a raised concrete/dirt center median. Traffic for east/west bound traffic was controlled by overhead flashing amber lights with a yellow reflective sign that warned of vehicles entering the intersection from the north/south legs. The north/south legs were controlled by stop signs. The southeast quadrant of the intersection consisted of a grassy area, stop sign, and a utility pole that was supported by two guy wires. The posted speed limit was 89 km/h (55 mph). The scene schematic is included as **Figure 12** of this report.
