Certified Advanced 208-Compliant Air Bag and Hybrid Vehicle Investigation
Vehicle to Objects
Dynamic Science, Inc. / Case Number: DS06023
2006 Lexus RX440h
Washington
September 2006

1. Report No. DS06023		2. Government Accession No.		3. Recipient Catalog No.	
4. Title and Subtitle Certified Advanced 208-Compliant Air Bag and Hybrid Vehicle Investigation				5. Report Date March 28, 2007

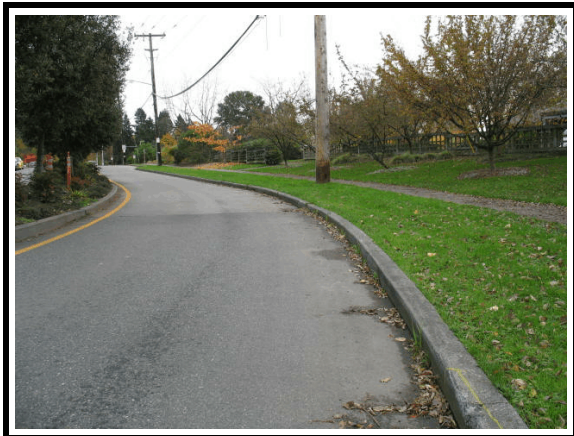
Figure 5. Approximate roadway departure area (southeast)

The driver fell asleep, likely prior to entering the curved section of roadway and failed to negotiate the curve. Just prior to the Lexus' roadway departure, the case vehicle's right tires contacted the curb several times, resulting in damage to both tire rims. The right front tire sidewall was holed (12RFWS1) as a result of the curb contact. The right rear tire sustained gouging/scuffing to the rim (12RBWS1). There were three distinct and separate sections of damaged curb documented during the scene inspection.

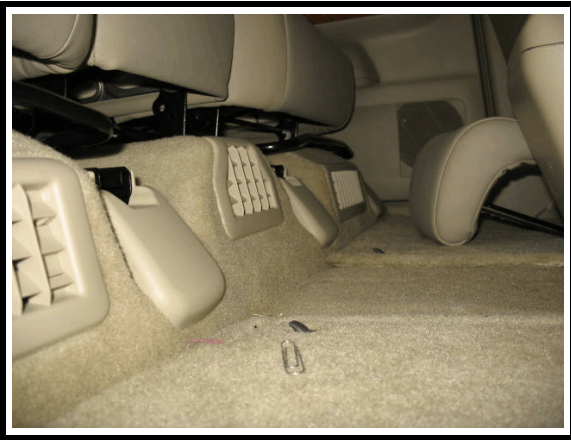
The RX440h's Hybrid Synergy Drive system uses the fourth generation of Toyota's hybrid system. It is a gas-electric system that combines a gas engine with three electric motor-generators that draw on 30 modules of nickel metal-hydride batteries. There are two high-torque electric drive motor-generators, one for driving the front wheels and the other for the rear wheels. The third electric motor starts the engine, recharges the batteries and runs the vehicle's power accessories. The batteries are split into three groups that are largely housed under the second row seats. The stability control feature and electronic brake system function in a way that help recharge the vehicle's batteries. The hybrid system is designed to shut itself down whenever the vehicle sensors detect a rollover situation. The hybrid power train adds 136 kg (300 lb) of weight to the RX440h, but most of that weight is mounted low in the vehicle. The rigidity of the Lexus's chassis was increased in order to manage the additional mass of the hybrid system. Some of the Hybrid Synergy Drive system interior components were visible through a panel located behind the second row seat backs, but the batteries themselves were not visible. Given the location and severity of the vehicle damage, it is highly unlikely that the integrity of the batteries were compromised during the crash.

Figure 8. Location of the nickel metal-hydride batteries (under 2nd row seats)

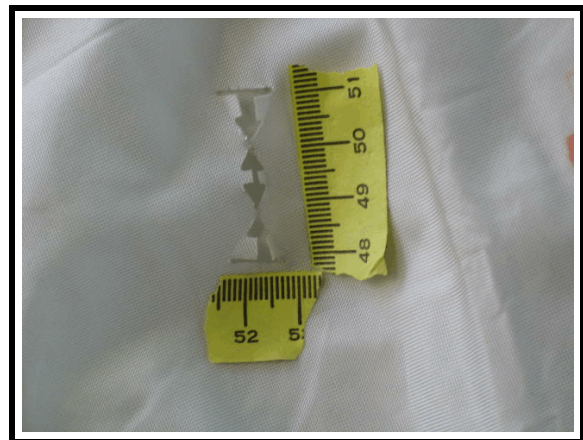
Figure 19. Close-up of one the driver's front air bag vent ports

The deployed air bag was circular in shape and measured 60.0 cm (23.6 in) high/wide in its deflated state. The maximum excursion of the deflated front air bag measured 34.0 cm (13.4 in) from the module face. The longitudinal distance between the module face and the driver's seat back as it was found at the inspection was 68.0 cm (26.8 in). The air bag had two internal tethers and there were two vent ports located on the back of the bag at the 11 and 1 o'clock positions. There was no damage to the air bag or air bag module cover flaps. There were a few cover flap deployment streaks found in the upper right quadrant on the front of the deployed air bag.

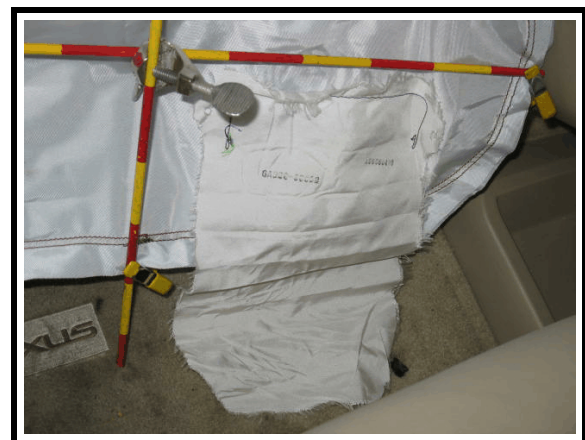
There was no damage to the module cover flaps. There was some dirt on the left half of the front of the deployed knee air bag. There was a faint tan transfer to the upper left quadrant on the front of the bag. The location of the transfer directly matched up with the location of a scuff to the lower left instrument panel and likely occurred during the deployment.

Figure 21. Additional piece of fabric stitched onto the lower right section of the knee air bag

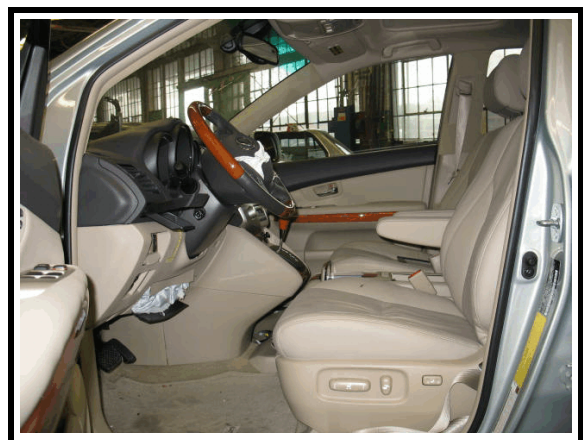
Figure 22. Driver's seating area

The driver's retractor pretensioner actuated during the crash and was locked in place post-impact. The lower left instrument panel was scuffed near the steering column due to contact with the deploying driver knee air bag. There was a tan transfer located on the knee air bag that directly matched up with the location of the instrument panel scuff. During the driver interview, the driver reported that he was wearing khakis at the time of the crash, but given the location of the tan transfer on the knee air bag, it is more likely the transfer was due to contact between the bag and the instrument panel, not the driver's clothing.
