ON-SITE CERTIFIED ADVANCED 208-COMPLIANT VEHICLE INVESTIGATION

CASE NUMBER - IN-06-032

VEHICLE - 2005 HONDA ACCORD

CRASH DATE - August 2006

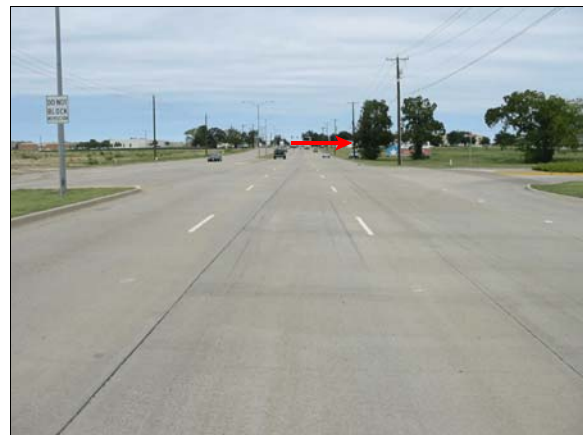
Pre-Crash: The case vehicle was traveling north in the center northbound through lane (**Figure 1**) and the driver was intending to continue northbound. The driver stated to police that a vehicle passed her on the left at a high rate of speed and then abruptly cut across her path. The case vehicle's driver steered right, crossed the outside lane and departed the east side of the roadway. The crash occurred on the east side of the roadway.

Figure 1: Approach of case vehicle northbound in center through lane, arrow shows location of utility pole impact

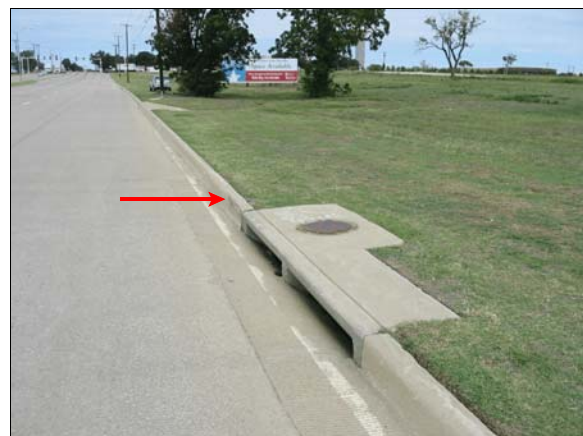
Crash: The case vehicle impacted and ran over the east curb (**Figure 2**) damaging the right front wheel (event 1), left front wheel (event 2) and the left rear wheel (event 3). The case vehicle then

Figure 2: Approach of case vehicle to curb impacts, arrow shows location of right front wheel curb impact

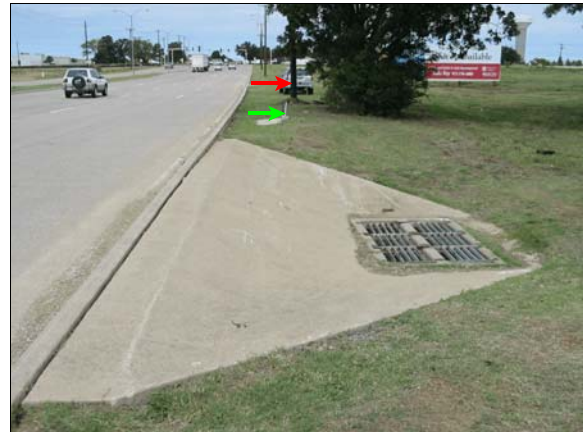
traveled through the grass and landed in a concrete drainage basin (**Figure 3**). The center left portion of the front bumper impacted a telephone utility box (event 4) north of the drainage basin. The front right of the case vehicle (**Figure 4**) then impacted a utility pole [**Figure 5** (event 5)] breaking it off at the base. The utility pole impact caused both stages of the case vehicle driver's front air bag to deploy. In addition, the driver's side curtain air bag and seat back-mounted side impact air bag deployed.

Figure 3: Approach of case vehicle across drainage basin to telephone utility box impact (green arrow) and utility pole impact (red arrow)

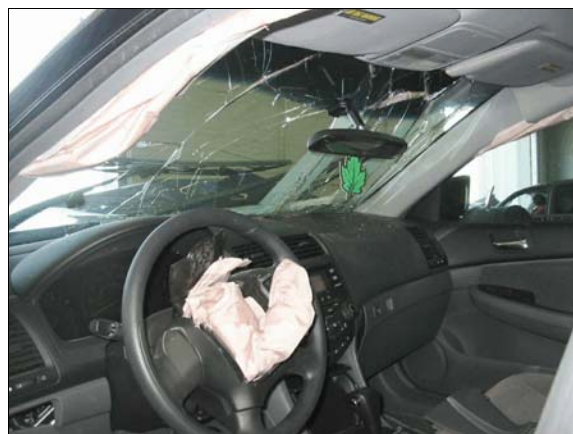
Vehicle Interior: Inspection of the case vehicle’s interior (Figures 7 and 8) revealed occupant contact evidence on the driver’s knee bolster and a lip stick print on the upper left quadrant of the driver’s air bag. No other occupant contacts were noted. There was no evidence of occupant compartment intrusions and no deformation of the steering wheel or compression of the energy absorbing steering column (Figure 9 below).

Figure 7: View through driver’s door of case vehicle’s steering wheel, windshield and instrument panel

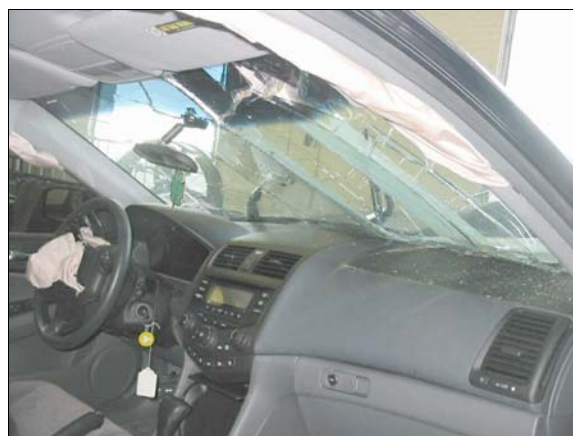
Figure 8: View through right front door of case vehicle’s instrument panel, windshield and steering wheel

The case vehicle's front right passenger air bag was located in the top of the instrument panel (**Figure 8** above). The front right passenger air bag did not deploy in this crash because no passenger was seated in the front right seat.

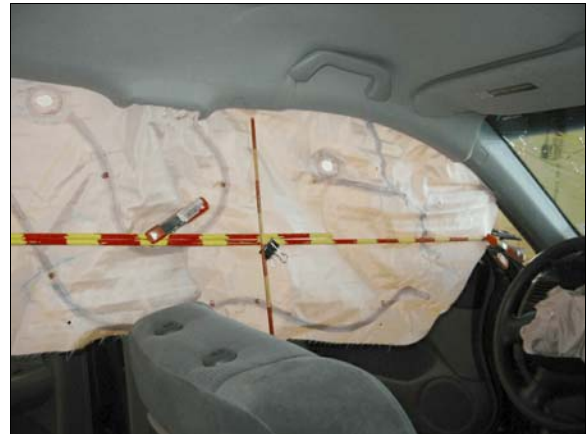
The case vehicle's left side curtain air bag was located along the left roof side rail (**Figures 12 and 13**) and folded accordion style inside the headliner. The air bag was designed to provide head protection for the driver and back left passenger seat positions. The air bag was anchored to the upper right A-pillar by an approximate 10 centimeters (4 inches) long cloth cord. The side curtain air bag was approximately 165 centimeters (65 inches) in length and approximately 38 centimeters (15 inches) in height. It was designed without tethers and had a large inflation chamber adjacent to the driver's seat position and a smaller inflation chamber adjacent to the back left seat position. The inside and outside sections of the air bag material were stitched together in single stitch seams and double stitched circular areas to form the air bag inflation chambers. There was an area at the front and back of the air bag that was not stitched and appeared to be a vent for the inflation gas. There was no evidence of damage due to deployment to the air bag, and no evidence of occupant contact was found on the air bag.

Figure 12: Overview of front portion of left side curtain air bag

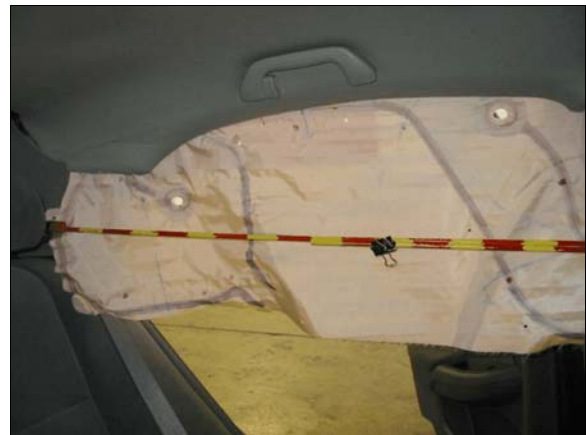
Figure 13: Overview of back portion of left side curtain air bag

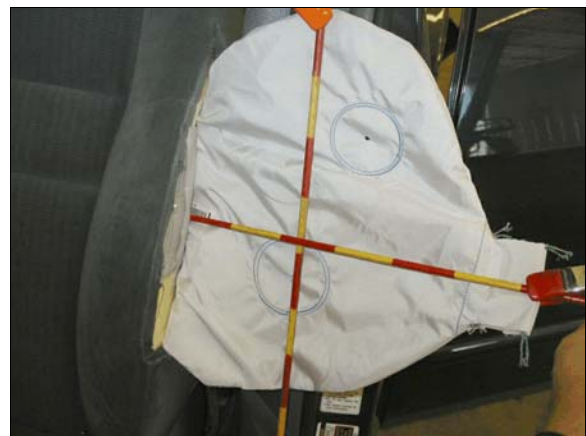
Figure 14: Inside surface of case vehicle driver's seat back-mounted side impact air bag

The driver's seat back-mounted side impact air bag was located in the outboard side of the driver's seat back (**Figure 14** above). The deployed air bag was approximately oval in shape and had a fabric tab on its leading edge that was separated from the body of the air bag by a stitch seam. The dimensions of the air bag were approximately 37 centimeters (14.6 inches) in width and 26 centimeters (10.2 inches) in height. The fabric tab was approximately 6 centimeters (2.4 inches) in length. The air bag was designed with two circular stitch patterns each approximately 6 centimeters (2.4 inches) in diameter that stitched the inner and outer surfaces of the air bag together and shaped the air bag inflation chambers during deployment. The air bag was designed without tethers and vent ports. There was no module flap on the side of the seat back. The air bag deployed through a tear-seam in the side of the seat back. There was no evidence of damage to the air bag due to deployment, and no evidence of occupant contact was found on the air bag.
