ON-SITE AIR BAG NON-DEPLOYMENT INVESTIGATION

CASE NUMBER - IN-06-033
LOCATION - WISCONSIN
VEHICLE - 2005 CHEVROLET COBALT
CRASH DATE - October 2006

Revised: March 31, 2008

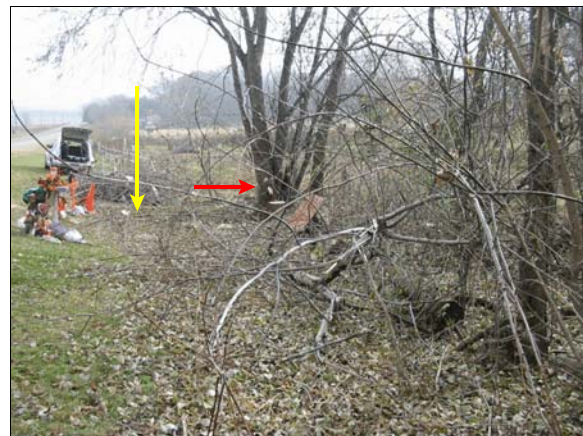
Post-Crash: As a result of the tree impact, the case vehicle rotated clockwise approximately 90 degrees and came to rest heading southwest (Figure 6). At final rest the case vehicle was approximately 3 meters (10 feet) north of the impacted clump of trees.

Figure 6: Red arrow shows impacted clump of trees, yellow arrow shows area of case vehicle's final rest

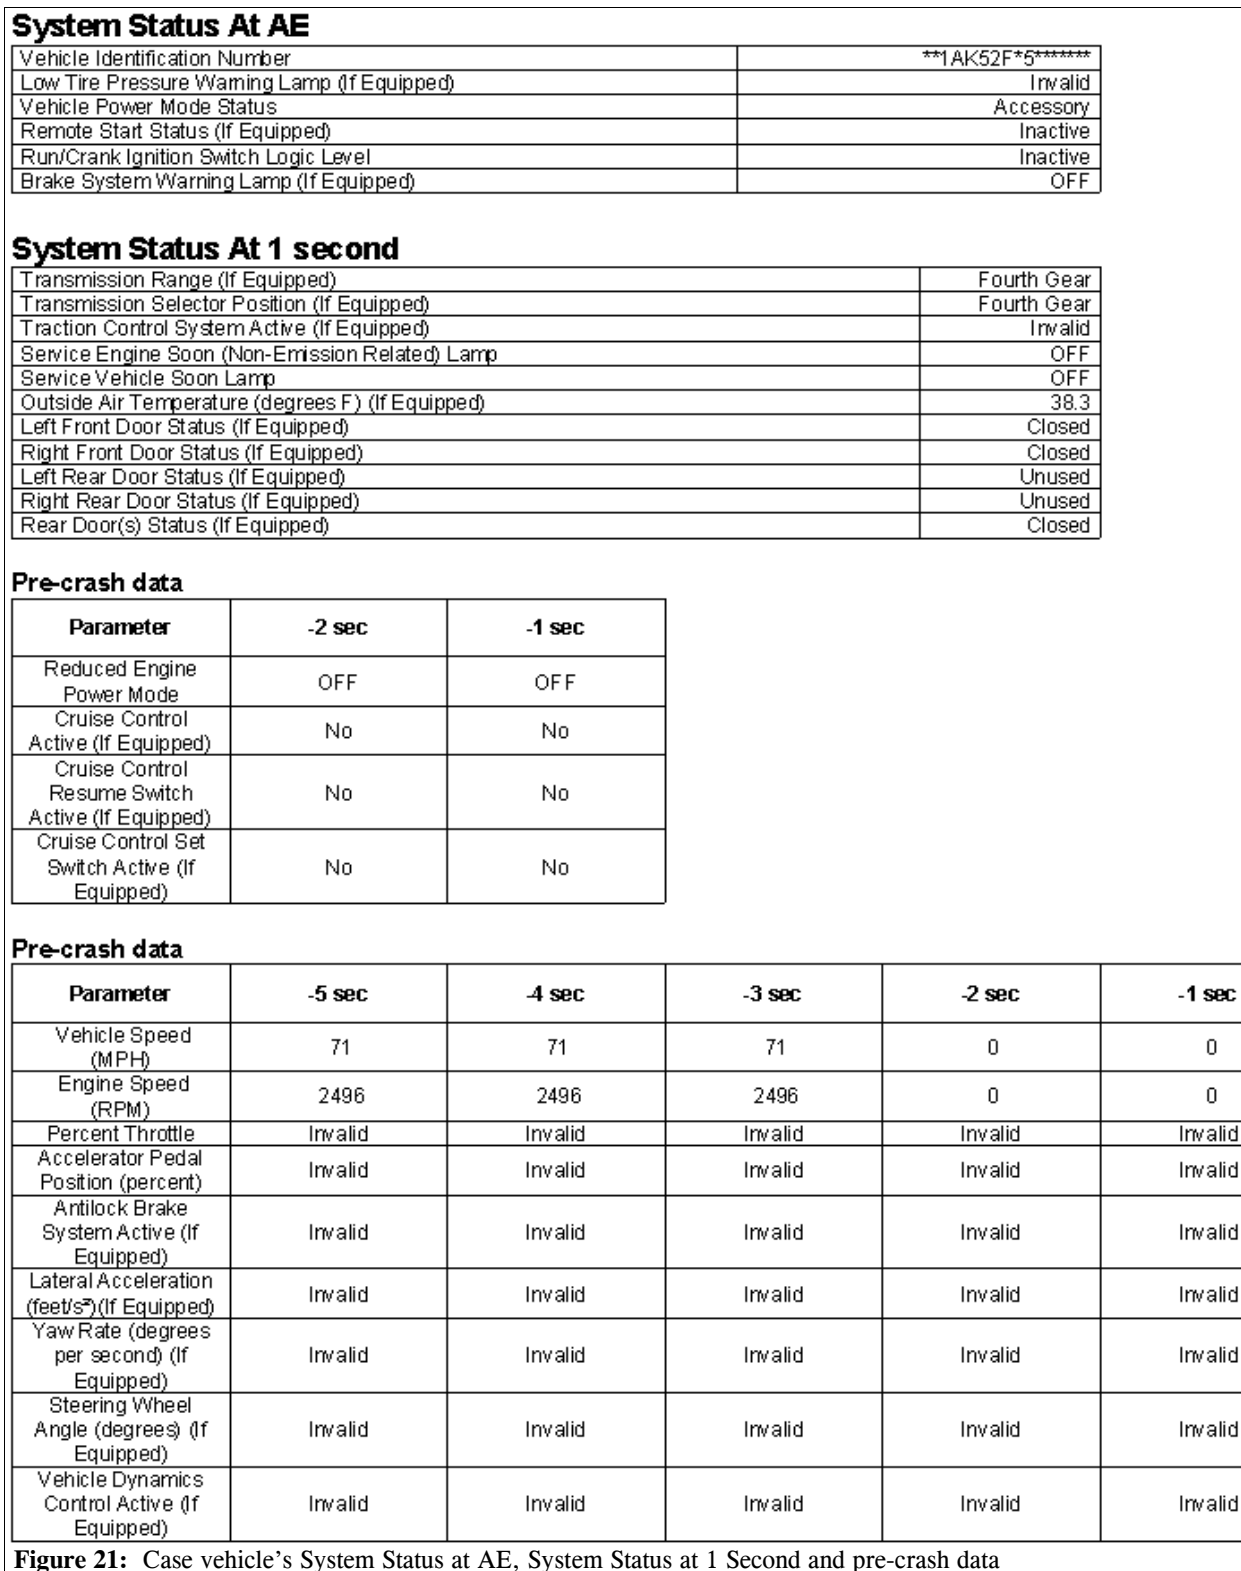
The EDR data also indicated that the vehicle power mode status was recorded as “accessory”. This indicates that the ignition switch was not in the “on” position at the time of the tree clump impact. This was supported by information from one of the investigating sheriff’s deputies, who reported to this contractor that the ignition switch was found jammed in the “accessory” position following the crash. This may explain why zeros were recorded for vehicle speed and engine speed in the final two seconds of the pre-crash data. It is possible the ignition switch could have been knocked to the “accessory” position by the driver’s leg or knee at the time of the vault. This investigation revealed that inadvertent contact with the ignition switch or a key chain in the 2005 Chevrolet Cobalt can in fact result in engine shut-down and loss of power. A GM service bulletin applicable to the 2005-2007 Chevrolet Cobalt entitled “Information on Inadvertent Turning of the Key Cylinder, Loss of Electrical System and No DTCs# 05-02-35-007A (10/25/2006)” describes this potential problem [see attached GM bulletin at the end of this report (**Figure 25**)]. The bulletin indicates that there is a potential for the driver to inadvertently turn off the ignition due to low ignition key cylinder torque/effort. The bulletin indicated this was more likely to occur if the driver is short and has a large and/or heavy key chain attached to the ignition key. The bulletin indicated the condition was documented to occur when a driver’s knee contacted a key chain while the vehicle was turning and the steering column was adjusted all the way down. A search of the NHTSA, Office of Defects Investigation (ODI) web site, complaint tab, revealed at least six complaints (ODI identification numbers: 10144299, 10145959, 10129121, 10132335, 10151346, and 10197022) relating to the engine shutting off and loss of power in Chevrolet Cobalts when the ignition switch or key chain was contacted by the driver. Some of the complaints reported a simple “brushing” of the key chain or touching of the ignition switch was all that was required for the engine to shut off. It is not known what role, if any, this may have played in the non-deployment of the air bags. Such a determination would most likely require an analysis of the air bag system and ignition wiring schematic in order to determine if in fact the air bag is capable of deploying when the ignition is switched from the “on” position to the “accessory” position. Such an undertaking was beyond the scope of this investigation.

Figure 21: Case vehicle’s System Status at AE, System Status at 1 Second and pre-crash data

System Status At Non-Deployment	
Ignition Cycles At Investigation	2784
SIR Warning Lamp Status	OFF
SIR Warning Lamp ON/OFF Time (seconds)	655200
Number of Ignition Cycles SIR Warning Lamp was ON/OFF Continuously	2783
Ignition Cycles At Event	2784
Ignition Cycles Since DTCs Were Last Cleared	254
Driver's Belt Switch Circuit Status	UNBUCKLED
Diagnostic Trouble Codes at Event, fault number: 1	N/A
Diagnostic Trouble Codes at Event, fault number: 2	N/A
Diagnostic Trouble Codes at Event, fault number: 3	N/A
Diagnostic Trouble Codes at Event, fault number: 4	N/A
Diagnostic Trouble Codes at Event, fault number: 5	N/A
Diagnostic Trouble Codes at Event, fault number: 6	N/A
Maximum SDM Recorded Velocity Change (MPH)	59.84
Algorithm Enable to Maximum SDM Recorded Velocity Change (msec)	170
Driver First Stage Deployment Loop Commanded	No
Driver Second Stage Deployment Loop Commanded	No
Driver Side Deployment Loop Commanded	No
