ON-SITE CHILD SAFETY SEAT INVESTIGATION

CASE NUMBER - IN-06-035

VEHICLE - 2000 PONTIAC MONTANA

CRASH DATE - November 2006

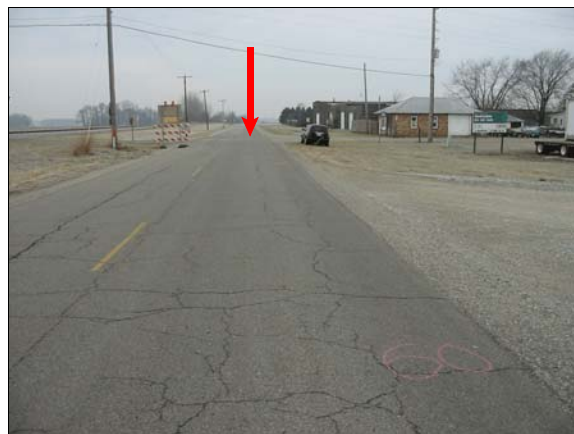
Figure 1: Approach of case vehicle westbound to area of impact (arrow), number on roadway shows meters to impact area

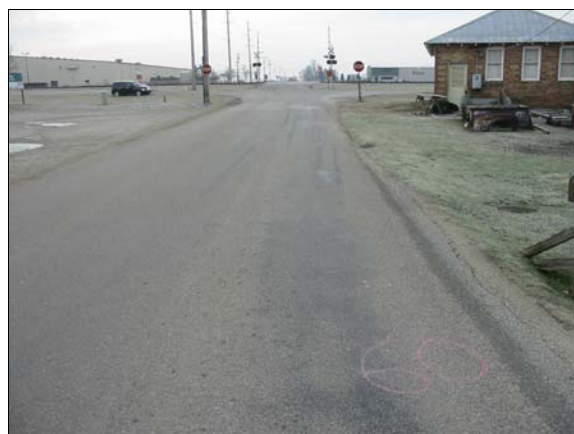
Figure 2: Approach of Freightliner southbound to intersection, number on roadway shows meters to impact area

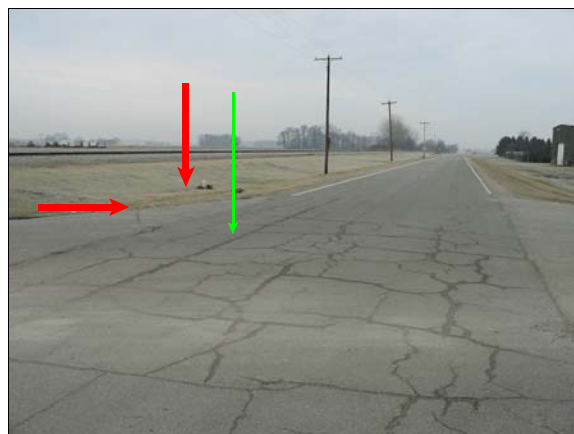
Figure 3: Overview of impact area (green arrow) from case vehicle's approach, and case vehicle's post-impact travel to rollover and final rest (red arrows)

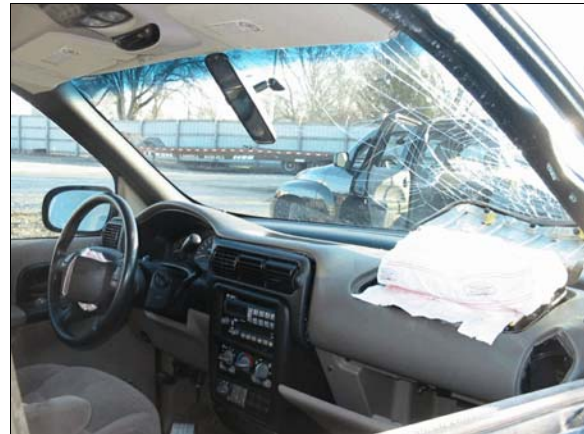
Vehicle Interior: Inspection of the case vehicle’s interior (**Figures 8, 9, and 10** below) revealed evidence of occupant contact to the right front door. The arm rest was dented and the plastic below the arm rest was broken. Load marks were observed on the driver’s shoulder belt. The safety belt in the second row right seat had been cut by rescue. There were numerous intrusions to the case vehicle’s right side. The most severe intrusions were 27 centimeters (10.6 inches) of

Figure 8: Overview of case vehicle’s instrument panel, windshield and steering wheel

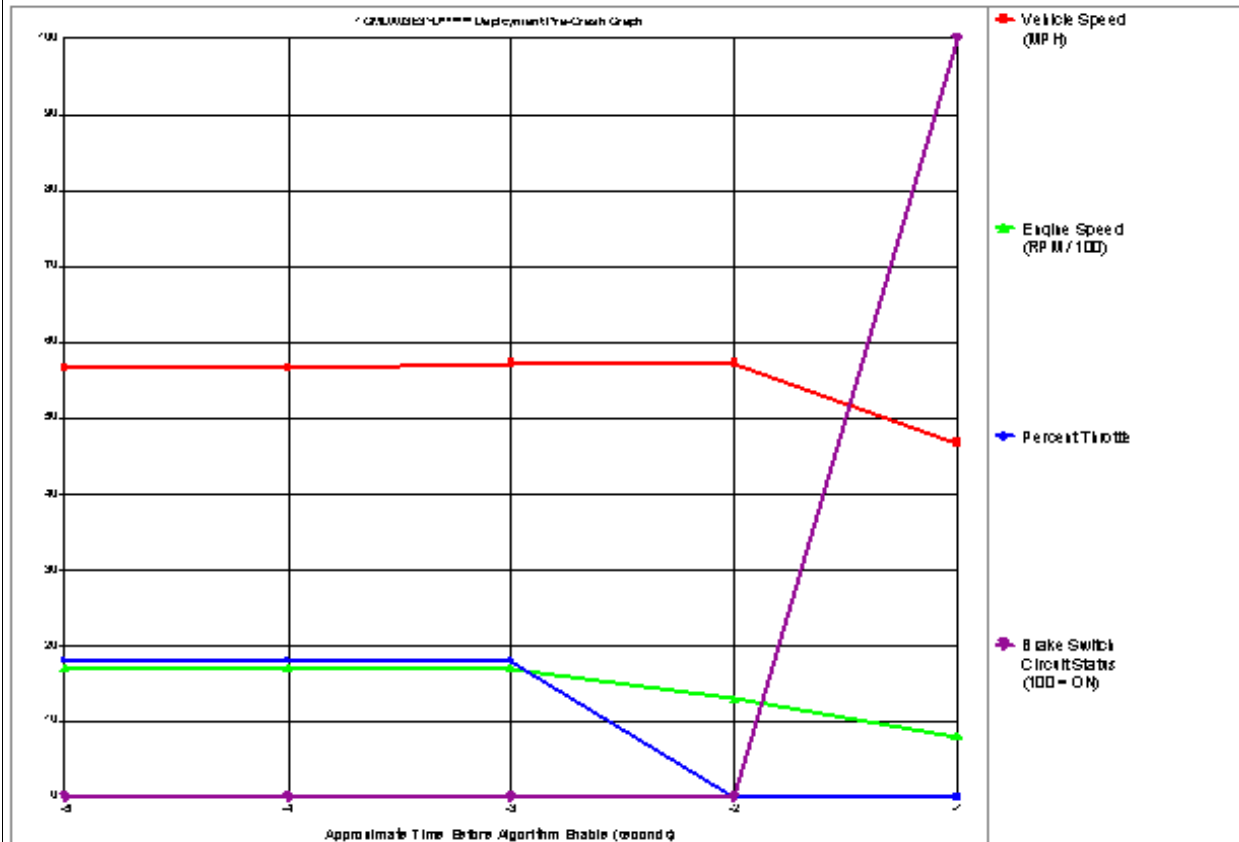
Seconds Before AE	Vehicle Speed (MPH)	Engine Speed (RPM)	Percent Throttle	Brake Switch Circuit Status
-5	57	1664	18	OFF
-4	57	1728	18	OFF
-3	57	1728	18	OFF
-2	57	1344	0	OFF
-1	47	832	0	ON

Figure 18: Case vehicle's System Status at Deployment report

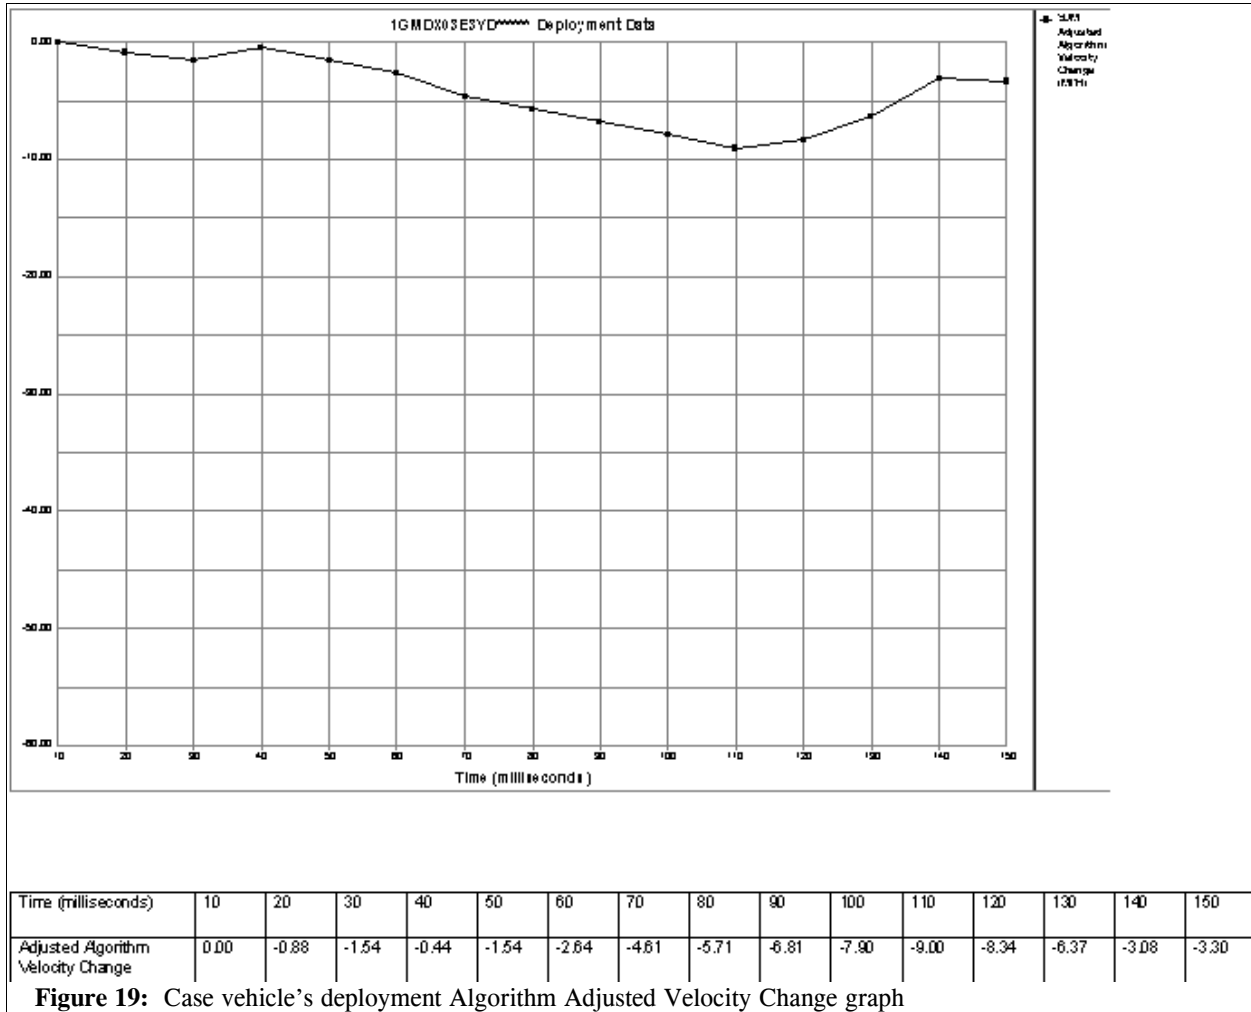
Figure 19: Case vehicle’s deployment Algorithm Adjusted Velocity Change graph
