**CALSPAN REMOTE REAR OCCUPANT PROTECTION PROGRAM CRASH
INVESTIGATION**

NASS/SCI COMBO CASE NO.: 2007-08-118B

VEHICLE: 2003 SUBARU LEGACY

CRASH DATE: JULY 2007

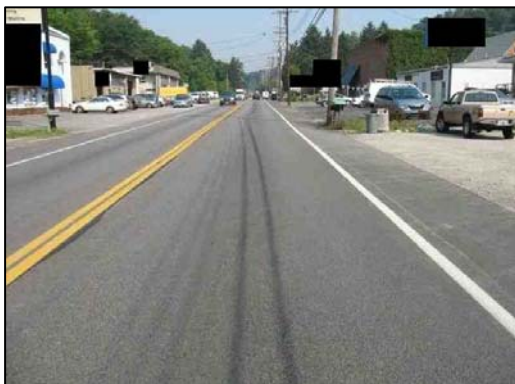
The 76-year old female driver of the Subaru was traveling northbound on the two-lane roadway while the 79-year old male driver of the Chrysler was traveling southbound on the same roadway (**Figures 2 and 3**). Both vehicles were traveling within the business district of a small rural town and intended to continue straight. The Subaru crossed the roadway’s centerline and entered the southbound lane. There was no evidence of pre-crash braking by the Subaru. During the NASS interview, the 79-year-old driver of the Chrysler reported that he had no time to initiate any avoidance actions prior to the crash.

Figure 2 - Northbound approach of the Subaru Legacy.

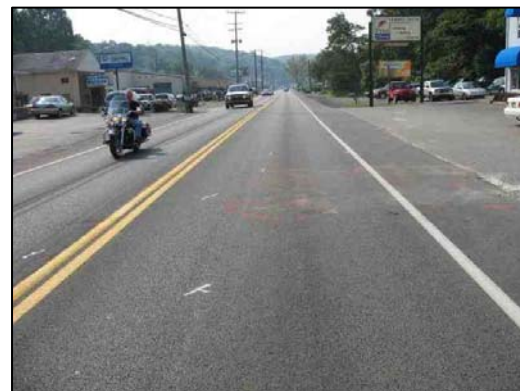
Figure 3 - Southbound approach of the Chrysler Voyager.

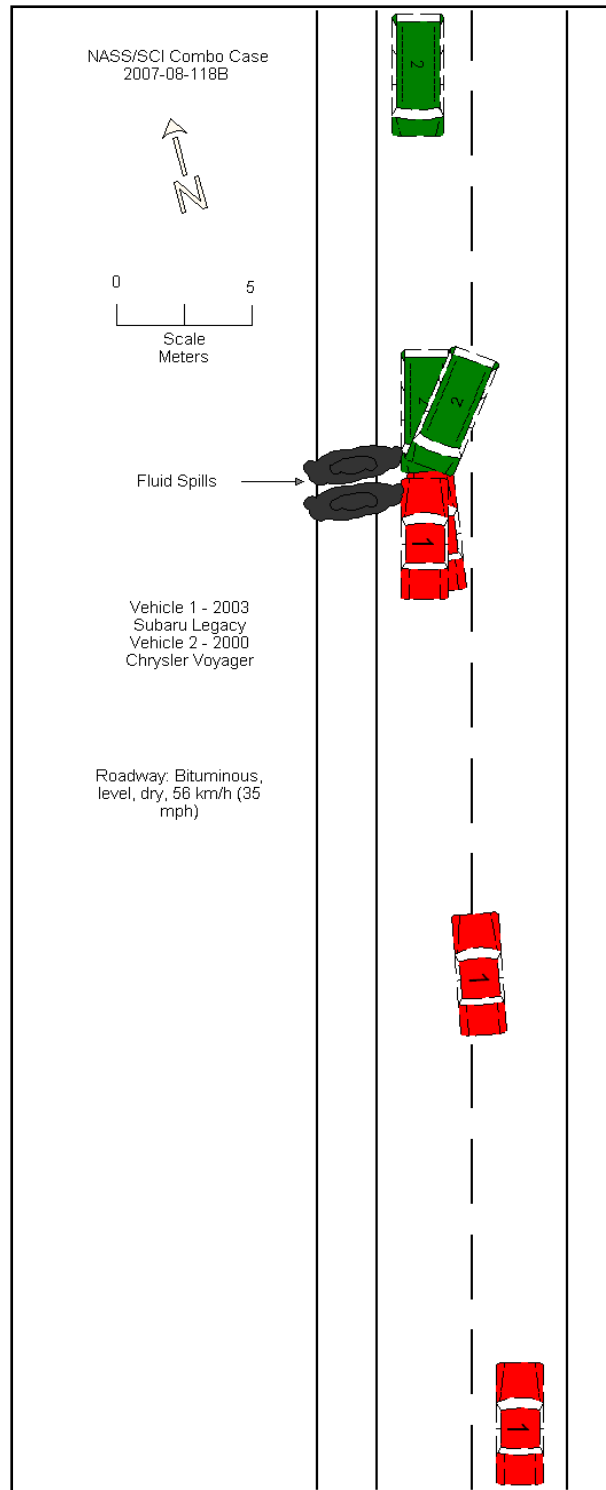
Figure 9 - Crash Schematic

The crash occurred on a two-lane north/south roadway in the state of Pennsylvania in July 2007. At the time of the crash, the asphalt roadway was dry and there were no adverse weather conditions. The roadway was straight and level and was configured with one lane in each direction that was separated by a painted double-yellow centerline. The lanes were 3.5 m (11.5 ft) in width and were bordered by painted white fog lines and asphalt shoulders. The crash occurred within the business district of a small rural town. The posted speed limit for the roadway was 56 km/h (35 mph). The Crash Schematic is included as **Figure 9** at the end of the narrative.
