Remote Combination ODI Side Curtain Non Deployment Investigation  
Dynamic Science, Inc. (DSI), Case Number 2007-75-041J  
2005 Volkswagen Touareg  
Colorado  
April 2007

1. Report No. 2007-75-041J	2. Government Accession No.		3. Recipient Catalog No.	
4. Title and Subtitle  Remote Combination ODI Side Curtain Non Deployment Investigation			5. Report Date September 11, 2008

**Dynamic Science, Inc.**  
**Crash Investigation**  
**Case Number: 2007-75-041J**

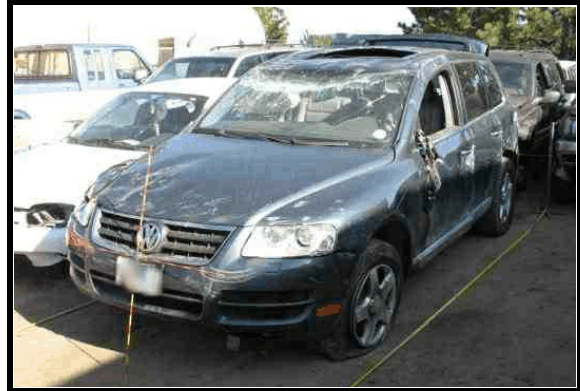
This single-vehicle rollover crash occurred in April 2007 at 0650 hours. The subject vehicle was a 2005 Volkswagen Touareg 4-door sport utility vehicle that was being driven by an unrestrained 37-year-old male (**Figure 1**). The vehicle was equipped with electronic stability control, 4-wheel ABS, a driver's frontal air bag, a right passenger frontal air bag, seat mounted side air bags, and left/right side curtain air bags. The Touareg was traveling eastbound on a curved, two-lane roadway. To the left of the roadway, there was a steep descending embankment. The driver lost control of his vehicle and it departed the roadway on the left side. The vehicle slid down the embankment for 19.6 m (64.4 ft) before striking a low-lying boulder with its left side. The vehicle then began a left side leading rollover and rolled four quarter turns for 24.9 m (82.0 ft). The driver was ejected at some point during this initial roll. The vehicle rolled two more quarter turns for 3.6 m (28.4 ft) before coming to rest on its roof facing east. During the rollover, the right side curtain air bag deployed. There were no other air bag/side curtain deployments. The driver sustained a skull fracture, multiple brain injuries, a rib fracture, and multiple contusions, abrasions, and lacerations. The Touareg was towed from the scene due to damage.

**Figure 1.** Subject vehicle, 2005 Volkswagen Touareg

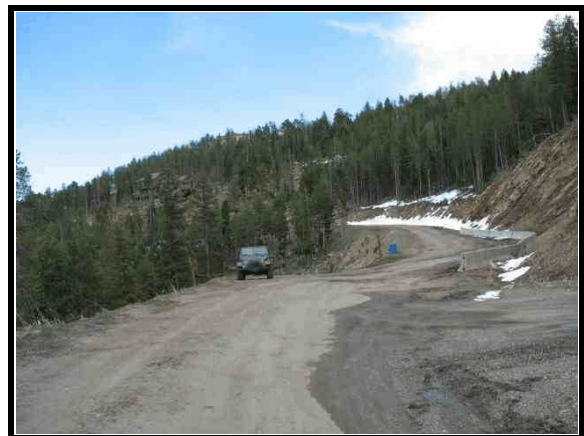
This single vehicle crash occurred on a two-lane, curved mountain road (**Figure 2**). The gravel/dirt road curved to the right and had an uphill grade. It was dark at the time of the crash. There were no streetlights present. The posted speed limit was 16 km/h (10 mph). To the left of the roadway (north) there was a steep embankment. The scene schematic is included as Attachment 1 at the end of this narrative report.

**Figure 2.** Eastbound approach to area of roadway departure

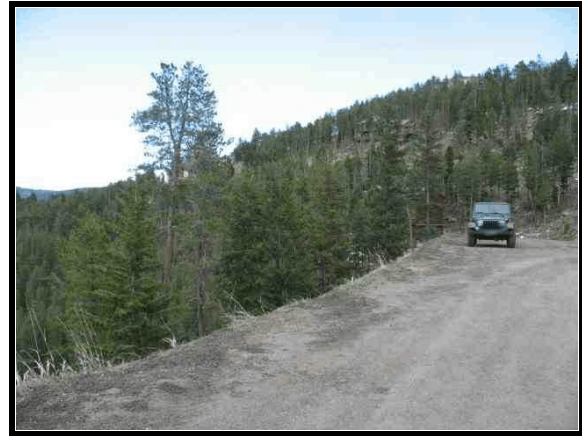
The 2005 Volkswagen Touareg was traveling eastbound up the mountain road. The 37-year-old unrestrained male driver entered the right hand curve and lost control of the vehicle. The vehicle crossed through the westbound lane and departed the roadway on the left (**Figure 3**).

**Figure 3.** Area of roadway departure (east)

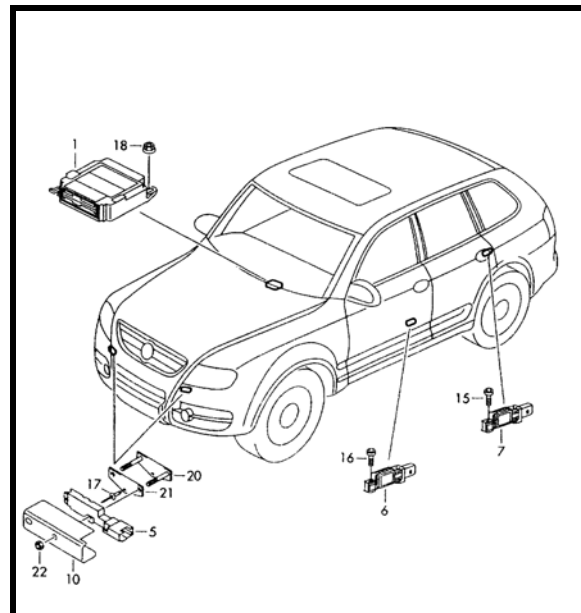
The side curtain air bags were designed to deploy during side impacts. There were four remote sensors, with two of the sensors located in the lower portion of the front doors and two of the sensors located at the belt line level of the rear doors. In **Figure 8**, items 6 and 7 are sensors for lateral impact acceleration.

**Figure 8.** Remote sensor locations
