ODI Tire Failure Investigation / Rollover
Dynamic Science, Inc. / Case Number: 2007-78-092B
1998 Plymouth Neon
Arizona
July 2007

| 4. Title and Subtitle ODI Tire Failure Investigation | | 5. Report Date February 14, 2008 | |

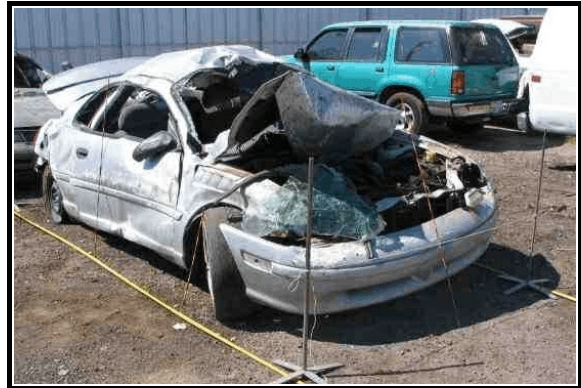
This single vehicle rollover crash occurred in July 2007 at 1140 hours. The crash occurred on a four-lane divided interstate highway. The case vehicle was a 1998 Plymouth Neon two-door sedan that was being driven by an 18-year-old female (**Figure 1**). The front right seat was occupied by an 18-year-old male. Both occupants were unrestrained. The Plymouth Neon was traveling westbound in the second lane from the right. The right rear tire tread separated. The driver stated that she had one hand on the steering wheel when the tread separated. The Plymouth Neon pulled to the right and pulled the steering wheel out of her hand. The Plymouth Neon began a clockwise rotation. The vehicle crossed the adjacent westbound lane before departing the roadway on the north side. The vehicle continued rotating as it traveled across the grass/dirt area between the roadway and the on-ramp. Just prior to entering the on-ramp, the Neon began a left side leading rollover. As the Neon entered the on-ramp, the vehicle struck a delineator post. The Plymouth Neon came to rest north of the on-ramp on its roof facing northeast. During the rollover sequence both occupants were ejected from the vehicle.

Figure 1. 1998 Plymouth Neon

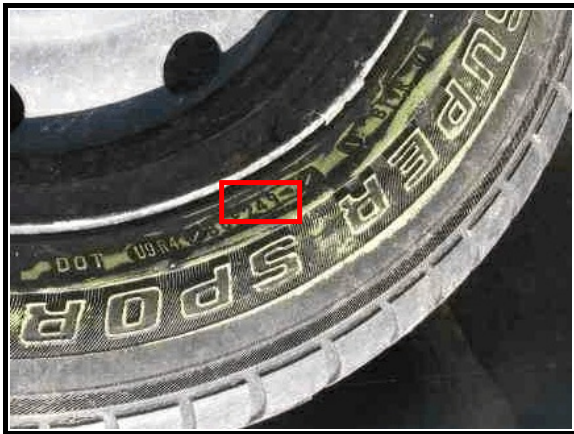
The Plymouth Neon was initially configured with Nexen N3000 205/40R17 tires on 17 inch custom rims. The tire manufacture's maximum pressure was 345 kPa (50 psi). The right rear tire was losing air during the trip. That tire was replaced by a Futura Super Sport P195/60R14 tire on a 14 inch steel rim. The tire manufacture's maximum pressure was 303 kPa (44 psi). The tire had been replaced in Texas. The driver reported that this was one of the tires originally on the vehicle. The Tire Identification Number (TIN) was U9R4 86F249. The build date as printed on the tire (249) was the 24th week of 1999, or June 1999 (**Figure 5**). The tread on the right rear tire separated prior to the rollover (**Figure 6**). The left rear tire/wheel appear to have separated from the vehicle during the rollover event. The specific tire information is as follows:

Figure 5. Tire build date
