**CALSPAN ON-SITE CHILD AIR BAG RELATED FATALITY
INVESTIGATION**

SCI CASE NO.: CA07-005

VEHICLE: 1998 PONTIAC TRANS SPORT MONTANA

CRASH DATE: SEPTEMBER 2006

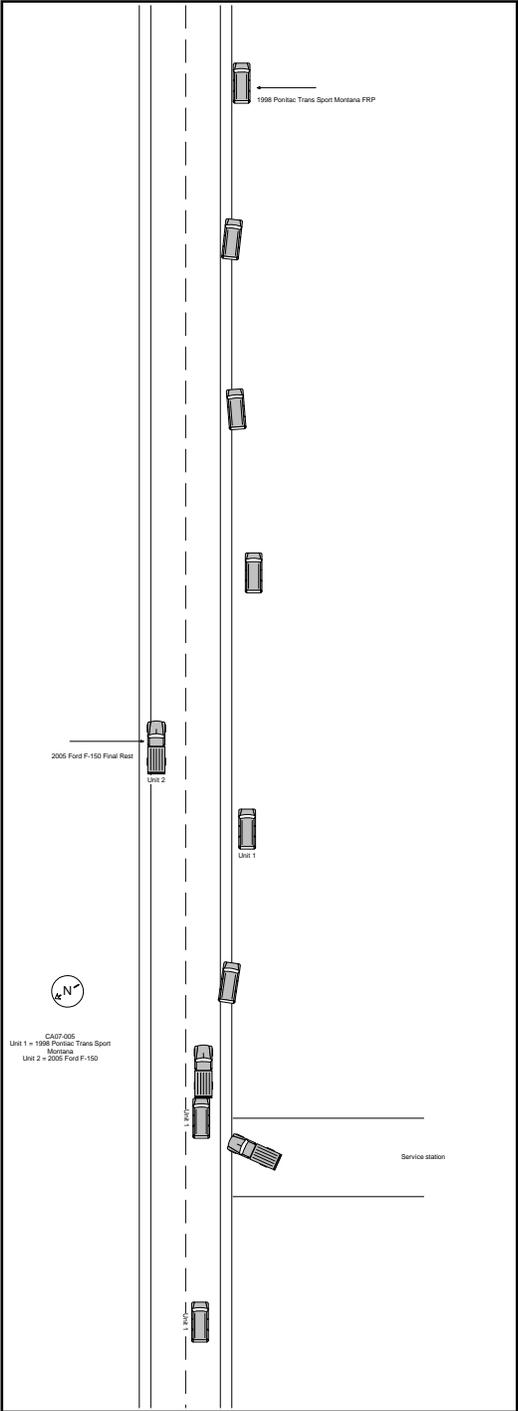
Figure 13: Scene Schematic

The crash occurred on a two-lane, two-way east/west rural roadway. At the time of the crash, the weather conditions were clear and dry. The lighting conditions were dark as the roadway was not equipped with overhead luminaries. The travel lanes were surfaced with asphalt and were separated by a broken yellow lane line and bordered by white fog lines. Asphalt shoulders extended beyond the fog lines. A service station was located on the south roadside in the area of the crash. The posted speed limit for this roadway was 72 km/h (45 mph). A schematic of the crash was reconstructed from the provided police data and is included in this report as **Figure 13**.
