ON-SITE NOT-IN-TRAFFIC SURVEILLANCE BACK OVER INVESTIGATION

CASE NUMBER - IN-07-011

LOCATION - WISCONSIN

VEHICLE - 2002 KIA SEDONA

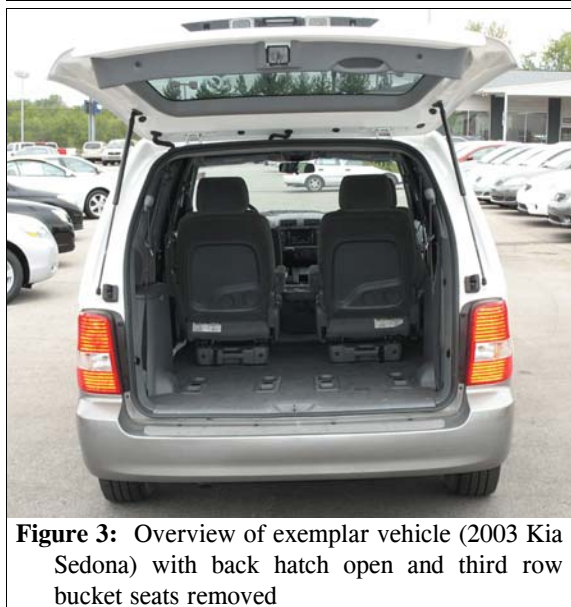
Crash: The Kia Sedona's driver stated that he only pulled partially into the parking space, stopped, immediately shifted the transmission to reverse, checked his rear view and side view mirrors, turned his head to the right looking over his right shoulder out of the open back hatch (**Figure 3** and **Figure 4** below), and began to back up. He estimated that the range of time between pulling into the parking space to backing up was 10 seconds or less. Meanwhile, unknown to the driver, the pedestrian had jumped out of the back of the Kia. Immediately as the driver began backing up, the back bumper struck the pedestrian. The pedestrian fell to the ground in the path of the right rear wheel, reportedly ending up on his back. Another adult, that was in the parking lot at the time, yelled at the driver to stop. Simultaneously, the driver felt the Kia make contact with something, and he stopped the Kia and pulled forward. The driver got out of the vehicle and discovered that the Kia's right rear tire (**Figures 5** and **6** below) had struck the pedestrian and rolled partially onto his chest. It was reported that the pedestrian was also momentarily unconscious. Based on the available information, it was estimated that the Kia had traveled backward from its stopped position to impact approximately 0.2 meter (0.7 foot), and had traveled from impact to final rest approximately 1.0 meter (3.3 feet). Based on the short distance traveled to impact, the Kia's impact speed was estimated to be 2 km.p.h (1.2 m.p.h.).

Figure 3: Overview of exemplar vehicle (2003 Kia Sedona) with back hatch open and third row bucket seats removed

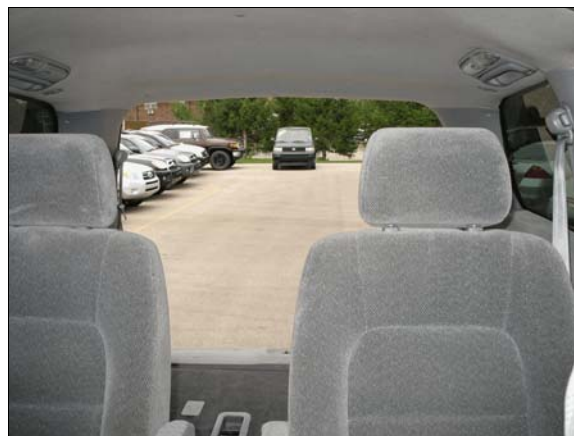
Figure 4: View from driver's seat of exemplar Kia out of open back hatch

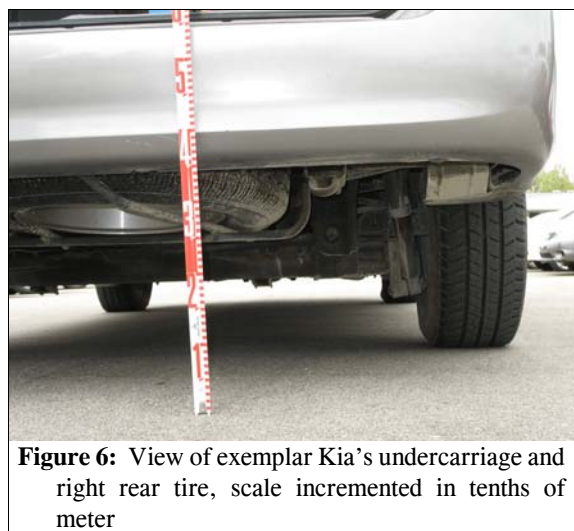
There was no evidence of pedestrian contact to the Kia Sedona's back bumper. There was also no evidence of contact to any of the Kia's rear undercarriage components. Based on the available information indicating the pedestrian was struck by the back bumper, a Collision Deformation Classification was estimated to be: **06-BRLU-1 (180 degrees)**. The Kia was driven from the scene.

Figure 6: View of exemplar Kia's undercarriage and right rear tire, scale incremented in tenths of meter
