Rollover Investigation / Vehicle v. Object
Dynamic Science, Inc. / Case Number: DS07015
2006 Honda Civic
California
February 2007

| 4. Title and Subtitle Rollover Investigation | | 5. Report Date November 8, 2007 | |
| 16. Abstract This on site investigation focused on a 2006 Honda Civic that was involved in a rollover crash. This single vehicle crash occurred in February 2007 at 0050 hours. The crash occurred on a five-lane divided state highway. The speed limit at this location is 105 km/h (65 mph). The case vehicle is a 2006 Honda Civic that was being driven by a restrained 24-year-old male. The Honda Civic was traveling westbound at a police reported speed of 129 km/h (80 mph) in the fourth lane from the right. According to the driver of the Honda Civic, the crash was caused by a non-contact vehicle braking in front of the Civic. The investigating police agency did not find any evidence of any other involved parties. The driver of the Civic lost control of his vehicle. The Civic veered across the adjacent lanes to the right. The Civic departed the roadway and struck a dirt/shrub covered embankment. The driver's frontal air bag deployed at this point. The Civic was redirected b

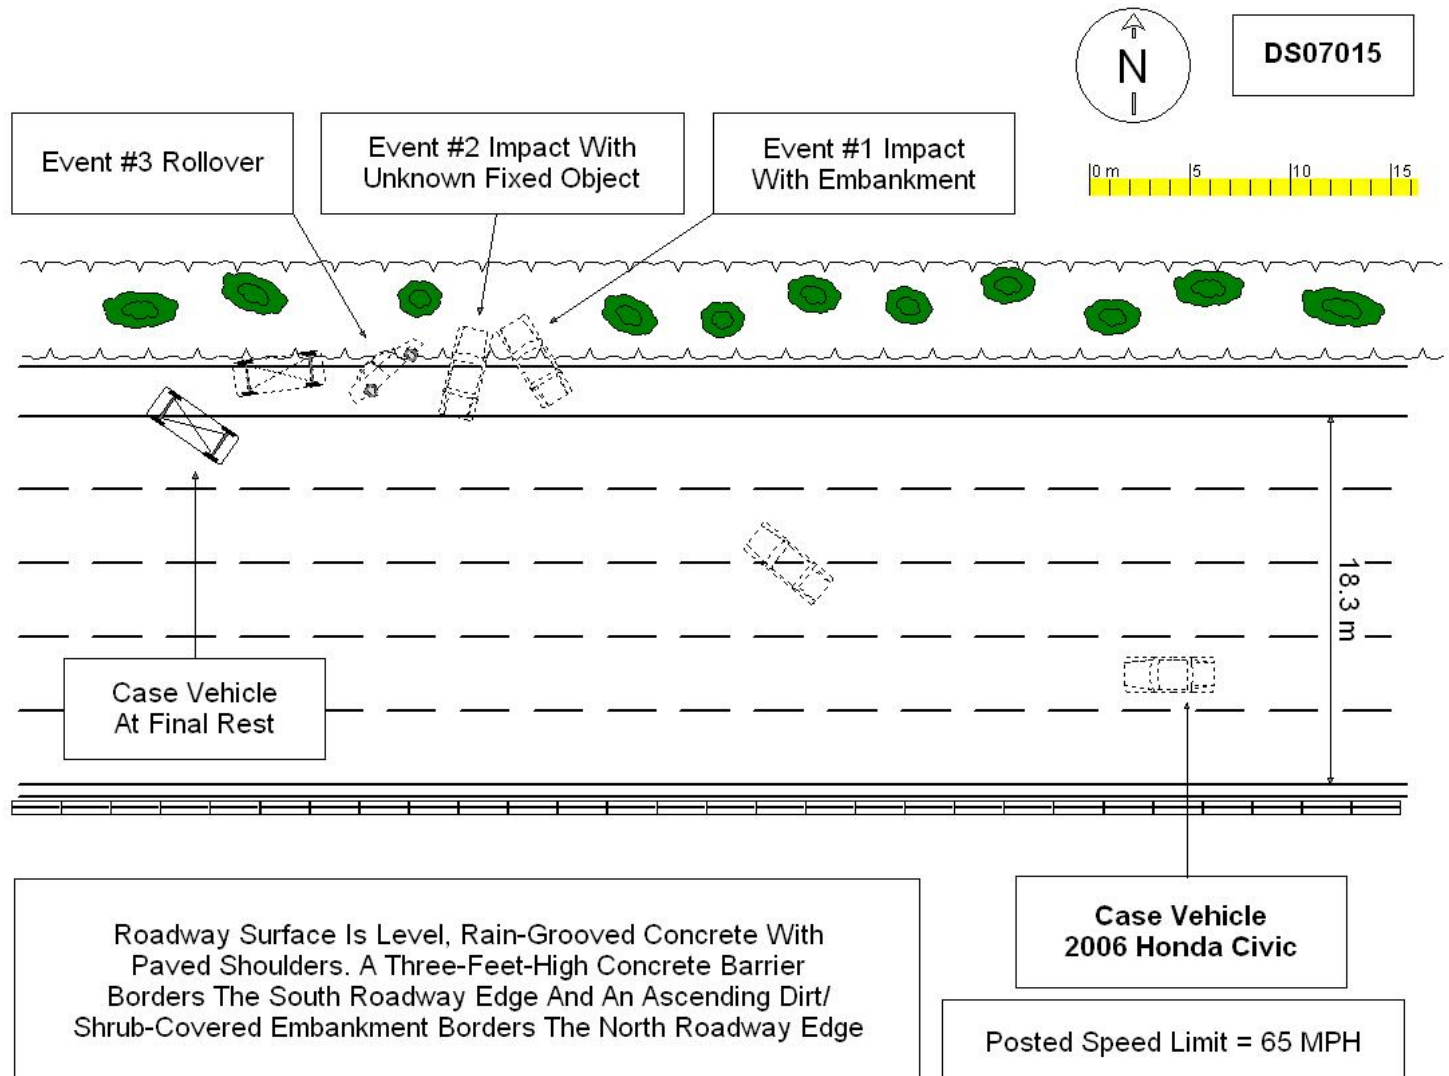
Attachment 1. Scene Diagram

The case vehicle continued the rollover and came to rest on its roof. The driver was able to exit the vehicle under his own power. He sustained minor hand abrasions and a neck strain. He was transported to a local hospital where he was treated and released.
