**CALSPAN ON-SITE CHILD SAFETY SEAT CRASH INVESTIGATION
SCI CASE NO: CA07-018**

**VEHICLE: 2007 CHEVROLET EQUINOX
LOCATION: NEW YORK
CRASH DATE: JUNE, 2007**

<p>1. Report No. CA07-018</p>	<p>2. Government Accession No.</p>	<p>3. Recipient's Catalog No.</p>	
<p>4. Title and Subtitle Calspan On-Site Child Safety Seat Crash Investigation Vehicle: 2007 Chevrolet Equinox Location: New York</p>		<p>5. Report Date: October 2007</p>	
		<p>6. Performing Organization Code</p>	
<p>7. Author(s) Crash Data Research Center</p>		<p>8. Performing Organization Report No.</p>	
<p>9. Performing Organization Name and Address Calspan Corporation Crash Data Research Center P.O. Box 400 Buffalo, New York 14225</p>		<p>10. Work Unit No. C00410.0000.0317</p>	
		<p>11. Contract or Grant No. DTNH22-07-C-00043</p>	
<p>12. Sponsoring Agency Name and Address U.S. Department of Transportation National Highway Traffic Safety Administration Washington, D.C. 20590</p>		<p>13. Type of Report and Period Covered Technical Report Crash Date: June 2007</p>	
		<p>14. Sponsoring Agency Code</p>

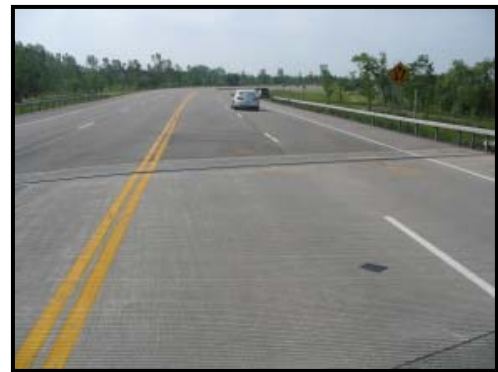
This two vehicle crash occurred during the afternoon hours of June 2007. At the time of the crash, it was daylight and the weather was clear and dry. The crash occurred on a straight segment of a four-lane road immediately south of a concrete bridge. At the crash site, the roadway consisted of two 3.7 m (12 ft) lanes in each direction that were separated by double yellow centerlines. The outboard edges of the travel lanes were bordered by white fog lines and 3 m (10 ft) wide shoulders. The speed limit in the area of the crash was 72 km/h (45 mph). **Figure 2** is a southbound trajectory view 60 m (200 ft) north of the point of impact. **Figure 3**

Figure 2: Southbound trajectory view.

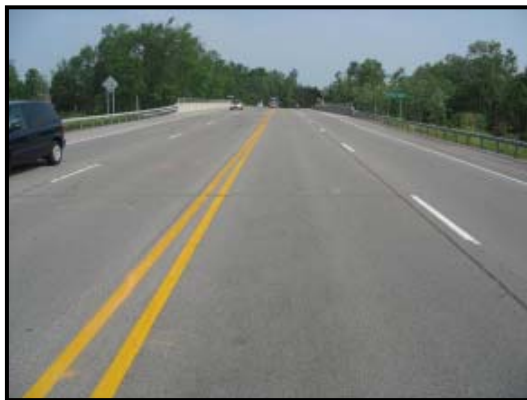
is a northbound trajectory view 30 m (100 ft) south of the point of impact. The point of impact was located within the inboard southbound lane, 0.9 m (3 ft) west of the double yellow centerline. The area of the impact (**Figure 4**) was denoted by a series of gouge and scratch marks and the beginning of a 24.4 m (80 ft) continuous scratch mark that defined the post-crash trajectory of the Buick. The post-crash trajectory of the Chevrolet was defined by a series of tire marks, scratches, and gouge marks on the southbound lanes of the road. The roadway physical evidence that defined the post-crash trajectories of the vehicles was documented during the SCI scene inspection.

Figure 3: Northbound trajectory view.

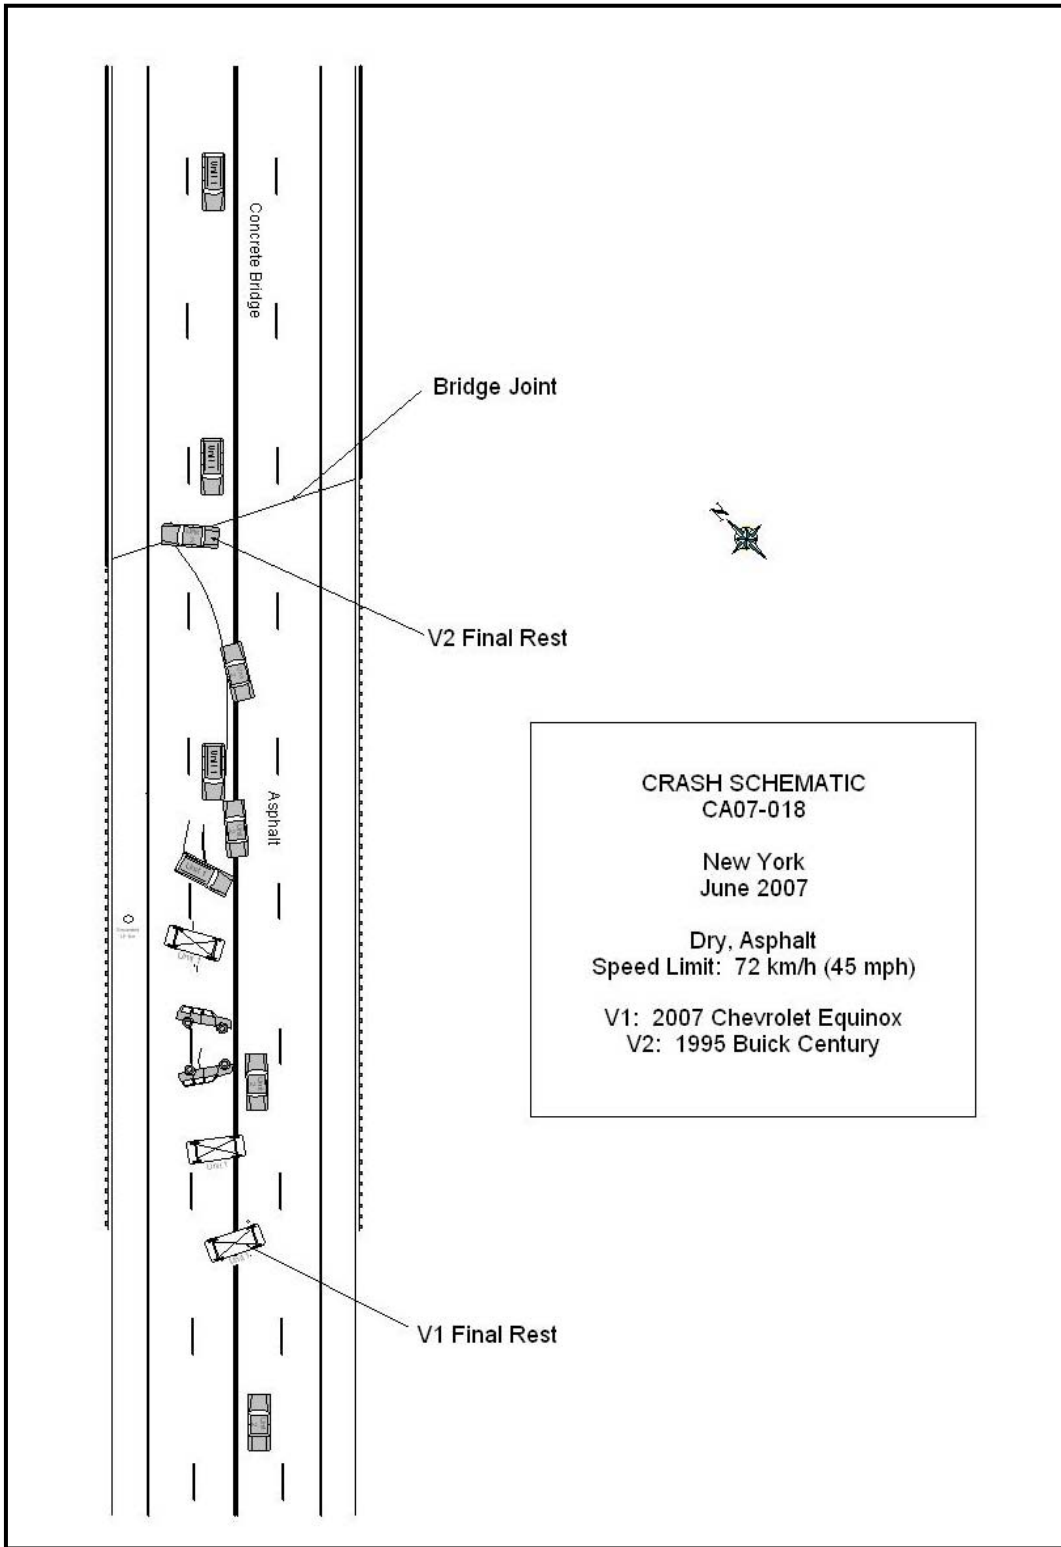
The 2007 Chevrolet Equinox was traveling south in the inboard southbound lane. The vehicle was driven by a 36 year old restrained male. The Chevrolet was occupied by a 35 year old restrained female front right passenger, a 1 month old female restrained within a rear-facing infant seat in the second row left position, and a 3 year old female restrained within a forward facing convertible child safety seat in the second row right position. The 1995 Buick Century was traveling north in the inboard northbound lane driven by a 30 year old restrained male. The driver was the sole occupant of the Buick. For unknown reasons, the driver of the Buick crossed the double yellow centerline directly into the path of the Chevrolet. The driver of the Chevrolet reported in his SCI interview that he was not aware of the approaching Buick and did not initiate any avoidance maneuvers prior to the crash. The driver estimated his speed was 64 to 72 km/h (40 to 45 mph). A schematic of the crash is attached to the end of this report as **Figure 16**.

Figure 16: Crash schematic.
