Remote Not In Traffic Surveillance Back Over Investigation  
Dynamic Science, Inc. / Case Number: DS07021  
2006 Chrysler 300  
California  
March 2007

1. Report No. DS07021		2. Government Accession No.		3. Recipient Catalog No.	
4. Title and Subtitle Not In Traffic Surveillance Back Over Investigation				5. Report Date August 1, 2008

**Dynamic Science, Inc.**  
**Crash Investigation**  
**Case Number: DS07021**

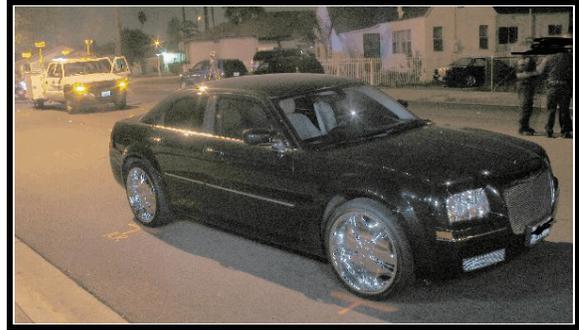
**Figure 1.** Subject vehicle, 2006 Chrysler 300

This single vehicle incident occurred in March 2007 at 1936 hours. The subject vehicle was a 2006 Chrysler 300 four-door sedan (**Figure 1**). The incident took place on an urban roadway in front of the driver's residence. The weather was clear and calm at the time of the incident. The roadway was dark but streetlights were present and on. The Chrysler was being driven by a 25-year-old male. The involved child was 3 years old and was the daughter of the driver. The driver was traveling eastbound on the urban roadway and was attempting to park his vehicle along the south curb line in front of his residence. As the driver of the Chrysler stopped his vehicle, he observed a vehicle attempting to pull out of his driveway. The Chrysler was partially blocking the driveway entrance and the driver needed to back up to allow room for the second vehicle to pull out. The 3-year-old female child was initially standing on the sidewalk directly in front of the residence, approximately 0.6-0.9 m (2-3 ft) from the south curb line. The driver indicated that he looked behind his vehicle and saw the child and felt that it was safe to back up to allow the other vehicle to pull out. The driver of the Chrysler began backing. The child left her position on the sidewalk and ran into the street behind the backing Chrysler. The driver recalled a "bump" and thought he may have struck the curb. The driver put his vehicle into DRIVE and pulled forward and made a U-turn to park along the north curb line, across the street from the residence. As he was turning, he looked to his left and observed that he had struck his daughter. The child sustained serious head injuries. She was transported to a local hospital where she was admitted and hospitalized.

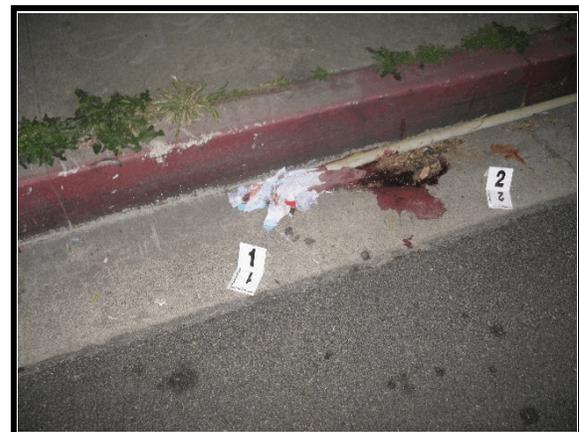
After the impact, the driver put his vehicle into DRIVE and pulled forward and made a U-turn to park along the north curb line (**Figure 4**), across the street from the residence. As he was turning, he looked to his left and observed that he had struck his daughter. The driver exited the vehicle and ran to the child who was lying near the curb (**Figure 5**). At this same time, a police patrol vehicle drove up to the scene while on their way to an unrelated call. The driver moved aside to allow the police officers to assist the injured child. The child sustained serious head injuries. She was transported to a local hospital where she was admitted and hospitalized for an unknown number of days.

**Figure 5.** Final rest of pedestrian/non-motorist (south)

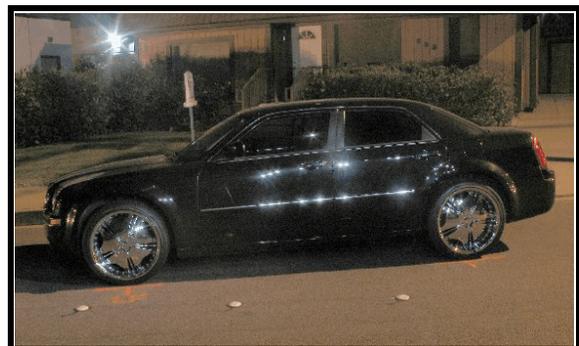
The child left her position on the sidewalk and ran into the street and into the path of the Chrysler as it was backing. The child would have been in the driver's blind spot at this time. The driver's vision was likely degraded due to the vehicle's tinted windows, but he did report that he was able to see the child before backing. It is not known why the child left the sidewalk, but police investigators indicated that it was most likely that she was excited to see her father get home from work and was running to meet him at the driver's door of the vehicle. The driver reported a backing speed of 3.2-4.8 km/h (2-3 mph). The Chrysler traveled rearward approximately 5.1 m (16.7 ft). The driver recalled a "bump" and thought he may have struck the curb. The child was struck by the right rear bumper, knocked down, and likely hit her head on the curb (**Figure 3**).

**Figure 6.** Left side, Chrysler 300, side glass tinting
