## ON-SITE NOT IN TRAFFIC SURVEILLANCE BACK OVER INVESTIGATION

CASE NUMBER - IN-07-026

VEHICLE - 1994 FORD RANGER

INCIDENT DATE - June 2007

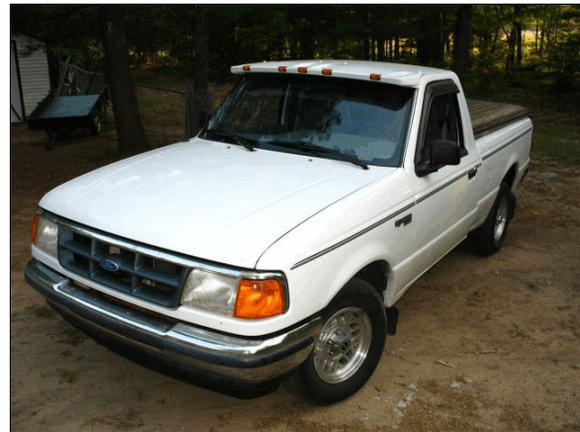
The 1994 Ford Ranger LX (**Figure 4**) was a rear wheel drive, regular cab, pickup truck VIN: 1FTRC10A8RU-----) equipped with a 2.3L, I4 engine and five-speed manual transmission. The Ford was not equipped with any backup/parking aid. The vehicle's left front window, right front window and backlight were all tinted with original equipment manufacturer tinting. The center portion of the Ford's backlight was constructed with two sliding windows. These windows as well as the left front and right front windows were closed at the time of the incident. The Ford was also equipped with a step-type back bumper and had a truck bed cover installed (**Figure 5**), which increased the height of the bed approximately 15 centimeters (~6 inches). The Ford's specified wheelbase was 274 centimeters (108 inches). The specified rear overhang was 109 centimeter (43 inches) and the specified overall length was 467 centimeters (184 inches). The beltline height was measured as 109 centimeters (43 inches). The distance from the ground to the bottom of the back bumper was 46 centimeters (18 inches). The distance from the ground to the top of the tailgate was approximately 114 centimeters (45 inches). The distance from the ground to the truck bed lid (at the centerline) was 125 centimeters (49 inches).

**Figure 4:** Front left view of case vehicle

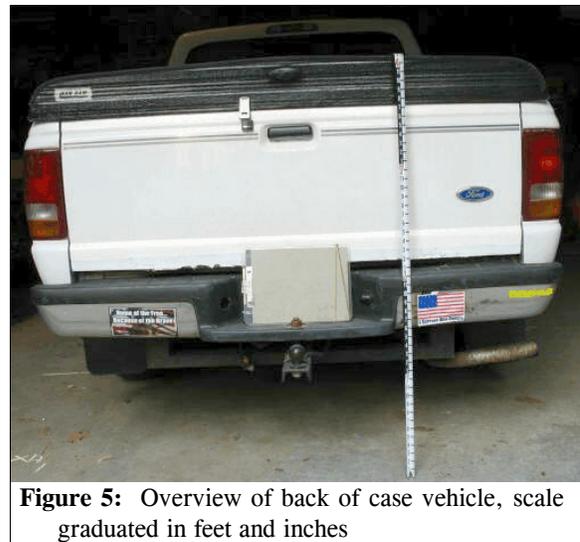
**Figure 5:** Overview of back of case vehicle, scale graduated in feet and inches
