Remote Child Safety Seat Investigation
Dynamic Science, Inc. / Case Number: DS07028
1998 Buick Century
North Dakota
January 2007

1. Report No. DS07028		2. Government Accession No.		3. Recipient Catalog No.	
4. Title and Subtitle Remote Child Safety Seat Investigation				5. Report Date May 27, 2008

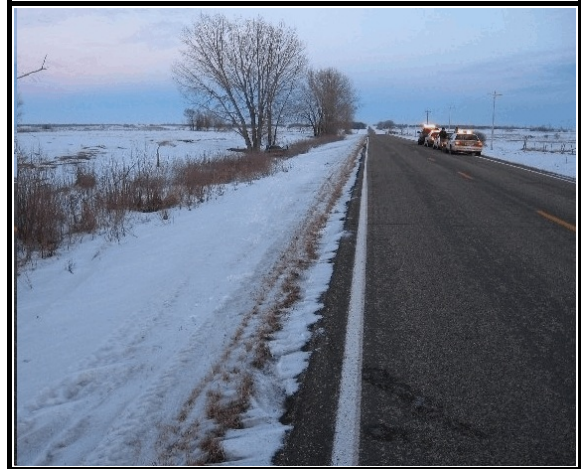
Figure 2. Area of roadside departure

This single-vehicle crash occurred on an east/west section of an undivided two-lane rural highway in January 2007. The roadway consisted of one lane in each direction (**Figure 2**). The roadway character was straight and level. The pavement was constructed of asphalt. The center line consisted of a yellow dash and solid stripe pattern which permitted eastbound traffic to pass. Just prior to the area of impact, the center line pattern changed to a single dash stripe. The north and south roadway edges were marked by solid white fog lines. Adjacent to the north roadway edge was a descending

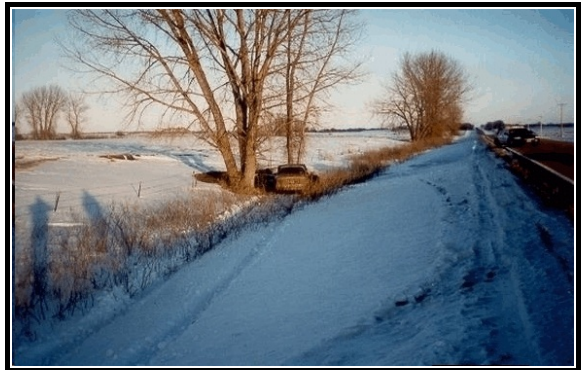
Figure 3. Approach to impact area

The 1998 Buick Century was traveling eastbound at a driver estimated speed of 89 km/h (55 mph). The 46-year-old driver was restrained by a 3-point manual lap and shoulder belt. The 4-year-old male occupied the second row left position. He was seated in an Evenflo high-back belt positioning booster seat and restrained by the 3-point manual lap and shoulder belt. The driver stated she heard a loud noise toward the rear of the vehicle, and turned to check on the child in the back seat. The Buick crossed the roadway's centerline, and traveled off the left side of the roadway, and down the descending embankment (**Figure 3**).
