ON-SITE NOT IN TRAFFIC SURVEILLANCE BACK OVER INVESTIGATION

CASE NUMBER - IN07028

VEHICLE - 2003 FORD EXPEDITION EDDIE BAUER

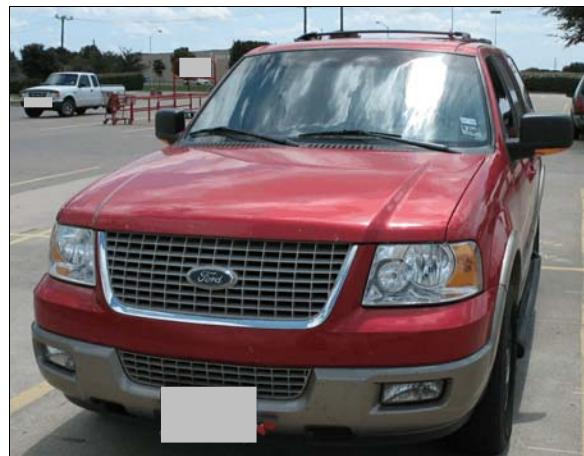
The 2003 Ford Expedition Eddie Bauer (**Figures 3 and 4**) was a rear wheel drive, four-door sport utility vehicle (VIN: 1FMRU17W43L-----) equipped with a 4.6L, V8 engine; automatic transmission, tinted side windows, tinted backlight, and an ultrasonic Reverse Sensing System (RSS). The Ford was equipped with no after market equipment except a replacement convex right side view mirror. The Ford's recommended tire size was P265/70R17, and the vehicle was equipped with tires of this size. The Ford's specified wheelbase was 302 centimeters (119 inches). The specified rear overhang was 122 centimeters (48 inches) and the specified overall length was 523 centimeters (205.8 inches). The distance from the ground to the bottom of the back bumper was measured as 50 centimeters (19.7 inches). The distance from the ground to the beltline was measured as 123 centimeters (48.4 inches). The distance from the ground to the bottom of the backlight was 130 centimeters (51.2 inches). The distance from the ground to

Figure 3: Overview of front of Ford Expedition

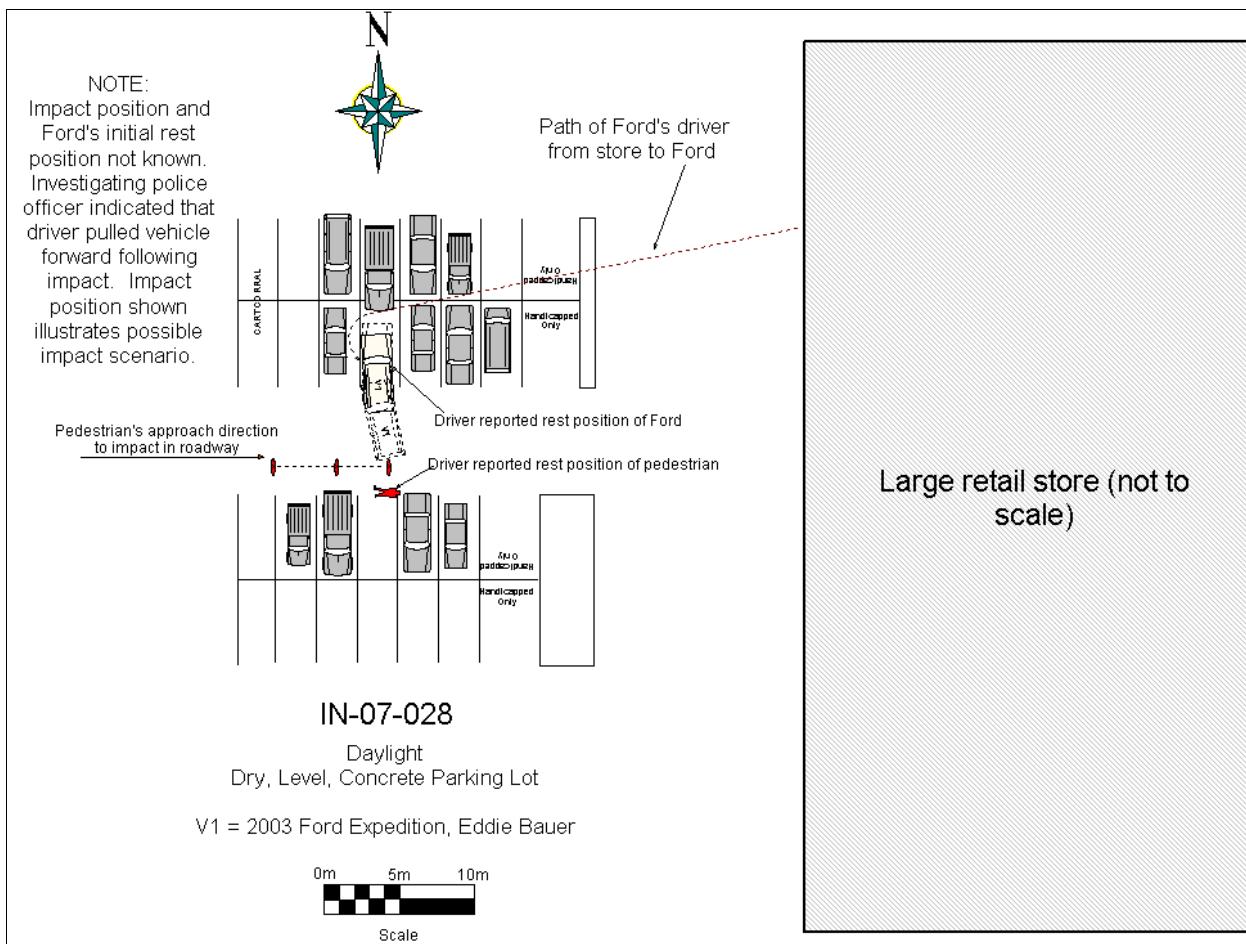
SCENE DIAGRAM

access roadways. The parking spaces were nominally 2.7 meters (8.9 feet) in width. The access roadways were nominally 7.2 meters (23.6 feet) in width. The parking spaces were oriented north/south and the access roadways were oriented east/west. At the time of the incident the light condition was daylight, the atmospheric condition was clear, and the roadway pavement was dry, level concrete. The site of the incident was suburban commercial. The Ford's driver (55-year-old, male) accompanied the SCI investigator to the incident scene. The driver showed the SCI investigator the location of the incident, described the sequence of events and pointed out the parked and final rest positions of the Ford as well as the final rest position of the pedestrian. See the Scene Diagram at end of this report.
