**CALSPAN ON-SITE CHILD SAFETY SEAT CRASH INVESTIGATION
CASE NO: CA07-035**

VEHICLE: 2007 PONTIAC G6

LOCATION: OHIO

CRASH DATE: NOVEMBER 2007

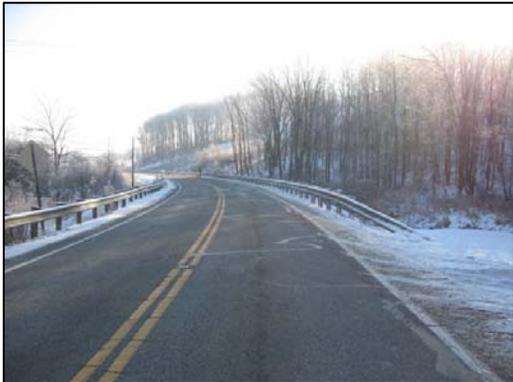
Figure 2 - Eastbound approach of 2007 Pontiac G6.

The 35-year old female driver of the Pontiac was operating the vehicle in an eastbound direction and was negotiating a sharp left curve (**Figure 2**). The 21-year old driver of the Buick was operating her vehicle in a westbound direction and was entering a right curve (**Figure 3**). A witness reported that the Buick had passed his vehicle earlier, 6.4 km (4 miles) from the crash site, and that the Buick was driving erratically and at a high rate of speed. The driver of the Buick was also suspected by police investigators to be driving under the influence of alcohol and narcotics. The Buick crossed the centerline of the roadway and was traveling in the eastbound lane prior to the impact. According to the vehicle’s EDR, the driver of the Pontiac was traveling 100 km/h (62 mph) at 2 seconds prior to the impact; however, the driver applied the brakes at 1 second prior to the crash and reduced the vehicle’s speed to 89 km/h (55 mph).

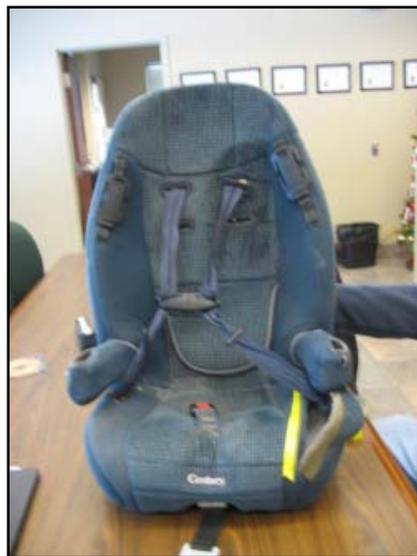
Figure 18. Century Breverra FFCSS.

The 2-year-old male was positioned in a Century Breverra Forward Facing Child Safety Seat (FFCSS) seat and was restrained by the integrated five-point harness system (**Figure 18**). The safety seat Model Number and Date of Manufacture were not identified. The label that contained this information was curled and torn along the outer aspects where these numbers were listed. The child seat was embossed with an expiration date

During the crash phase the child passenger loaded the internal harness system. The loading of the lower left harness strap tore the cloth and foam seat cushion (**Figure 18**). The tear began at the harness strap opening on the cushion and extended forward 17 cm (6.7"). As the 2-year-old male passenger continued loading the harness system the retainer clip unlatched. The unlatching of the harness retainer clip was supported by the tearing of the cushion from loading. This tearing probably would not have occurred if the harness clip was not latched. **Figure 20** is a police post-crash image of the FFCSS which show the harness system and the harness retainer clip prior to the removal of the FFCSS from the vehicle. No damage was evident during the SCI inspection and the retainer clip functioned as designed.

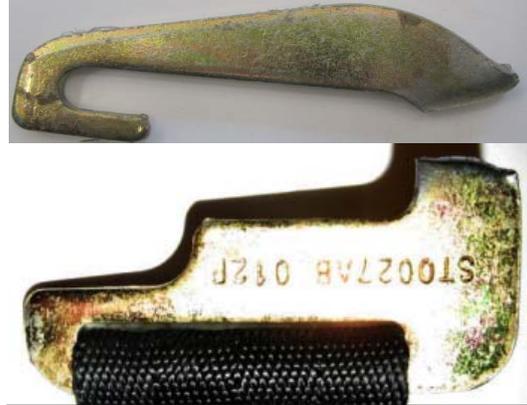
Figure 24. Splitter plate configuration.

In the course of the loading, the right side (closed end) of the splitter plate fractured (**Figure 21**). The fracture occurred approximately 0.6 cm (0.25") below the apex of the top right side aspect (**Figures 22 and 23**). **Figure 24** is of the splitter plate configuration. Due to the splitter plate fracture, the harness straps partially threaded through the top slots. The movement of the harness straps against the FFCSS shell resulted in frictional abrasions on the rear of the shell. The abrasions from the left harness strap were diagonally oriented (top left to bottom right) and began at the top slot and extended 25 cm (9.8") (**Figure 25**). Frictional abrasions were present within the right harness

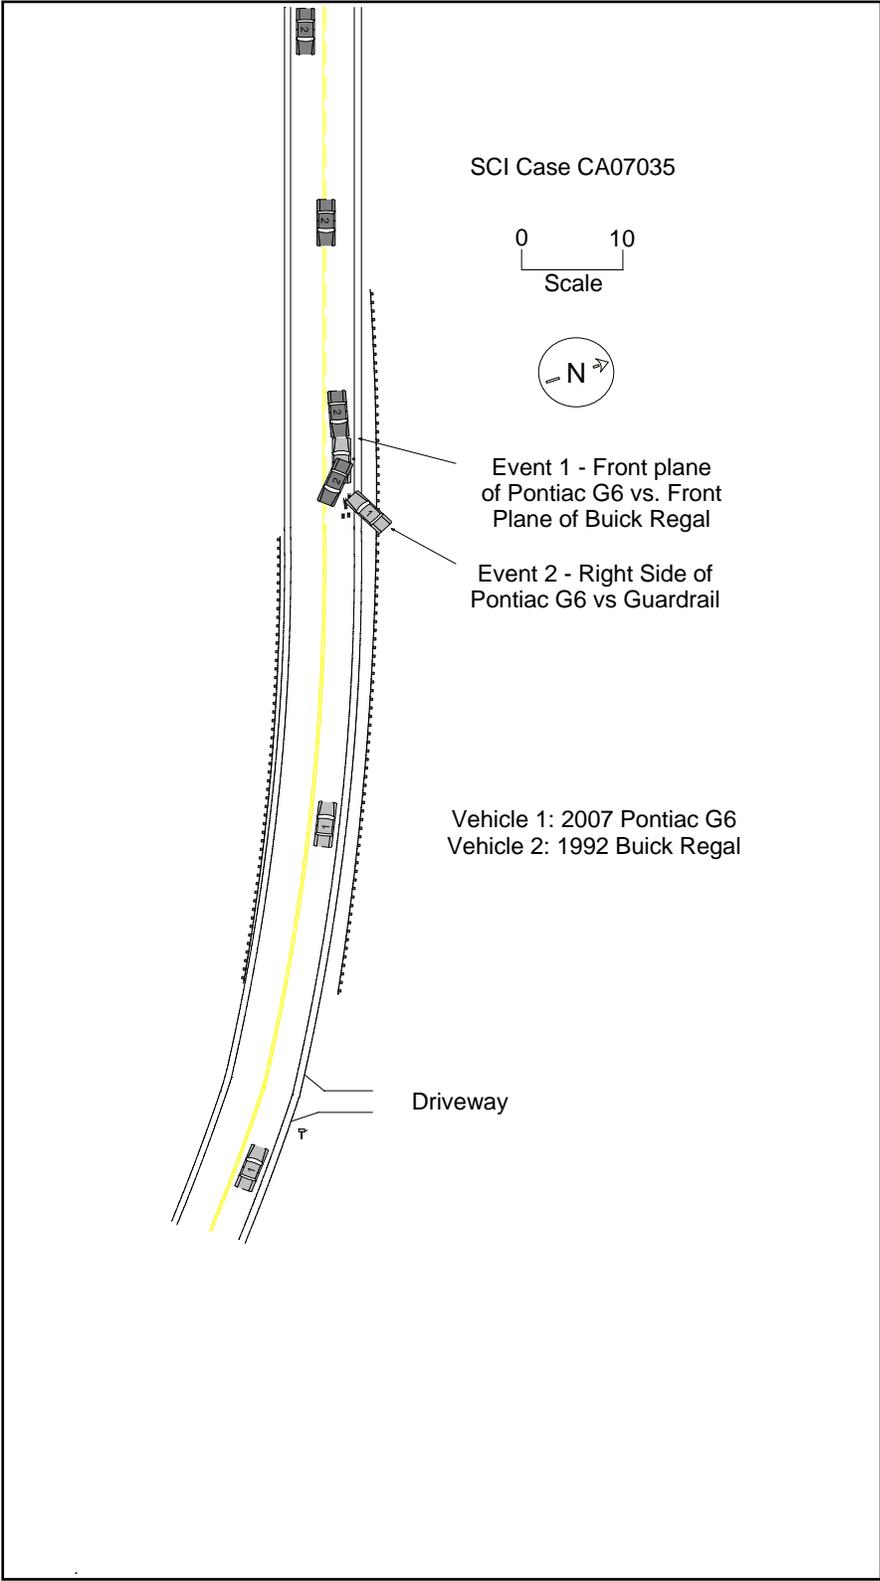
Figure 26: Scene Schematic

The crash occurred during the daylight hours in November 2007. At the time of the crash, the asphalt roadway was dry and there were no adverse weather conditions. The crash occurred on a two-lane east/west winding roadway in a rural setting. The width of the eastbound lane was 3 m (10 ft) and the width of the westbound lane was 3.3 m (10.8 ft). The travel lanes were separated by solid double yellow centerlines for eastbound traffic and solid and broken double yellow centerlines for westbound traffic. The roadside environment consisted of natural growth and 1 m (3 ft) asphalt shoulders bordered the roadway. W-beam guardrails were located 1 m (3 ft) outboard of the road edges of each travel lane. The roadway was curved at the point of impact and had a radius of 265 m (869 ft). The speed limit in the area of the crash was 89 km/h (55 mph). The Crash Schematic is included as **Figure 26** at the end of this narrative report.
