# INDIANA UNIVERSITY

## ON-SITE CHILD SAFETY SEAT INVESTIGATION

CASE NUMBER - IN07036  
LOCATION - TEXAS  
VEHICLE - 2001 CHEVROLET MALIBU  
CRASH DATE - October 2007

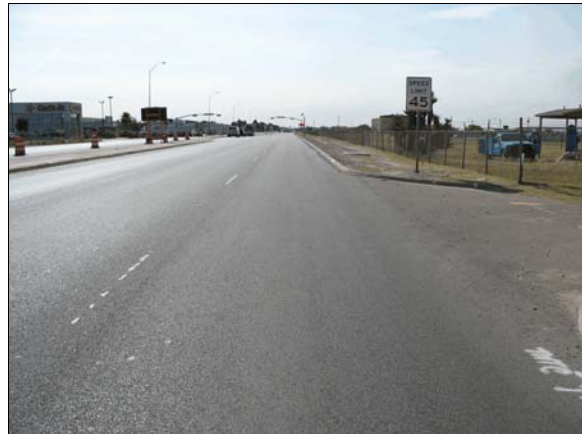
**Figure 2:** View south to the area of the crash

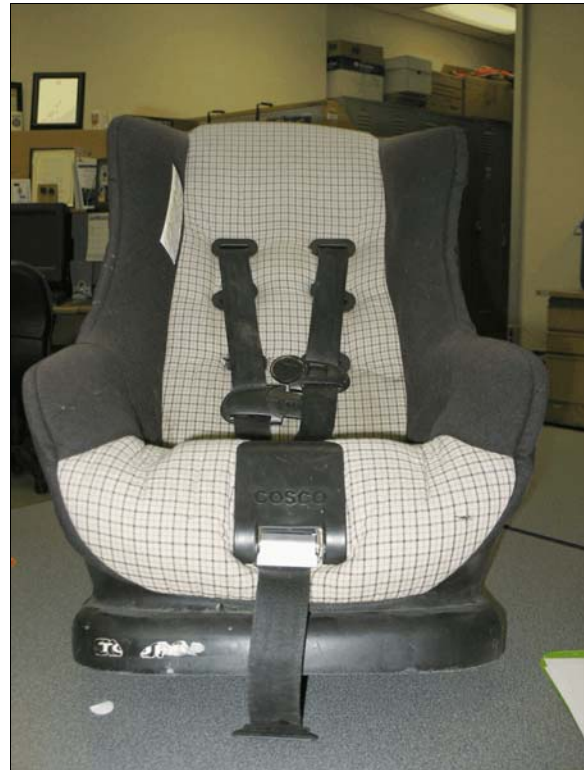
**Second Row Left Child Safety Seat:** The Chevrolet's second row left passenger [18-month-old, female; 76 centimeters and 10 kilograms (30 inches, 22 pounds)] was seated in a forward-facing, convertible CSS (Figure 11). The CSS was designed for children over 1-year-old who weighed 9-18 kilograms (20-40 pounds) and were 74-102 centimeters (29-40 inches) tall. The CSS was manufactured by the Dorel Juvenile Group. There were no labels indicating model number or date of manufacture remaining on the CSS. A partial label on the front indicated the CSS was a Touriva model. The CSS was designed with a five-point harness and there were three sets of slots on the back of the CSS to thread the harness straps through. The harness straps were threaded through the top set of slots and a harness retainer clip was attached to the harness straps. The driver stated during the interview that the child was restrained by the harness and the harness clip was positioned at the child's armpit level. The vehicle's lap-and-shoulder belt was routed through the forward facing belt path at the time of the crash. The driver did not realize the retractor was switchable and didn't extend the belt webbing fully to activate the locking feature. She pulled the lap-and-shoulder belt tight to secure the CSS.

Figure 11: Chevrolet's second row left CSS

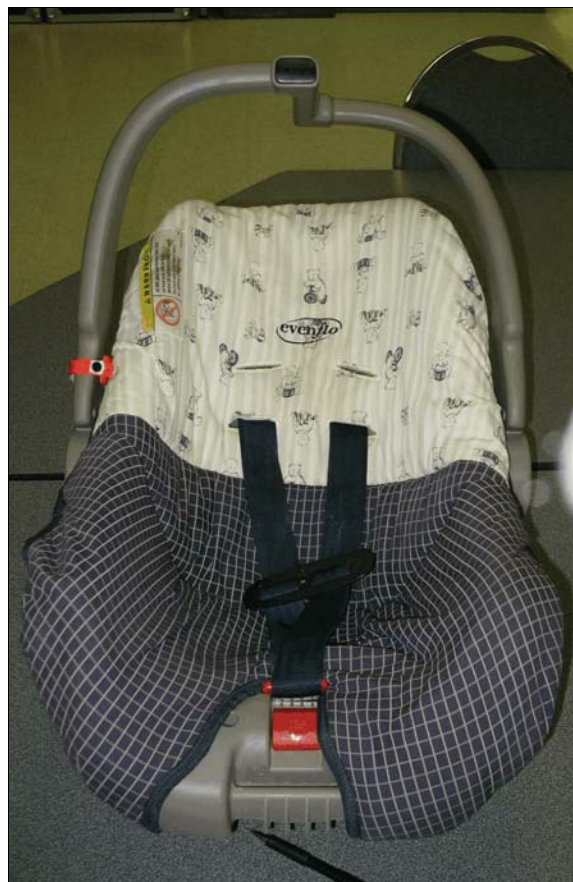
**Second Row Center Child Safety Seat:** The Chevrolet's second row center passenger [1½-month old, male; 53 centimeters and 5 kilograms (21 inches and 10 pounds)] was seated in a rear-facing, infant seat (Figure 13). The CSS was designed for infants who weighed 2-10 kilograms (5-22 pounds) and were 74 centimeters (29 inches) tall or less. The CSS was an Evenflo Discovery and

**Figure 13:** Chevrolet's second row center infant seat

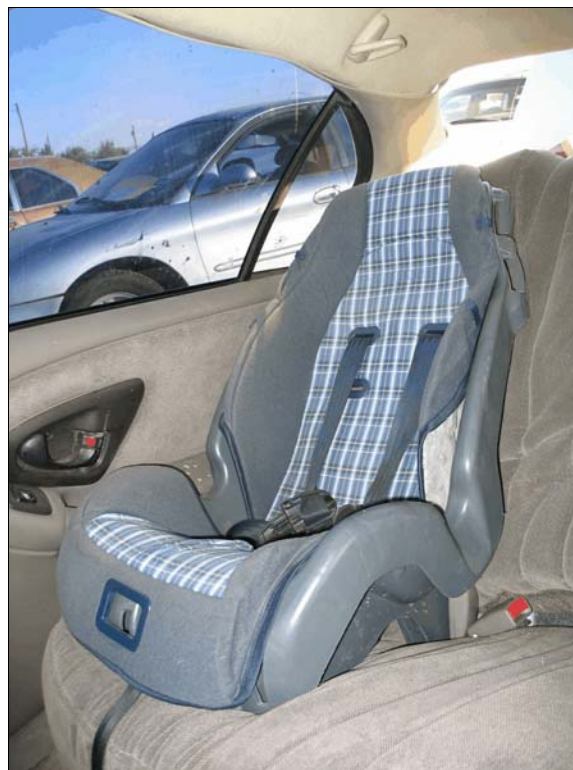
Back Booster CSS (**Figure 15**). The CSS was designed for children over 1-year-old who weighed 13-36 kilograms (28-80 pounds) and were 74-132 centimeters (29-52 inches) tall. The CSS was manufactured on February 16, 2005, and its model number was 22-208-WAL. The CSS was designed with a five-point harness and a tether. There were 2 sets of slots on the seat back to route the harness straps through, and they were routed through the top set of slots. The harness straps were also routed through a set of slots in the bottom of the CSS. A harness retainer clip was attached to the harness straps, which was positioned at the child's armpit level. The driver routed the vehicle's lap-and-shoulder belt through the forward facing belt path and pulled tightly to secure the CSS; however, she did not activate the retractor's locking feature before to securing the CSS.

**Figure 15:** Chevrolet's second row right CSS as found by the SCI investigator
