Child Safety Seat Investigation
Dynamic Science, Inc. / Case Number: DS07038
2001 Nissan Quest
California
September 2007

1. Report No. DS07038	2. Government Accession No.		3. Recipient Catalog No.	
4. Title and Subtitle Child Safety Seat Investigation		5. Report Date August 27, 2008

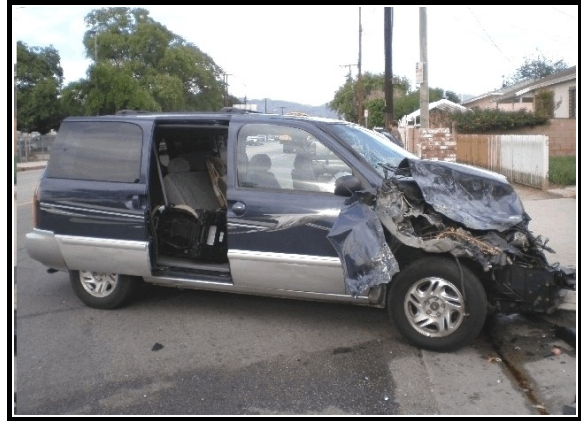
This on-site investigation focused on two child safety seats in the second row of a 2001 Nissan Quest minivan (**Figure 1**) that was involved in a crash with a 1984 Chevrolet Silverado pickup. The subject vehicle was a 2001 Nissan Quest minivan that was being driven by a 36-year-old female. The second row left seat was occupied by a 19-month-old male seated in a forward facing Dorel High Back booster seat. The second row right seat was occupied by a 3-year-old male seated in an Evenflo Big Kid booster seat. The Nissan was traveling east, and the Chevrolet was traveling west. The Chevrolet initiated a left turn at the intersection and the front end of the Nissan impacted the right side of the Chevrolet. Both vehicles traveled short distances, contacted the curb near the southeast corner of the intersection, and came to rest at the curb. The driver of the Nissan sustained an unspecified fracture to the right lower leg and minor abrasions, contusions and lacerations. She was transported to a local hospital, treated and released. The 19-month-old second row left seat occupant sustained a contusion to the left clavicle area. He was transported by air ambulance to a local children's hospital, treated and released. The 3-year-old second row right seat occupant was unrestrained and was displaced in a forward trajectory from his booster seat, and his head contacted the windshield. He sustained a forehead abrasion, a contusion to the left eye, a contusion to the back of the head, and a contusion to the right medial leg. He was transported by air ambulance to a local children's hospital where he was admitted for one day.

Figure 1. Subject vehicle, 2001 Nissan Quest

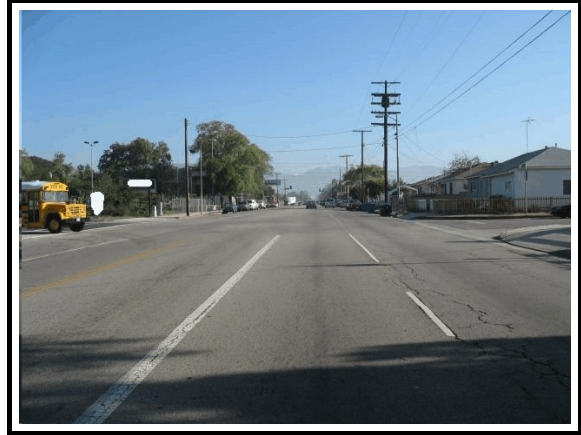
The Nissan was traveling eastbound in the second lane from the right at an unknown speed (**Figure 2**). The Chevrolet was traveling westbound in the left turn lane at an unknown speed (**Figure 3**). The driver of the Nissan reportedly observed the Chevrolet approach the intersection. She indicated she was attentive and not distracted. She also indicated that as she approached the intersection, she saw the Chevrolet preparing to turn left, but thought it would stop since she was also entering the intersection. The Chevrolet initiated a left turn and entered the path of the Nissan. The driver of the Nissan indicated in the interview that she braked but was unable to avoid contact with the Chevrolet.

Figure 2. Eastbound approach for the Nissan Quest.

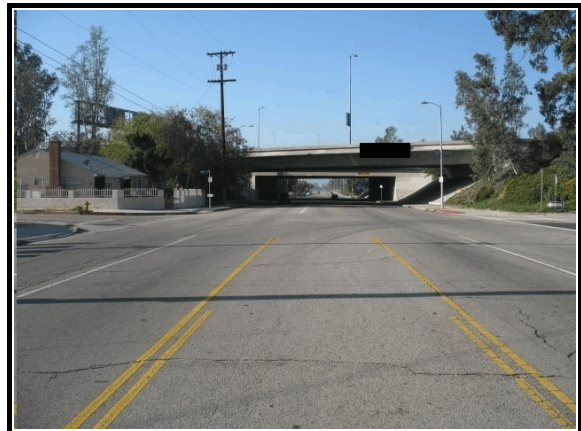
Figure 3. Westbound approach for the Chevrolet Silverado

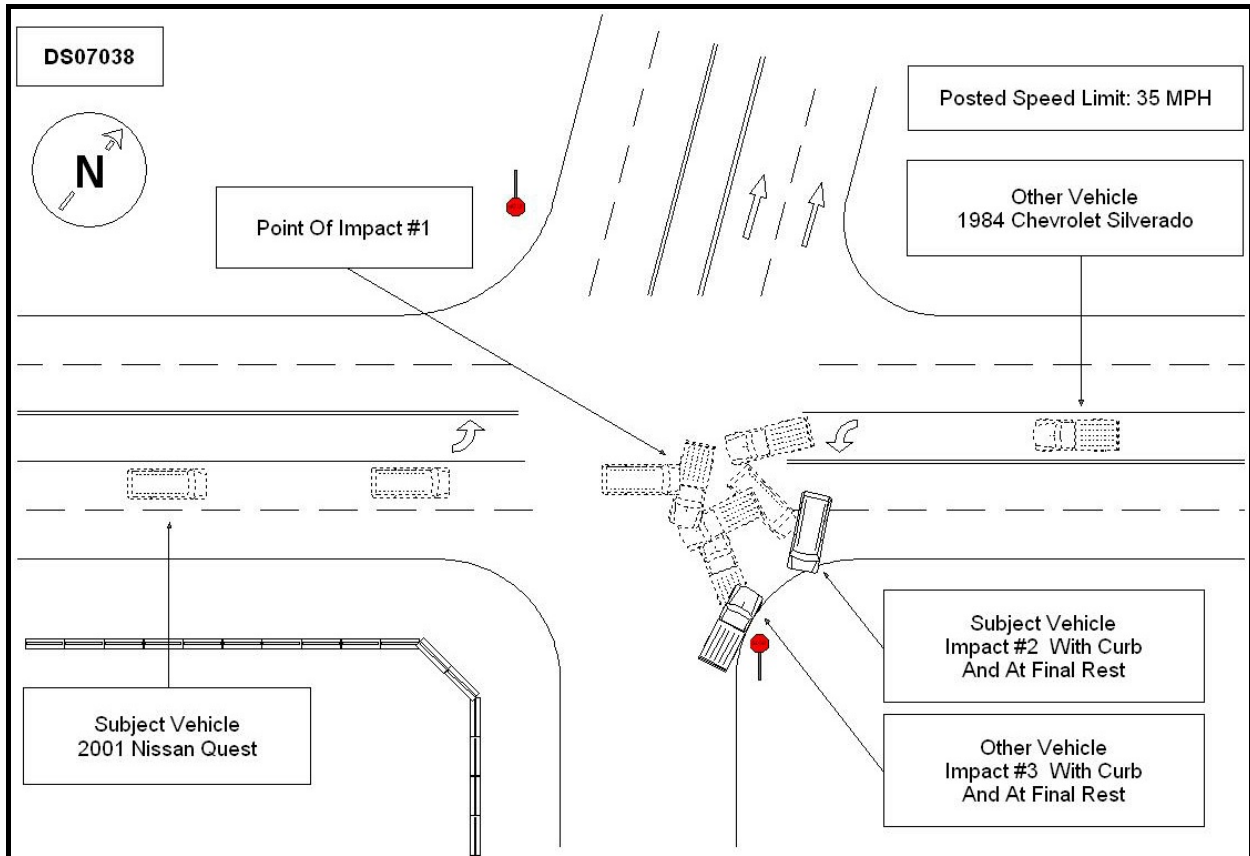
Attachment 1. Scene Diagram

The front end of the Nissan impacted the right side of the Chevrolet. As the vehicles were engaged they initiated a clockwise rotation. Following the impact, the Nissan traveled approximately 10.1 meters (33.1 ft.) before impacting a curb on the south roadway edge with its front end, where it came to final rest facing south. The Chevrolet traveled approximately 9.9 meters (32.5 ft.) before striking a curb near the southeast corner with its right front tire, where it came to final rest.
