Child Safety Seat / Vehicle To Vehicle Investigation
Dynamic Science, Inc. / Case Number: (DS07044)
2002 Ford Expedition
California
September 2007

1. Report No. DS07044		2. Government Accession No.		3. Recipient Catalog No.	
4. Title and Subtitle Child Safety Seat Investigation			5. Report Date June 2, 2008

14. Sponsoring Agency Code		
15. Supplemental Notes					
16. Abstract This on-site investigation focused on child occupants involved in a two vehicle crash involving a 2002 Ford Explorer XLT and a 2002 Chevrolet Silverado K3500 pickup. The crash occurred within a four-leg intersection. The subject vehicle was being driven by a restrained 26-year-old female and there were three children seated in the second row. The second row left seat was occupied by a 5-year-old female seated in a forward facing booster seat. The second row middle seat was occupied by a 21-month-old male seated in a child safety seat. The second row right seat was occupied by a 3-year-old male reportedly seated in a child safety seat. The other vehicle was a 2002 Chevrolet Silverado pickup being driven by a 27-year-old male. The Ford was traveling north; the Chevrolet was traveling west. As the Ford traverse

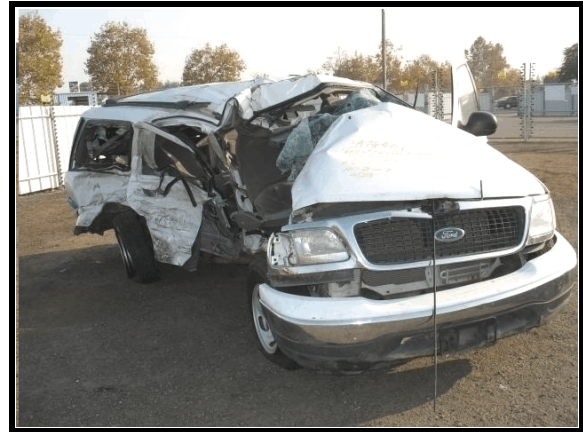
Figure 1. 2002 Ford Expedition XLT

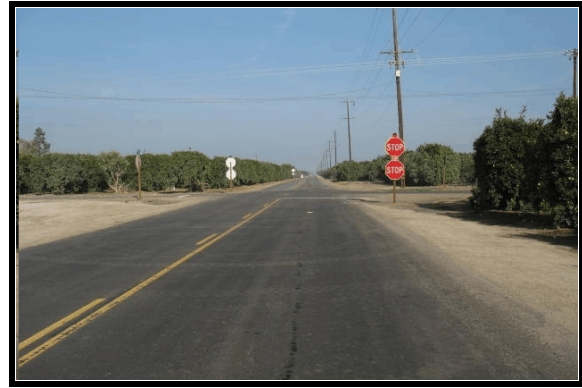
four-way intersection. The intersection consisted of a north/south roadway and an east/west roadway. The north/south roadway was configured with one travel lane in each direction (**Figure 3**). The lanes were separated by a dashed and solid stripe pattern, which prohibited passing for vehicles approaching the intersection from the north. The lane widths for the north/south roadway were 4.4 m (14.5 ft) each. The east/west roadway was configured with one travel lane in each direction. The lanes were separated by a dashed and solid stripe pattern, which prohibited passing for vehicles approaching the intersection from the east. The lane widths for the east/west roadway were 3.4 m (11.0 ft) each. Both roadways were constructed with an asphalt surface and the grade was level (**Figure 4**). This intersection was controlled with posted stop signs and surface painted stop lines for east and westbound traffic. (Two months after this crash, posted double stop signs were installed for all traffic entering the intersection.) The crash occurred during daylight, and the temperature at the time of the crash was 22 degrees C (72 degrees F). Conditions were cloudy, with no precipitation, and the roadway was dry. The speed limit at this location was 89 km/h (55 mph). The roadways were bordered on all sides by generally level ground planted with rows of orange trees.

Figure 3. Approach view north to intersection

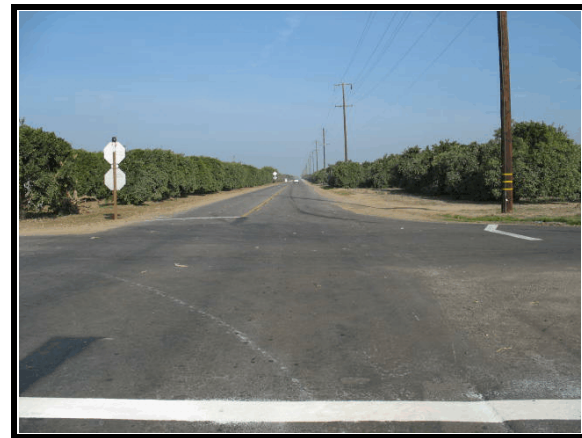
Figure 4. Area of impact, view north

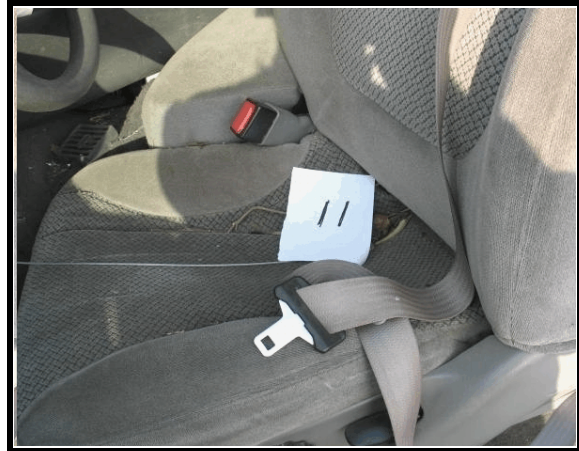
The 2002 Ford Expedition was equipped with 3-point manual lap and shoulder belts for the first row outboard seat positions. The belts were configured with adjustable D-rings. The driver side D-ring was in the full down position. The right passenger side was in the middle position. The first row safety belts were configured with sliding latch plates and Emergency Locking Retractors (ELR). The driver's safety belt webbing had a small puncture hole and stretch marks, which indicated the belt was loaded by the occupant during the crash (**Figure 14**). Damage to the right B pillar left the passenger belt retractor exposed. This belt remained in the stowed position.

Figure 14. Driver safety belt, subject vehicle

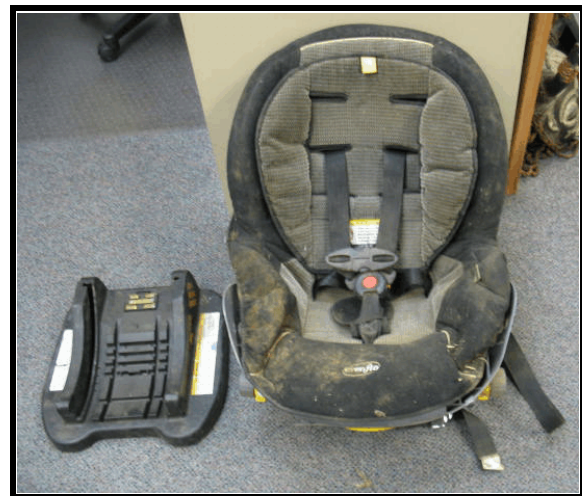
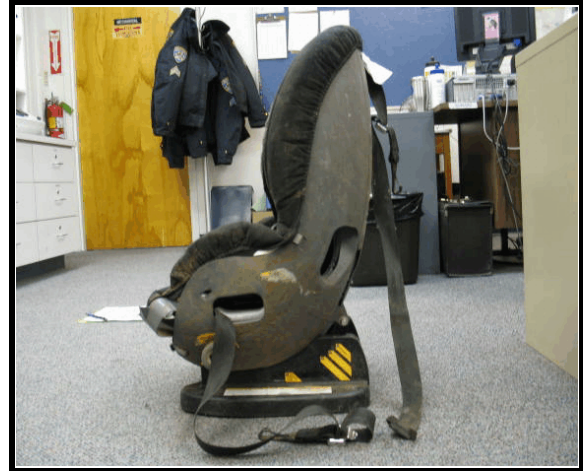
The second row middle occupant was seated in a child safety seat. It is probable the child seat was used forward facing. The child and the seat were ejected from the vehicle during the crash. The seat was an Evenflo Comfort Touch convertible seat, which could be used forward or rearward facing (**Figure 20-21**). The model number was 3591453 P1 and the date of manufacture was October 4, 2005. Instruction labels on the seat indicated the seat could be secured by routing the vehicle belt through two slots in the back of the frame when used forward facing. The vehicle's second row middle seat was equipped with a retractable lap belt.

Figure 20. Evenflo Comfort Touch CSS

Figure 21. Evenflo Comfort Touch CSS, shown placed on base
