On Site Child Safety Seat / Vehicle To Object Investigation
Dynamic Science, Inc. (DSI), Case Number DS08004
1998 Mitsubishi Montero Sport
California
January 2008

1. Report No. DS08004		2. Government Accession No.		3. Recipient Catalog No.	
4. Title and Subtitle Child Safety Seat Investigation			5. Report Date December 11, 2008

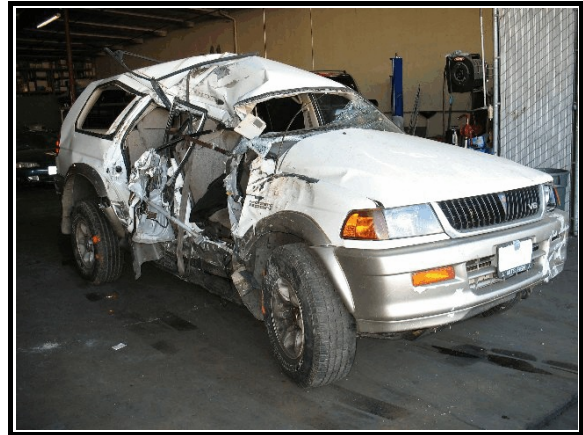
This on site investigation focused on a child safety seat that was installed in the second row of a 1998 Mitsubishi Montero Sport (**Figure 1**). The Mitsubishi was involved in a single vehicle crash with a metal utility pole. The crash occurred off-road on the southeast corner of an intersection. The Mitsubishi was being driven by a restrained 27-year-old female, and the first row right seat was occupied by a restrained 27-year-old male. The second row right seat was occupied by a 23-month-old female who was seated in a Cosco/Dorel High Back Booster Seat. The Mitsubishi was exiting a state highway on an exit ramp and drove off the left side of the roadway. The Mitsubishi crossed a paved shoulder and traveled over a raised concrete curb. The vehicle continued traveling over unpaved ground and knocked down a chain link fence with its front end. After driving through the fence, the vehicle contacted a steel utility pole with its right side. The Mitsubishi then traveled a short distance further before impacting a sign post and reentering the roadway. The vehicle came to rest facing north in a northbound lane.

Figure 1. 1998 Mitsubishi Montero Sport

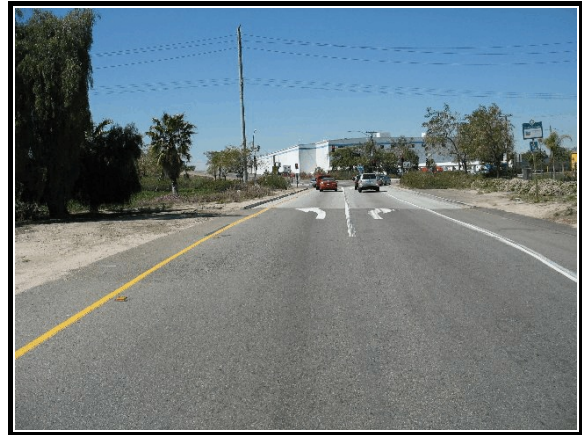
This single vehicle crash occurred at 0957 hours in January 2008. The crash occurred off-road near the intersection of a highway exit ramp and the adjoining roadway (**Figure 2**). The intersection consisted of an east to west highway exit ramp that led to a north/south roadway. The speed limit for the exit ramp was 64 km/h (40 mph). The exit ramp was configured with a single lane that expanded to two lanes near the intersection. Initially, the exit ramp was characterized by a gentle right curve. At 64 meters (210 feet) from the intersection, the roadway straightened and expanded to two lanes. The curved section was paved with asphalt; the straight section was concrete. At the intersection, the first lane from the right was a right turn only lane; the second lane from the right was a left turn only lane. The lanes were separated by a solid stripe pattern which led to the intersection.

Figure 2. Approach view, exit ramp
