**CALSPAN ON-SITE CHILD SAFETY SEAT
CRASH INVESTIGATION**

CASE NO: CA08005

VEHICLE: 2002 SATURN VUE

CRASH DATE: JANUARY 2008

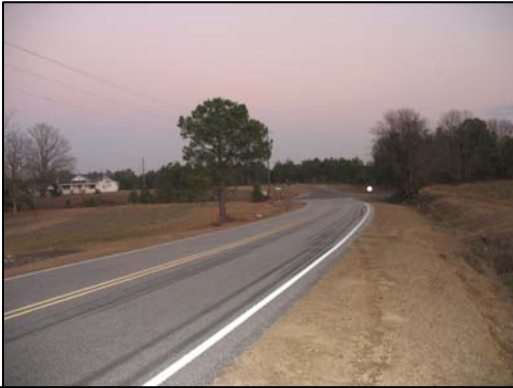
The 2002 Saturn Vue was occupied by an unrestrained 22-year old female driver and by a 3-year old male restrained by the lap and shoulder belt within a booster seat in the center rear position. The Saturn was traveling eastbound approaching a T-intersection (**Figure 2**). The driver leaned to the right and down towards the front right floor in an attempt to

Figure 2 - Eastbound approach of Saturn.

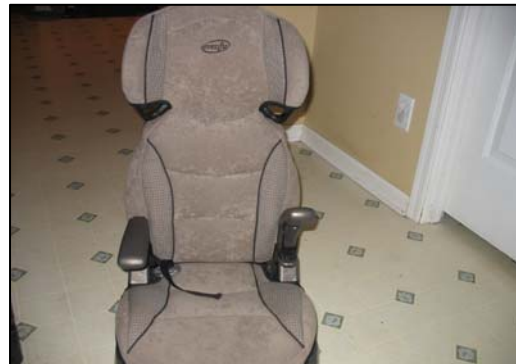
The 3-year old male child was seated in the center position of the Saturn’s second row within an Evenflo Big Kid belt positioning booster. The seat was manufactured on December 18, 2006 and had the model number 3371689A. The labels indicated that the seat was for use by children between 13.6 – 45.3 kg (30 – 100 lb) and 97 – 145 cm (38 – 57”). These usage requirements were denoted for when the BSS was utilized with the detachable seatback. Without the back support, the BSS was recommended for use by children between 18 – 45 kg (40 – 100 lb) and 102 – 145 cm (40 – 57”) in height. **Figure 8** is a frontal view of the BSS used in this crash. Following the crash, the BSS was removed from the vehicle and taken to the driver’s home. It was inspected at that location during the on-site SCI investigation.

Figure 8 - Frontal view of Evenflo Big Kid BSS.

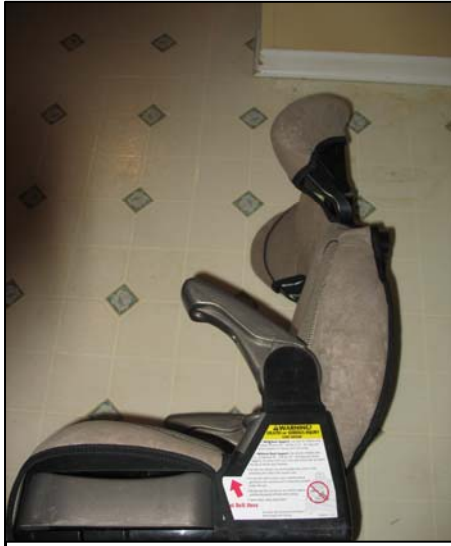
Figure 9 - Left side of the BSS.

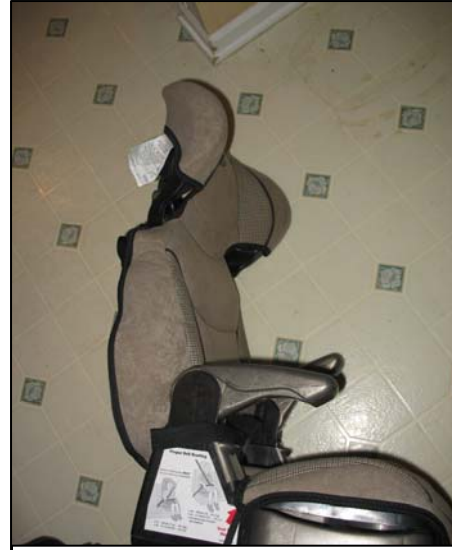
Figure 10 - Right side of the BSS.
