## ON-SITE SIDE IMPACT INFLATABLE OCCUPANT PROTECTION INVESTIGATION

CASE NUMBER - IN08013  
LOCATION - TEXAS  
VEHICLE - 2007 TOYOTA CAMRY LE  
CRASH DATE - January 2008

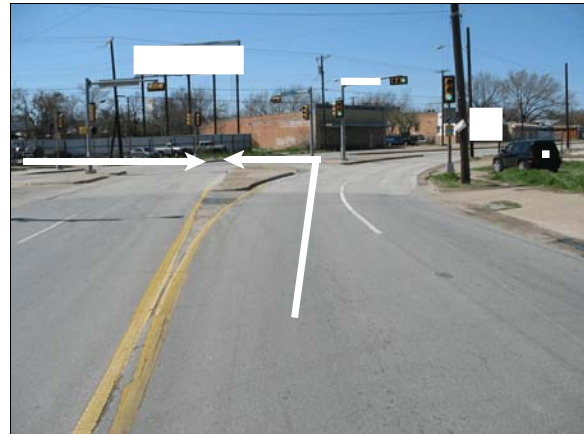
**Figure 2:** Approach of Toyota (right arrow) to the intersection and left turn lane channel; left arrow is approach of Mitsubishi

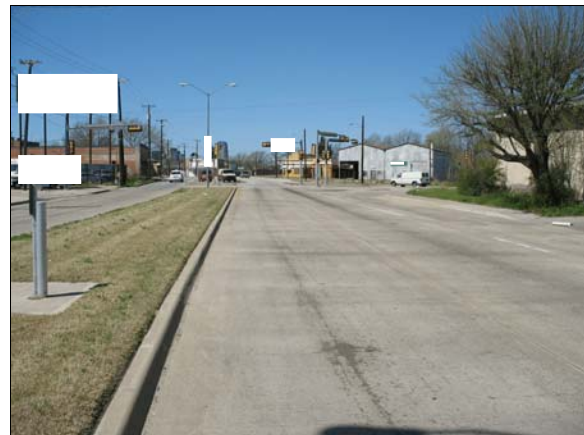
**Figure 3:** Approach of Mitsubishi to the intersection
