**CALSPAN ON-SITE OFFICE OF DEFECTS CRASH INVESTIGATION**

**SCI CASE NO.: CA08023**

**VEHICLE: 2007 DODGE CALIBER**

**CRASH DATE: MARCH 2008**

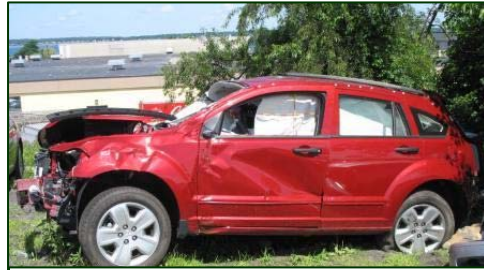
**Figure 1. Left side view of the 2007 Dodge Caliber.**

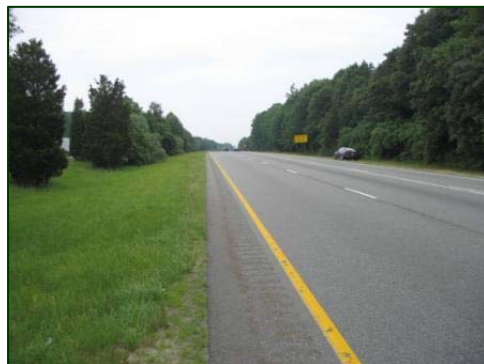
**Figure 2. Overall view of the reported crash site.**

It should be noted that no physical evidence associated with the crash was identified during the on-site inspection of the crash scene. The SCI investigator searched the area prior to and beyond the referenced location of the crash on the Police Crash Report (PAR). Additionally, the tow facility was contacted by telephone in an attempt to locate a more precise location of the crash. The proprietor referred the SCI investigator to the investigating police agency who only logged the call with the location reference on the PAR. During the second attempt to locate the scene, the SCI investigator was instructed to leave the Interstate by a police officer who cited State policy and safety concerns.

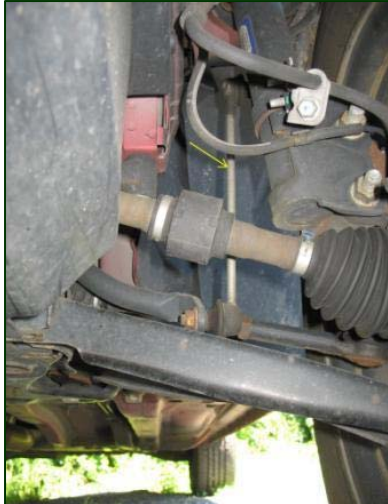
The vertical stabilizer links that connected the sway bar to the strut were deformed. These links consisted of a solid rod with a small tie-rod-type pivot at the top and bottom ends. The studs were fastened to the sway bar and the strut housing. Based on an exemplar vehicle, these stabilizer links were 27 cm (10.5 in) in length (centerline of bearing studs) and were 6 mm (0.25 in) in diameter. The left stabilizer link was bowed at the upper third in a lateral inboard direction. The upper third aspect of the right link was bowed in a forward direction. There was no evidence of contact from adjacent suspension/steering components. These links probably deformed during the rollover as the front suspension was fully compressed by tire contact to the ground. The pivots remained intact and tight on both links. **Figures 9 and 11** are of the front stabilizer links of an exemplar vehicle. **Figures 10 and 12** are the deformed links from the 2007 Dodge Caliber case vehicle.

**Figure 9. Left front stabilizer link of an exemplar vehicle.**

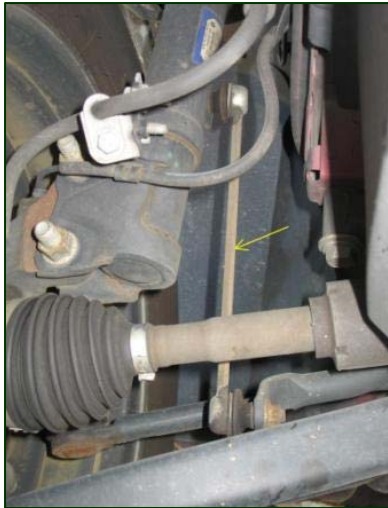
**Figure 11. Right front stabilizer link of an exemplar vehicle.**

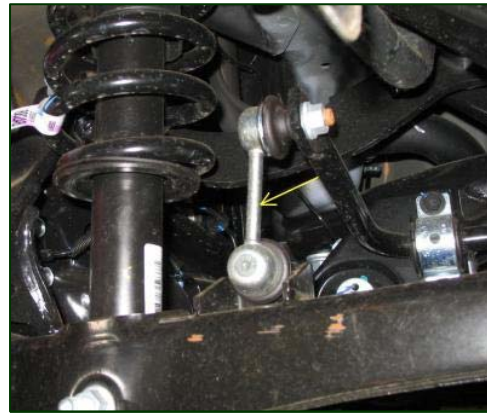
The rear stabilizer links were similar to the fronts with knuckles at the mounting points. Both rear stabilizers were intact and tight at the knuckle joints; however, both were deformed at the lower aspect due to the forward displacement of the rear axle. An inspection of an exemplar vehicle indicated that these stabilizer links were originally straight (**Figure 14**) with a length of 8 cm (3.1 in) at the mid points of the knuckles and a diameter of 6 mm (0.25 in). The deformed links from the 2007 Dodge Caliber are shown in **Figures 15 and 16**.

**Figure 14.** Left rear stabilizer link of an exemplar vehicle.

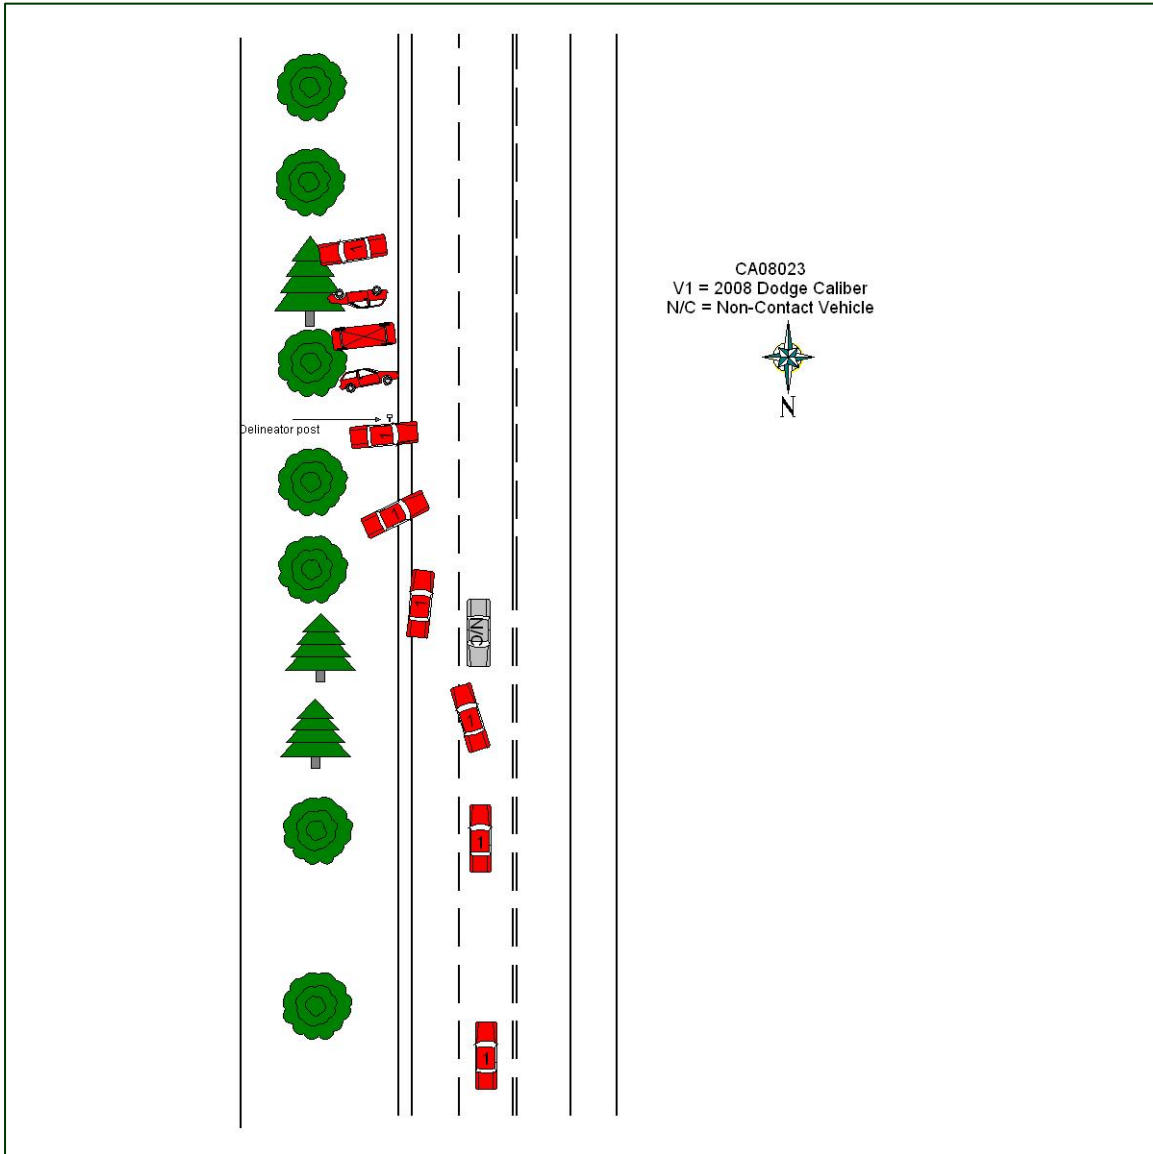
Figure 19. Crash Schematic

travel lanes were bordered by asphalt shoulder's that were 1.2 m (4 ft) in width with tactile warning devices (rumble strips) cut into the surface of the shoulder immediately outboard of the painted edge lines. The road was straight with a slight positive grade for southbound traffic. The posted speed limit was 105 km/h (65 mph). The Crash Schematic is included as **Figure 19** of this report.
