**CALSPAN ON-SITE CERTIFIED ADVANCED 208-COMPLIANT VEHICLE
CRASH INVESTIGATION**

SCI CASE NO: CA08029

VEHICLE: 2007 SUBARU LEGACY

CRASH DATE: JULY 2008

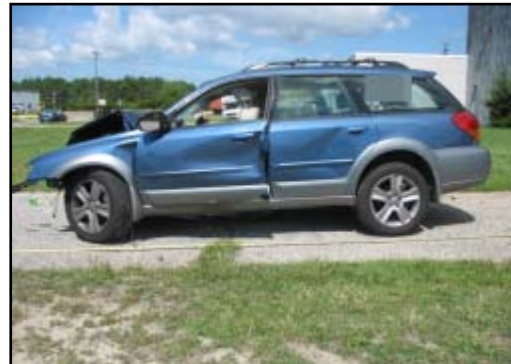
This on-site investigation focused on the Certified Advanced 208-Compliant (CAC) safety system in 2007 Subaru Legacy (**Figure 1**) and the resultant injuries to an unrestrained 55-year-old female driver. The manufacturer of this vehicle has certified that the Legacy is compliant to the Advanced Air Bag portion of Federal Motor Vehicle Safety Standard No. 208. The Subaru's CAC system consisted of dual stage frontal air bags, seat track position sensors, safety belt buckle switch sensors, retractor mounted safety belt pretensioners for the front seats, and an occupant weight sensor for the front right seat. In addition to the CAC system, the Subaru was equipped with seat back mounted side impact air bags and curtain air bags for the outboard seating positions. The Subaru was involved in a head-on frontal collision with a 2006 Lexus GX 470. As a result of the crash the driver's frontal air bag deployed in the Subaru. The driver of the Subaru sustained fatal injuries and was pronounced deceased 27 minutes post-crash.

Figure 1. 2007 Subaru Legacy.

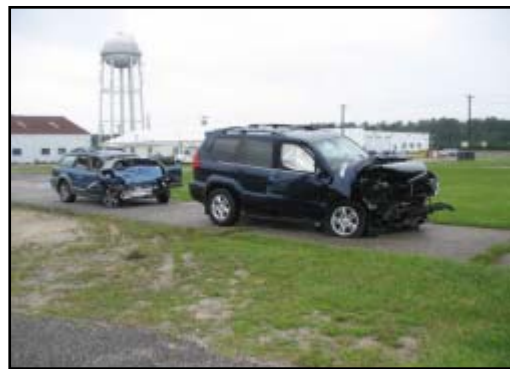
Figure 2. Overall view of the Subaru and the Lexus.

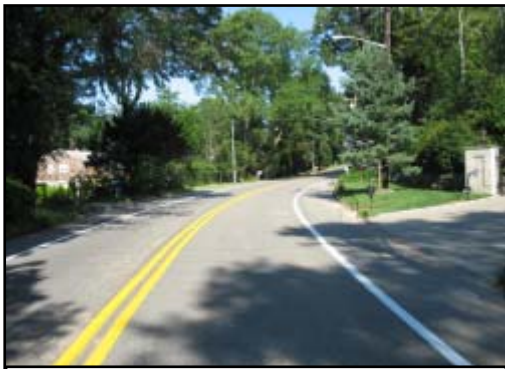
The 55-year old female driver of the 2007 Subaru was operating the vehicle in an easterly direction on the two-lane roadway. The vehicle entered a 90 meter (295') long right curve during its eastbound travel. As the vehicle neared the end of the right curve, the driver allowed the Subaru to cross the double yellow centerline and enter the westbound travel lane (**Figure 3**). The driver's autopsy revealed that her post-mortem Blood Alcohol Content (BAC) measured 0.39.

Figure 3. Eastbound approach of the Subaru.

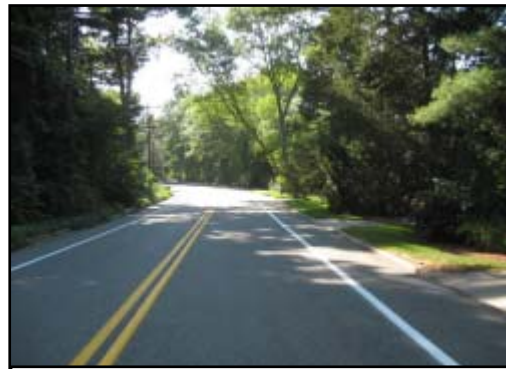
The 39-year-old female driver of the Lexus was operating her vehicle westbound approaching the curved section of the roadway (**Figure 4**). In the westbound direction, the roadway curved left. The driver of the Lexus observed the Subaru in the westbound lane as she neared the left curve. The driver of the Lexus applied a left steering input in an effort to avoid the Subaru. The Scene Schematic is included as **Figure 17** of this report.

Figure 4. Westbound approach of the Lexus.

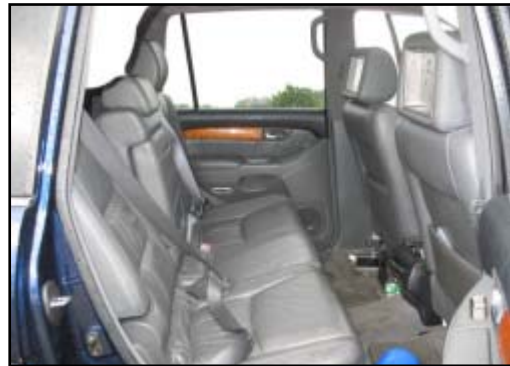
Figure 11. Overall view of the second row of the Lexus.
