**CRASH DATA RESEARCH CENTER**

**CALSPAN ON-SITE ROLLOVER CRASH INVESTIGATION  
CALSPAN CASE NO: CA08031**

**VEHICLE: 2007 CHEVROLET SILVERADO  
LOCATION: NORTH CAROLINA  
CRASH DATE: JUNE, 2008**

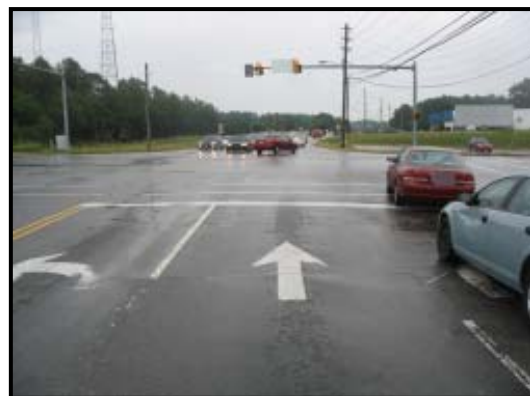
**Figure 2: View of the area of impact from the eastbound approach of the Chevrolet Silverado.**

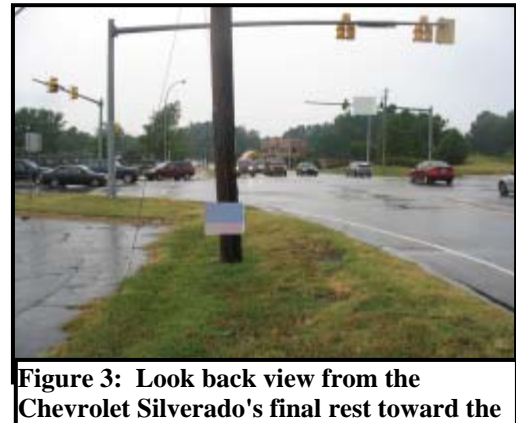
Immediately after the first impact the Chevrolet Silverado began to rollover. The frontal impact induced a slight clockwise (CW) rotation which exacerbated the initial rollover forces. The Chevrolet Silverado rolled three-quarter turns to the left (Event 2) as it traveled in a southeast trajectory. The Chevrolet Silverado departed the southeast quadrant and entered the grass roadside where it impacted a wooden utility pole with the undercarriage (Event 3). The Chevrolet Silverado came to rest on its right side against the utility pole. The interrupted roll distance was approximately 24 m (80 ft). **Figure 3** is a look back view from the Chevrolet Silverado's final rest position toward the intersection. The Chevrolet Cobalt rotated CW and was redirected in a southeast trajectory where it departed the southeast roadside. The Chevrolet Cobalt came to rest in the parking lot on the southeast roadside 25 m (82 ft) from the impact.

**Figure 3: Look back view from the Chevrolet Silverado's final rest toward the**
