## ON-SITE SIDE IMPACT INFLATABLE OCCUPANT PROTECTION INVESTIGATION

CASE NUMBER - IN08032

VEHICLE - 2007 HONDA CIVIC LX

CRASH DATE - June 2008

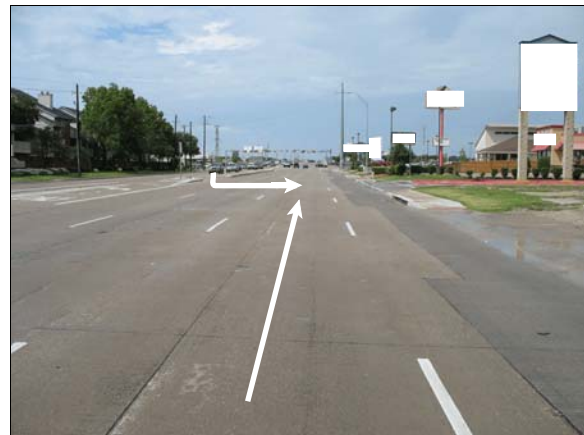
**Figure 2:** Approach of Honda northbound in the outside center travel lane and Buick turning left from left turn lane

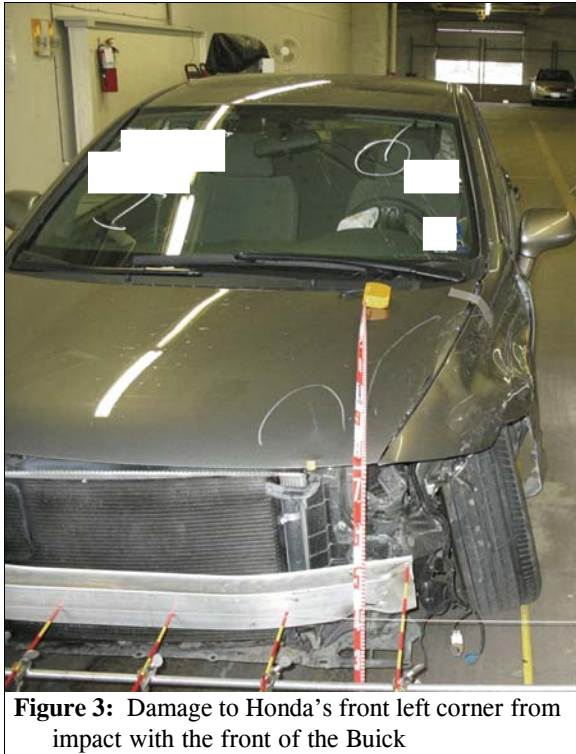
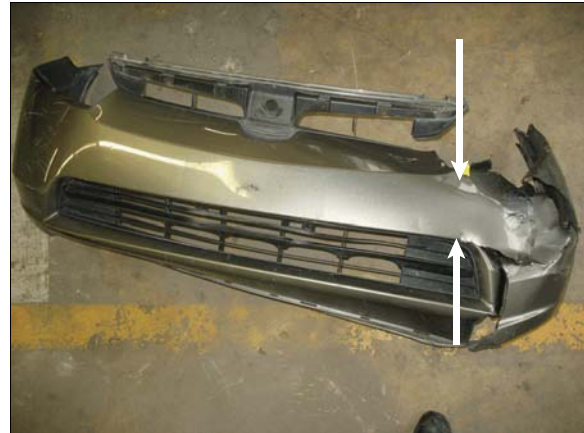
**Crash:** As the Buick's driver proceeded through the left turn, the vehicle's front left impacted the Honda's front left bumper corner (**Figures 3 and 4**, event 1). The Honda's direction of force was within the 11 o'clock sector and the impact force was sufficient to deploy the driver's frontal air bag. The impact caused the Honda to rotate clockwise and the Buick to rotate counterclockwise, and the right rear corner of the Buick impacted the Honda's left lower B-pillar (**Figure 5**, event 2). The Honda's direction of force was within the 9 o'clock sector and the impact force was sufficient to trigger the deployment of the Honda's left side curtain air bag and the front left seat back-mounted side impact air bag. Both vehicles came to final rest on the north leg of the intersection heading north.
